Arborist Report

Site/Address: Holy Family Church, 120 Ave NE, Kirkland, WA 98033
Date: March 10, 2009

Arborist: E. John Deutsch ISA Certified Arborist # PN 3994A
810 19th Lane West Kirkland, WA 98033

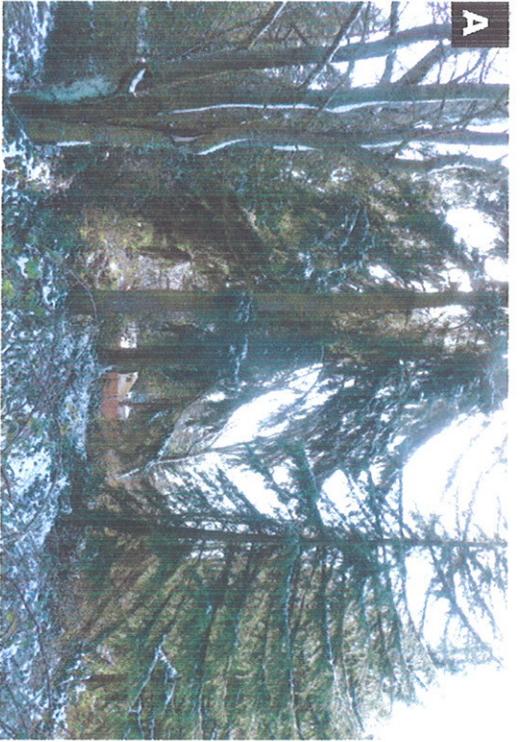
A	B	C	D	E	F	G	H	I	J	K	L	M	N	O
Tree #	Species	DBH	Height	Width	Dripline	Limits Disturb.	LCR %	Crown Class	Structure & Form	Trunk	Root system	Overall	Viable	Tree Credits
3	Cherry #3007 #3009	9-11	40	30	15	7		Co-Dom.	Major Assym.	Poor	Good	Poor	No	4
<p>Conclusion/Recommendation: Photo A and B, extreme left, Photo G: close-up of four trunks. Tagged previously as #3007, #3009. Major cavity wounds, bark damage, stubs, major lean, little aesthetic value, removal an option, not a major risk.</p>

Conclusion/Recommendation: Photo A (middle left), Photo B (to the right of 4 trunk deciduous), Photo H (to the right of scoreboard sign)
 Tagged previously as #3011, Previously topped. Not a significant risk.

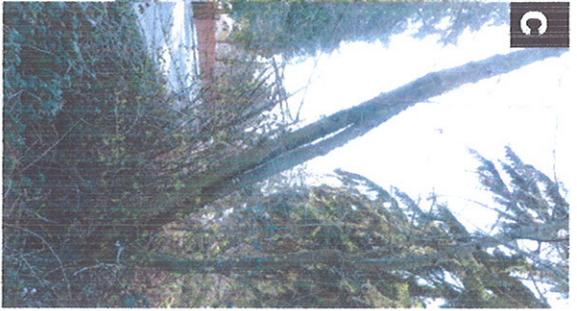
C

B	Decid	10-12	30	25	15	8		Co-Dom.	Major Assym	Poor	Good	Poor	No	3
<p>Conclusion/Recommendation: Photo C, 3 trunk, Two trunks have major lean towards busy NE 70 ST (heavy traffic and pedestrian use), These two trunks are growing into the street light and will interfere with illumination in future years, Little aesthetic value, Significant risk, Removal a viable option.</p>

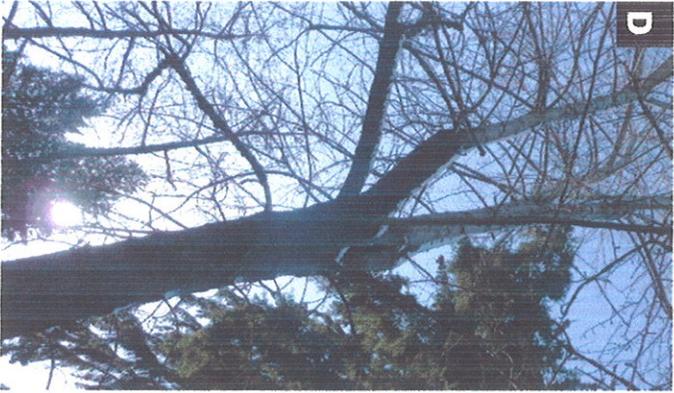
A	Cottonwood	30	60	35	20	18		Co-Dom.	Major Assym	Poor	Good	Poor	No	11
<p>Conclusion/Recommendation: Photos D and E, Tagged previously as #3010 Major decay on top, medium lean towards busy NE 70 ST (heavy traffic and pedestrian use), Loosely attached leaders approx. 25 ft from ground level, no practical measures to correct structural deformity, major risk and removal is recommended.</p>

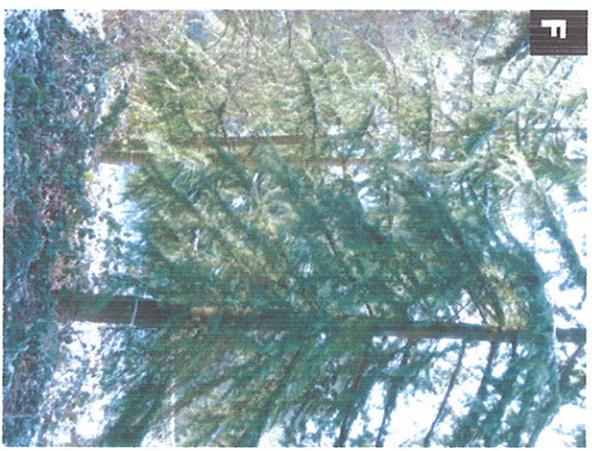
Conclusion/Recommendation: Photo F (right side), Photo H (left side), Slight, self-corrected lean, Good form

Conclusion/Recommendation: Photo F (left side), Photo H (right side), Two trunk, Satisfactory form
