JOB SITE: 9105 128th Ave NE, Kirkland, WA, 98033

SUBJECT: Tree Inventory and Assessments for Parcel #1238500350

DATE: April 22, 2013

PREPARED BY: Nicholas W. Dankers,
ISA Certified Arborist #PN-5628A
ISA Qualified Tree Risk Assessor

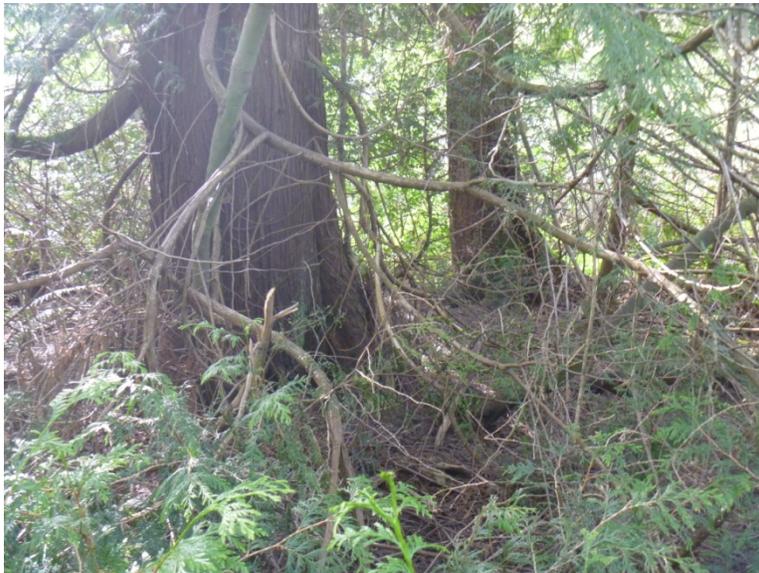
Nearby, the largest conifer on site is the 30.9-inch diameter Western Red cedar (*Thuja plicata*) Tree #982.

Photo 2: Western Red Cedar Trees #981 and #982 from the W

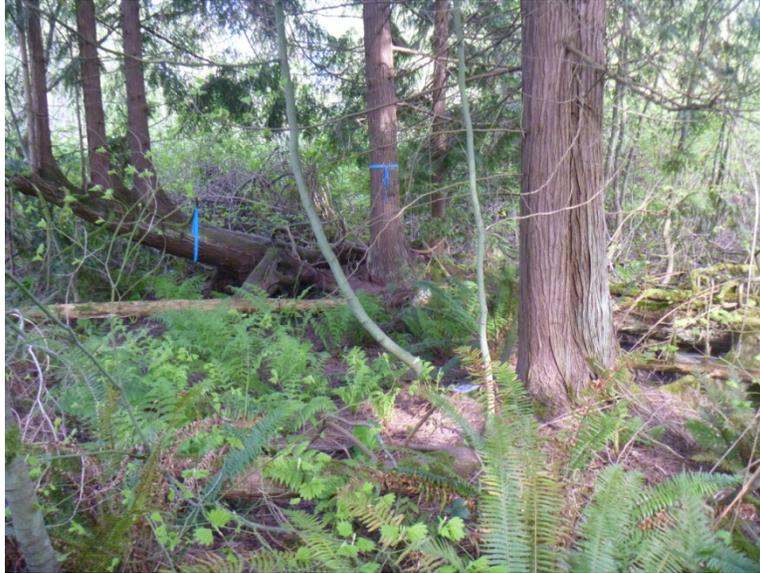
A group of the Western Red cedar trees, #986 through #991, are growing off a single tree that had fallen over previously. Multiple shoots had since grown upwards and rooted into the ground. I noted internal decay in Tree #990.

Photo 3: Western Red Cedar Trees #986 through #991 from the W

Despite the questionable roots of the Western Red cedar trees growing off a fallen parent, it is likely that this group will continue to root themselves into the ground. Trees #986 through #991 should be inspected every 5 years to determine their structural integrity.

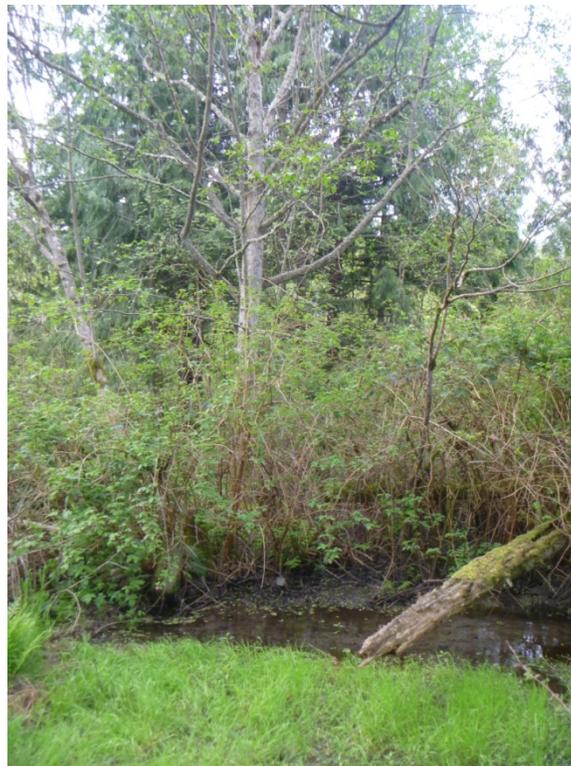
Numerous Red alder (*Alnus rubra*) trees have corrected leans, where the trunks curved towards the vertical orientation after a past, partial failure. Many trees have dead tops and show other signs of decline.

Photo 4: Red Alder Trees #992 and #993 from the N

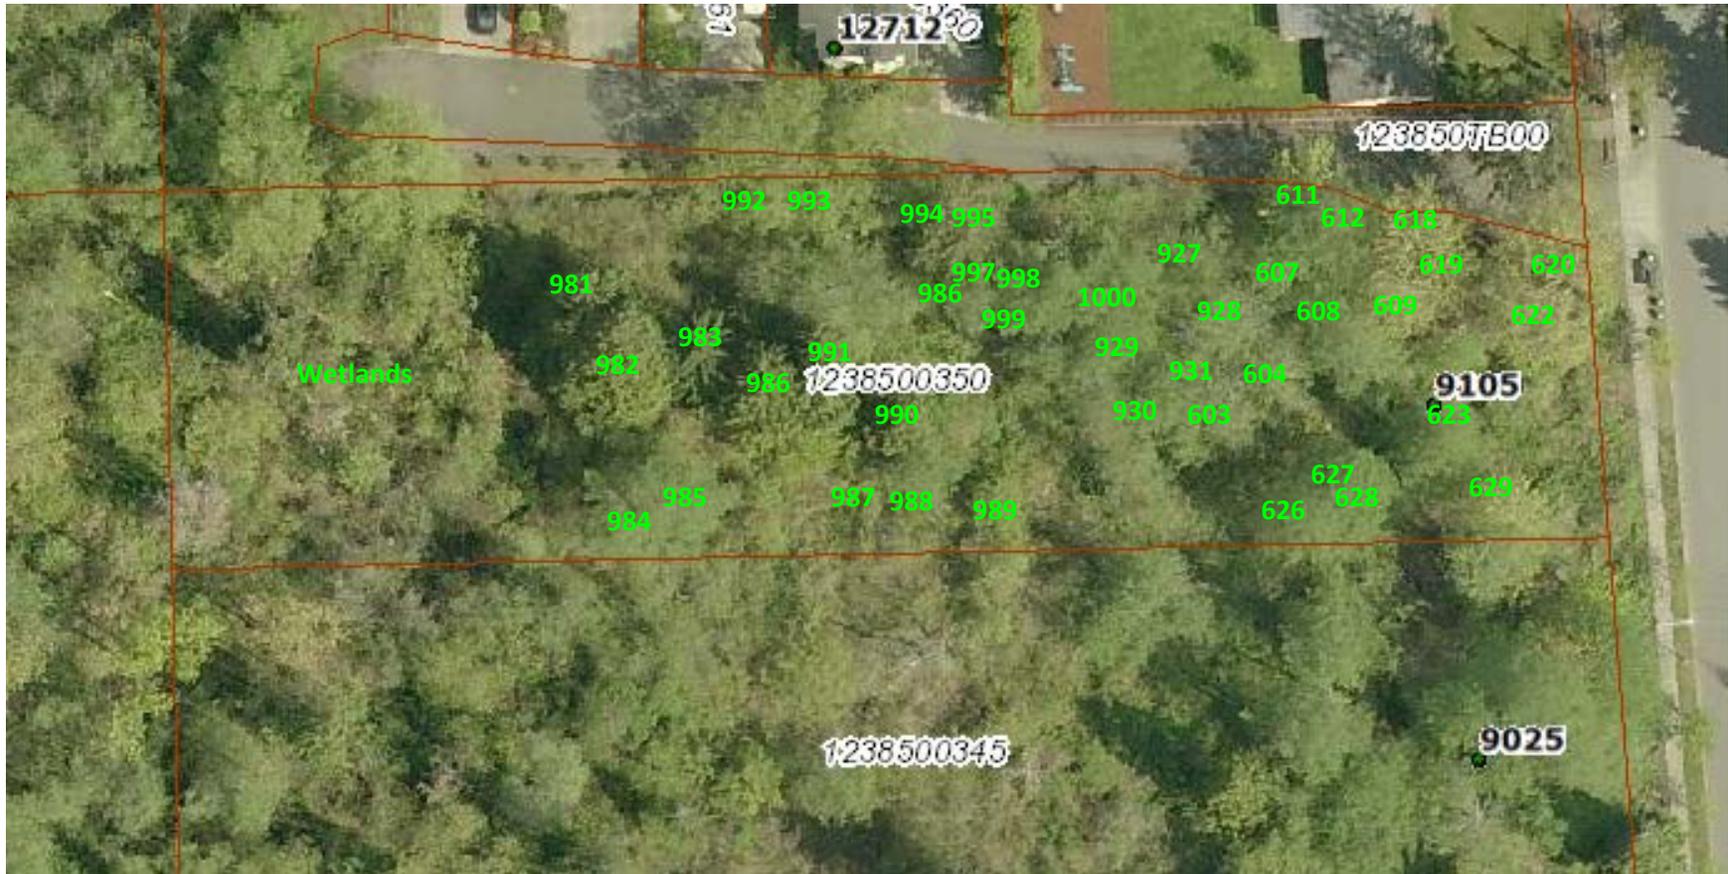
Tree Locations for Lot at 9105 128th Ave NE, Kirkland, WA, 98033

Due to some of the patches of this invasive species, I could not tag Trees #994, #995, #626, and #628. These tree locations are indicated on the Site Photograph.
