JOB SITE: 10613 NE 38<sup>th</sup> Place, Kirkland, WA 98033

SUBJECT: Tree Inventory & Viability Assessment

DATE: July 14, 2014

PREPARED BY: Scott Baker,  
ASCA Registered Consulting Arborist #414, ISA Board Certified  
Master Arborist PN-0670B, ISA Qualified Tree Risk Assessor

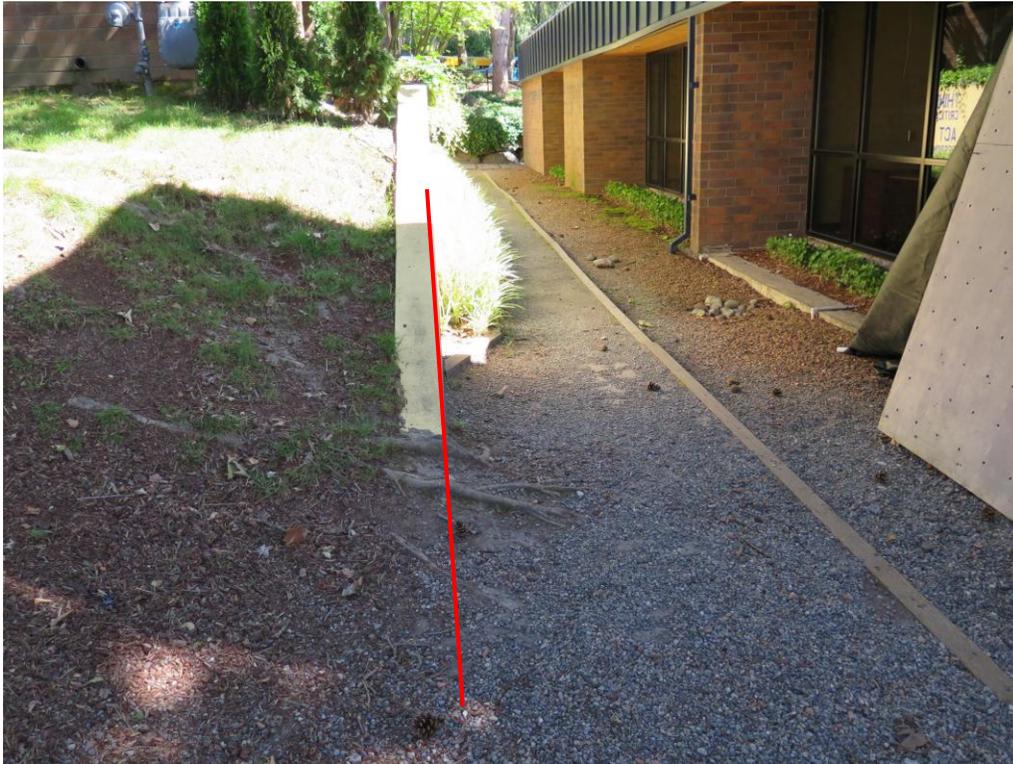
**Photo 1: Limits of disturbance for tree 531 represented by red line – careful root pruning necessary & acceptable**

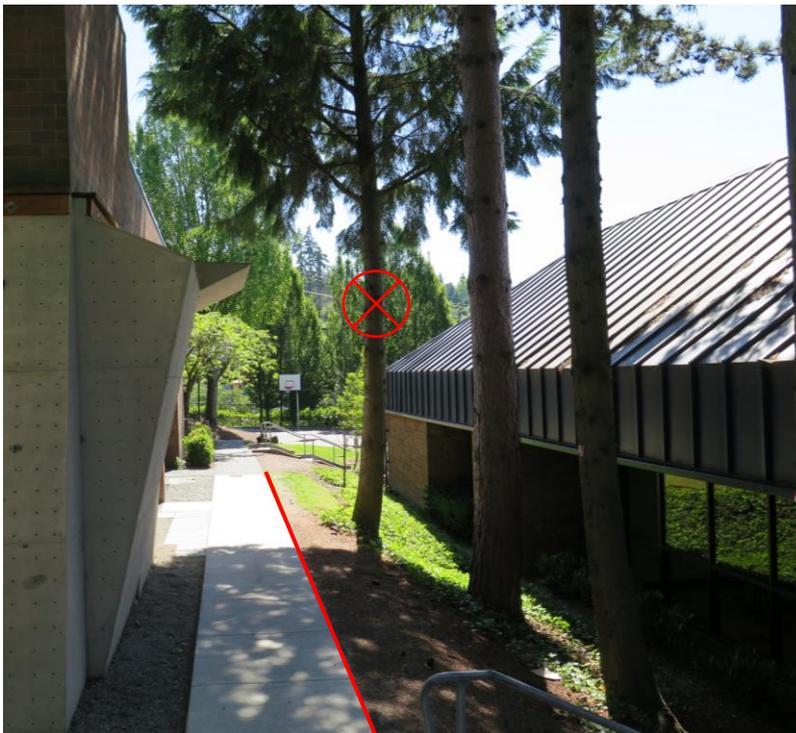
**Photo 2: Limits of disturbance for trees 532, 533, & 534 represented by red line – tree 535 to be removed (red circle with X)**

- Perform required root exploration for trees 532, 533, 534, and 544 prior to commencement of site work activities.
- Install tree protection for trees to be retained prior to heavy equipment arriving on site.
- Trees to be retained should not be damaged by trees that will be removed.

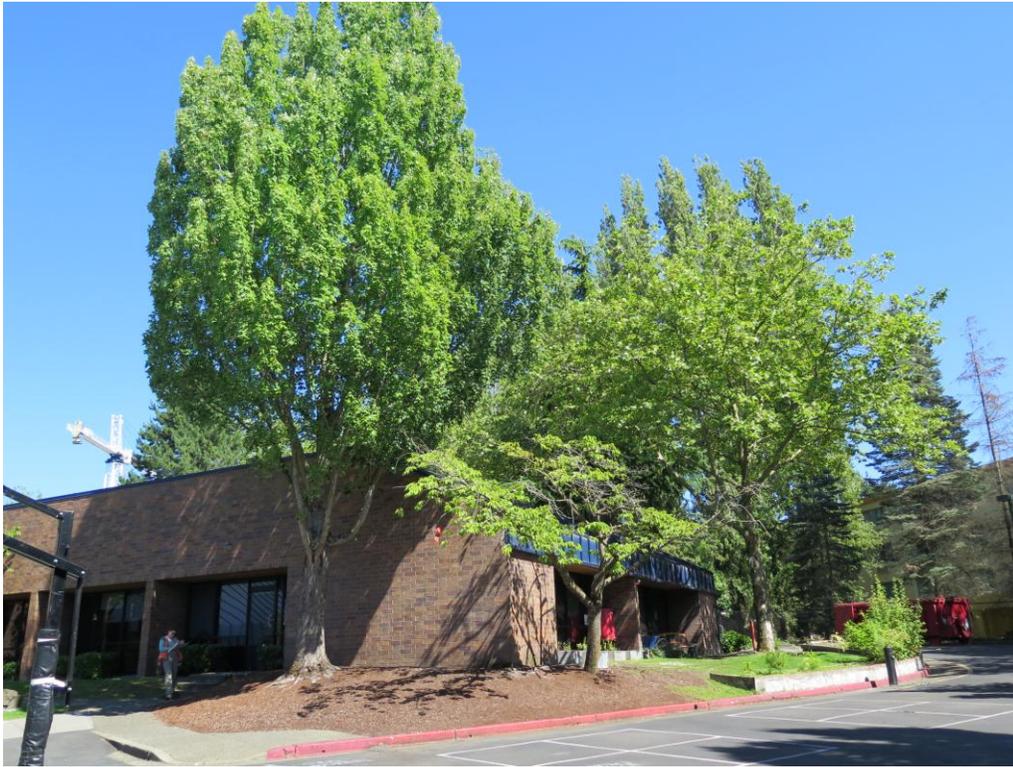
**Photo 3: Trees to be removed at west end of site (left to right: 537, 538, & 539)**

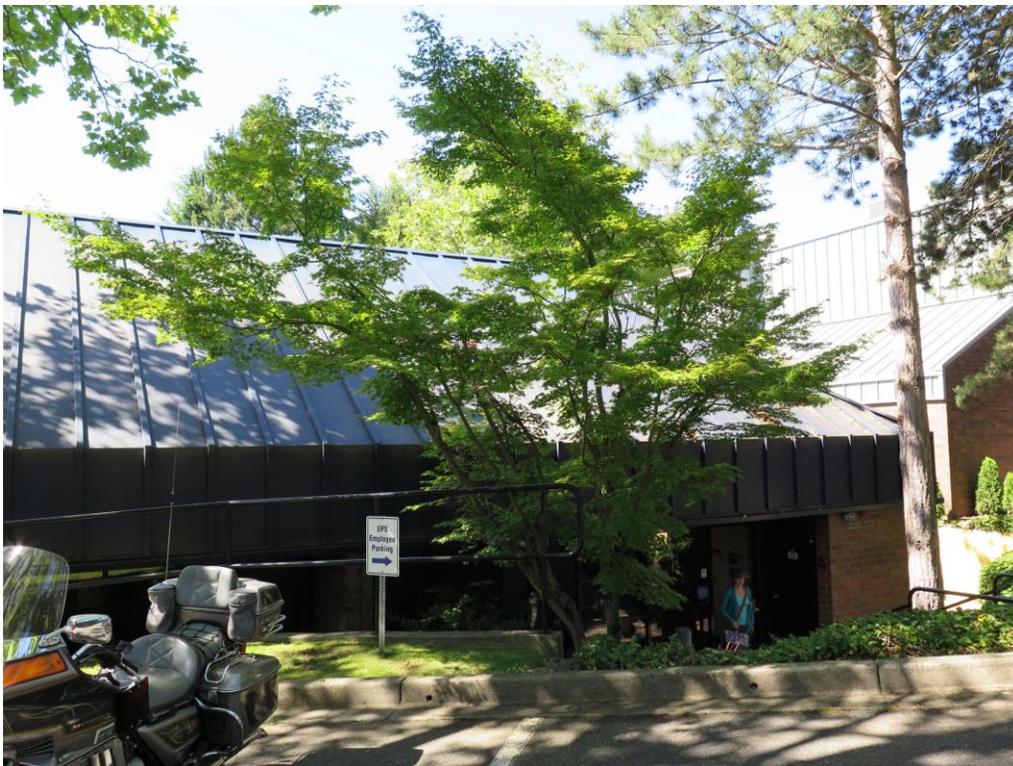
**Photo 4: Tree 543 to be retained**

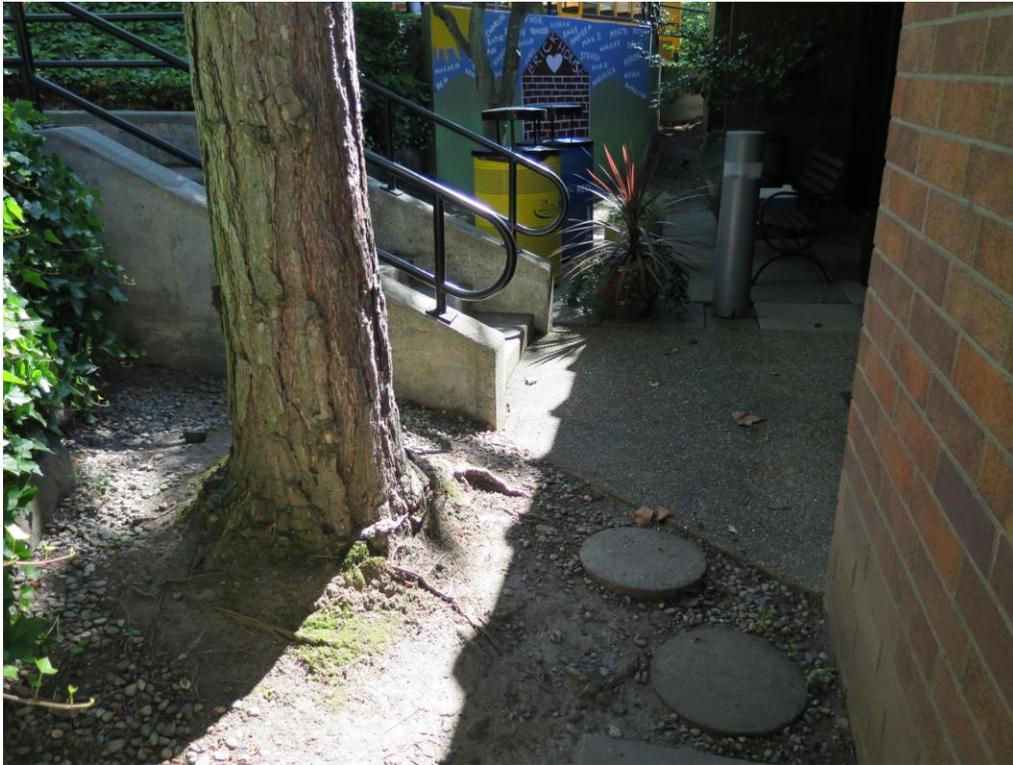
Photo 5: Base of tree 544 – root exploration required to determine if tree can be retained

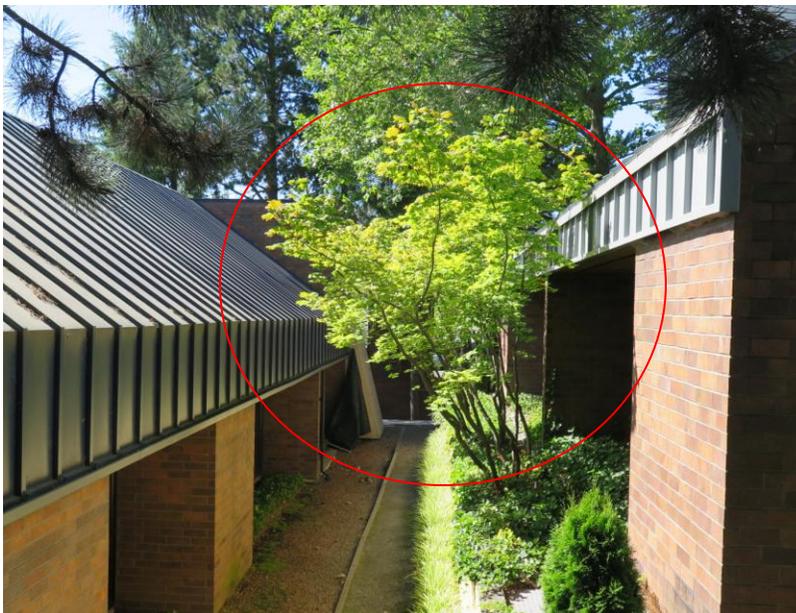
Photo 6: Looking northwest from southeast corner of site at grouping of non-significant Japanese maple trees (circled in red) – advisable to tie back canopies during site work activities in order to avoid damage from machinery
