TO: Ron Hastie
JOB SITE: 12215 NE 128th St.
SUBJECT: Madison House Tree Inventory and Report
DATE: July 16, 2014
PREPARED BY: Chris Madison
ISA Certified Arborist PN-7671A
ISA Qualified Tree Risk Assessor

Assignment & Scope of Report

This report outlines the site inspection by Chris Madison of Tree Solutions Inc. on June 25, 2014. Included are observations and data collected at the site located at 12215 NE 128th Street. Ron Hastie, of RJ Development, requested these services to acquire information for project planning.

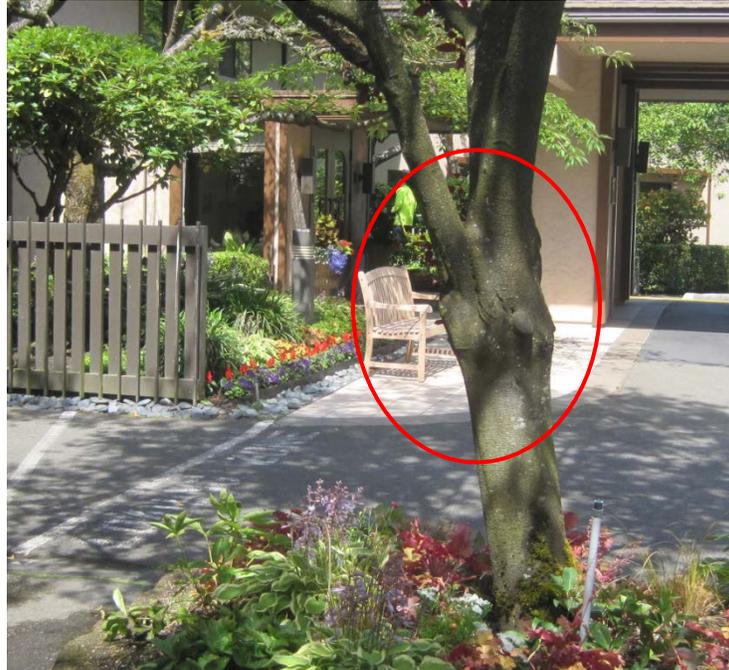
Tree 3 is a Flowering plum measuring 8.9 inches DSH. This tree has multiple branch attachments at a single union, with narrow angles of attachment. This form is also see in Trees 20 and 24- both flowering plums. It's most likely these trees were form pruned this way by the nursery. While this form is typical to this tree, it's not a structurally strong form which is why I gave this tree a fair structural rating (see [Photo 2](#)).

Photo 1- Tree 3. Note the close angle of attachments.

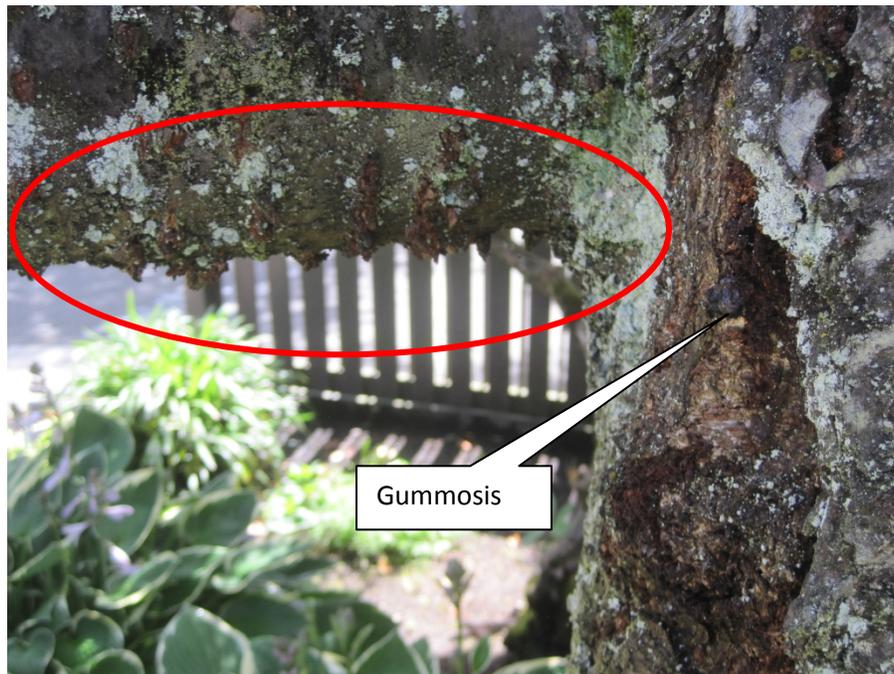
Many of the trees are flowering cherry trees, showed significant dieback in their canopy. During my visit I noted signs of Cherry bark tortrix (*Enarmonia formosana*) on many of the trees (see [Photo 1](#)). Cherry bark tortrix (CBT) is a moth whose larval form eats away at the vascular tissues of the plant, which cause branch dieback and eventual death of the entire tree if infestations are heavy enough. Branches which have died back do not recover, and pose a potential hazard to nearby targets. CBT is attracted to trees with fresh wounds on it, including pruning wounds. If trees were pruned during the time that adults are active (May through September) then infestation could have occurred.

Photo 2- Evidence of Cherry bark tortrix on Tree 5. Note the orange colored frass tubes hanging from the tree branch. Also note the gummosis, a response *Prunus* sp. give in attempt to ward off CBT.

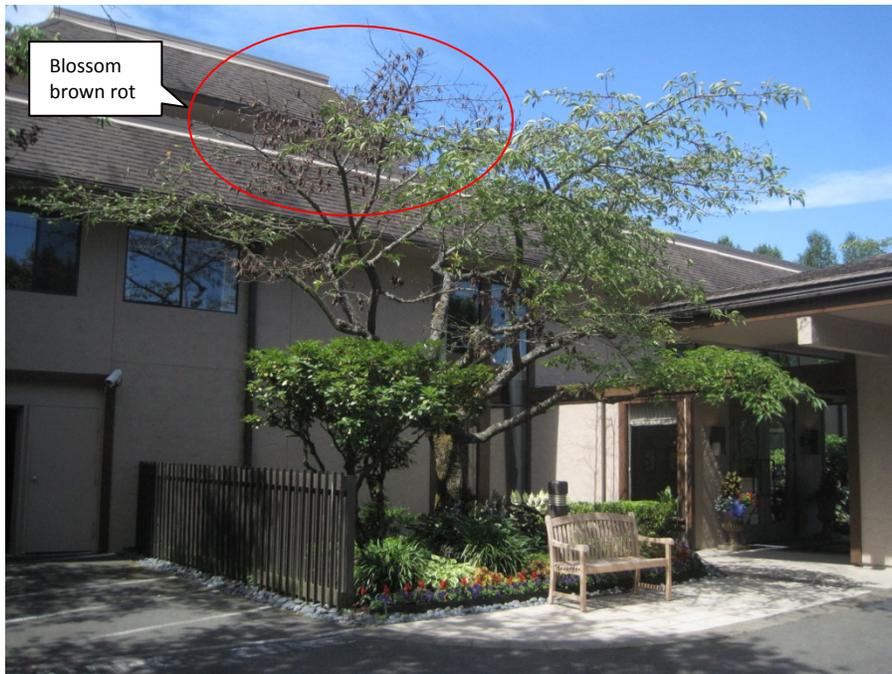
Tree 5 is a flowering cherry measuring 16.4 DSH, and showed significant dieback in the crown (see [Photo 3](#)). This tree is situated by the entrance way to the east, with one of the scaffold branches hanging over a bench in the front. I estimated this tree to have a 40% live crown ratio (LCR). Any branches that die on this tree will possess a potential hazard to the targets below, including sidewalk pedestrians, the fence, and the bench and its users. This tree had signs of blossom brown rot and CBT.

Photo 3- Tree 5 showing some dieback in the upper crown. Note area of dieback is above the branch that showed CBT evidence (Photo 2). Hanging foliage and flowers are signs of blossom brown rot.

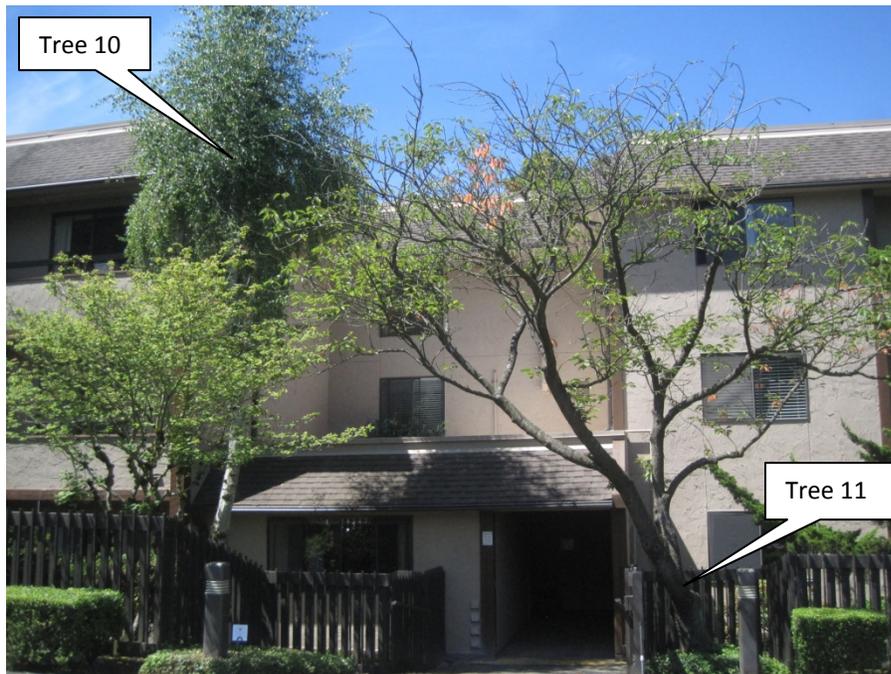
Tree 10 is a European birch, measuring 11.2 inches in diameter. This tree has a history of top cuts- resulting in a "lollipop" shape, which I have given a 'poor' structural form rating (see [Photo 4](#)).

Tree 11 is a flowering cherry measuring 10.1 DSH (using the single trunk formula). This tree also showed significant dieback in the crown (see [Photo 4](#)). This tree is located just west of the service entrance on the western wing of the building. I estimated this tree to have 30% LCR. Like **Tree 5**, Any branches that die on this tree will possess a potential hazard to the targets below using the service entrance. This tree had signs of blossom brown rot and CBT.

Photo 4- Note the overhanging branches of Tree 11, which are located over the service entrance. Dead twigs and old foliage/flowers hanging likely signs of blossom brown rot. Also note the 'lollipop' form of Tree 10.

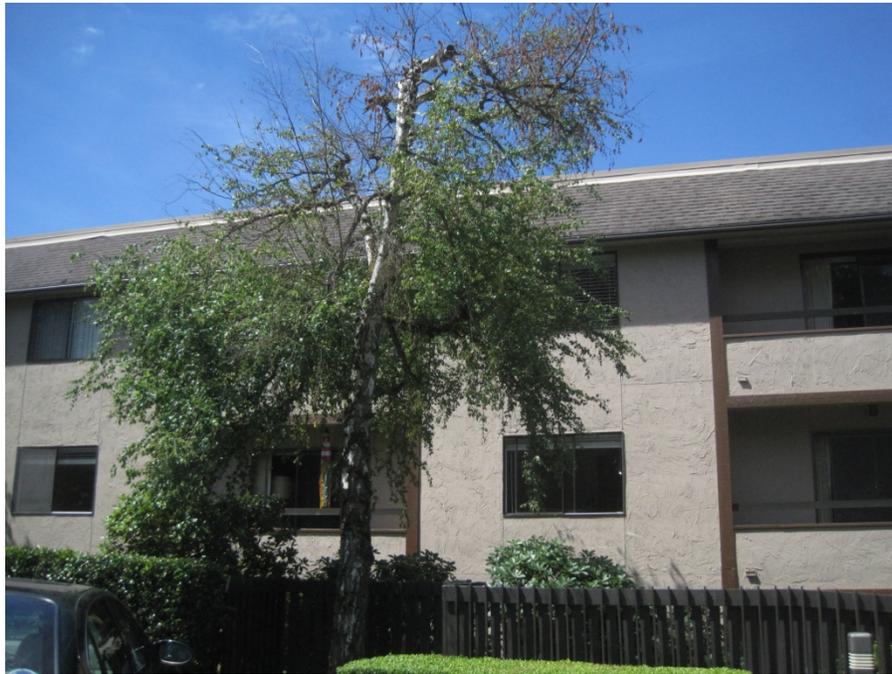
Tree 8 is a European birch, measuring 13.6 inches in diameter. I rated this tree with poor health and poor structure. The canopy of this tree is dying back, a typical symptom of BBB (see [Photo 5](#)). This tree was in the worst condition of all of the birches on site.

Photo 5- Tree 8. Note the top dieback, most likely due to bronze birch borer. Also note history of poor pruning history involving topping cuts, with no current top regrowth.

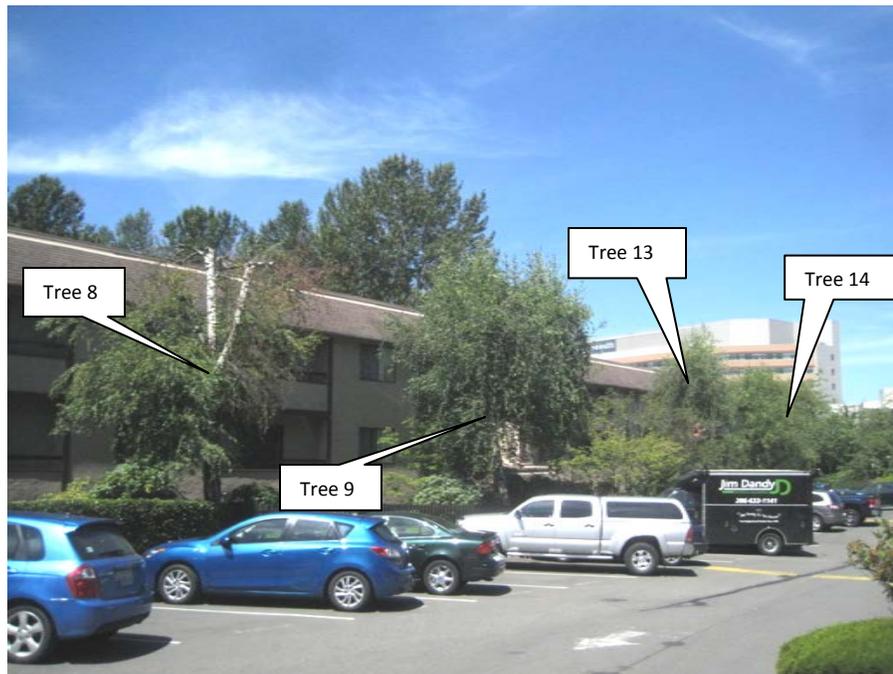
Tree 9 is a European birch, measuring 11.2 inches in diameter. This tree has a history of top cuts- resulting in a fair structural form (see [Photo 6](#)).

Tree 13 is a European birch, measuring 7.2 inches in diameter. This tree has a history of top cuts- resulting in a fair structural form (see [Photo 6](#)).

Tree 14 is a European birch, measuring 11.2 inches in diameter. This tree has a history of top cuts- resulting in "lollipop" form which I have rated as poor structural form (see [Photo 6](#)).

Photo 6- The row of birches as seen from the east. Note the extreme dieback of Tree 8, and the topped forms of Tree 9 and 13. (The brightness and contrast of this photo was adjusted so that the tree forms could be more visible)

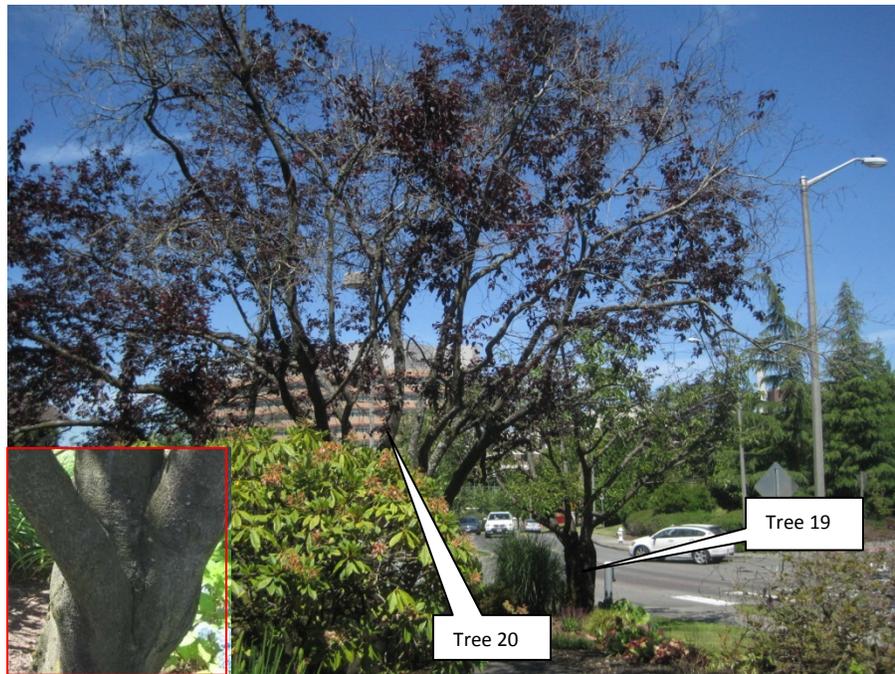
Tree 19 is a flowering cherry measuring 19.9 inches DSH. I rated this tree at poor health, because it possessed a sparse canopy with dieback of the smaller branches (see [Photo 7](#)). I also noted that the graft union of the tree was swollen, so I had to take the measurement below this area. The swelling of this union can indicate possible defects, which did affect my health and structural rating of this tree. Topping cuts are visible throughout the canopy. This tree had signs of blossom brown rot and CBT.

Tree 20 is a Flowering plum measuring 13.2 inches DSH. This tree has multiple branch attachments at a single union with narrow angles of attachment. This tree also has a lot of dieback in the crown, and a sparse canopy. I rated the health of this tree as poor, and its structural condition fair (see [Photo 7](#)).

Photo 7- Photo of Tree 20 showing a sizeable amount of dieback in the crown. Note the photo of the narrow angle of attachments as well. Tree 19 and the sparse canopy can also be seen from this photo.
