EVALUATION OF SELECTED TREES AT

KIRKLAND PARKPLACE
6th Street & Central Way
Kirkland, WA 98033

August 30, 2010

GILLES CONSULTING

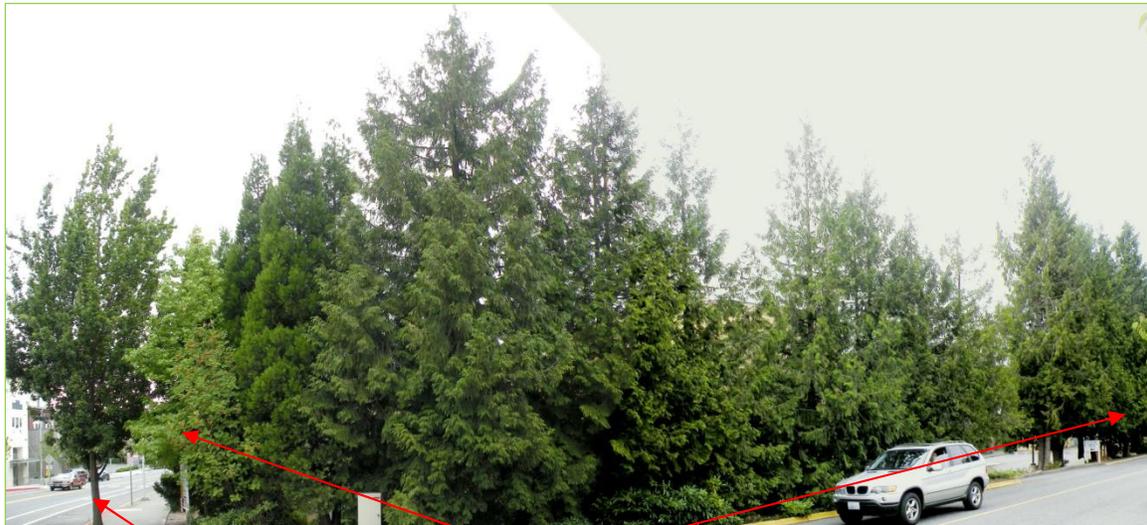
Photo # 1: Panoramic view of the west property line extension with trees # 101 - 124

Trees 102 -- 124

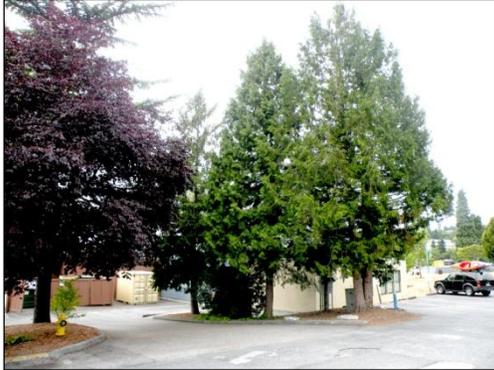
Tree # 101 is in the Kirkland Avenue sidewalk and will need to be protected during construction

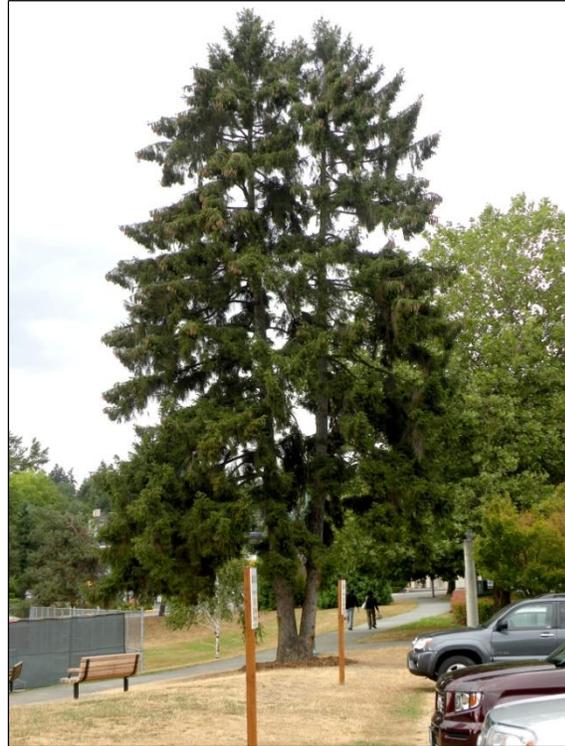
Photo # 3: Tree # 183 west of the west property line

Photo # 4: The base of # 183 showing the open wound and the included bark

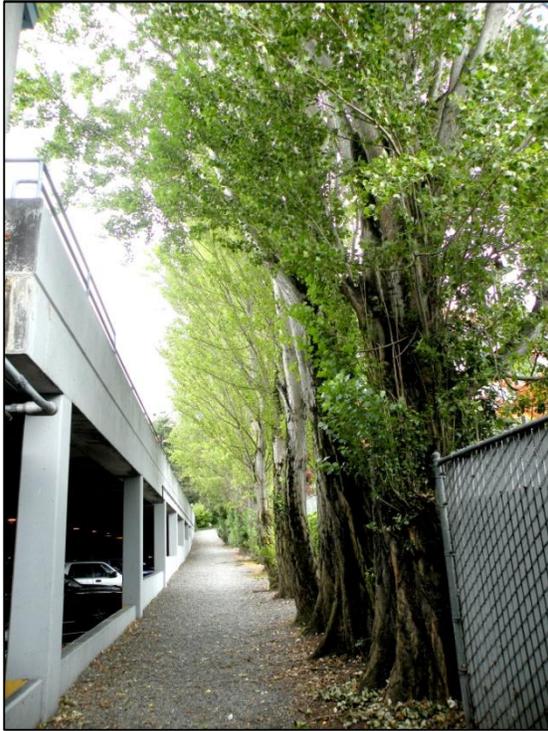
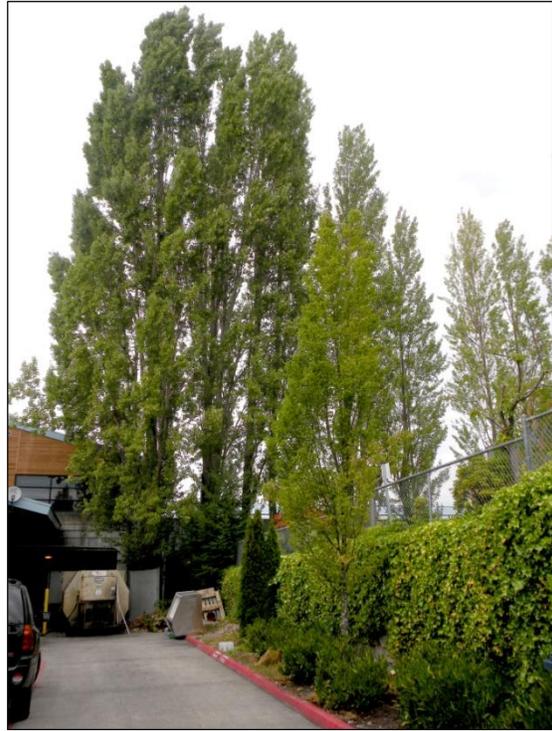
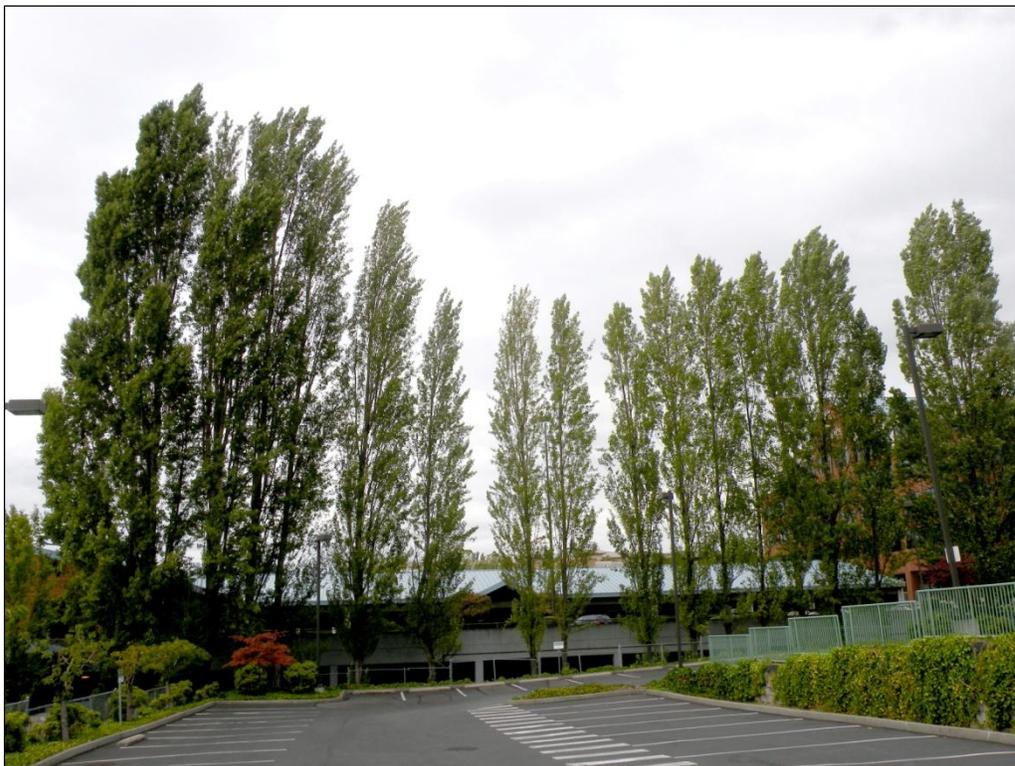
There are 30 trees along the southern property line that are in this category. Trees # 138 through 153 are a row of Lombardy Poplars, *Populus nigra 'Italica,'* that are growing in a row between the parking garage structure and the block retaining wall that is holding up the parking lot on the adjacent property to the south. They are all in Fair to Good Condition. This is surprising given the limited soil volume they have to exploit.

Photos # 5, 6, & 7: showing the row of Lombardy Poplars from various views

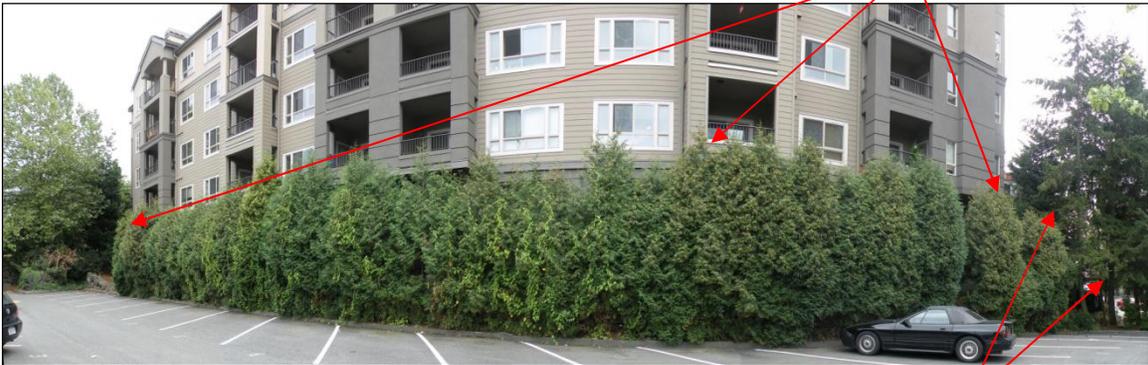
Photo # 8: Panoramic view of the Pyramidalis Hedge of 37 trees listed as # 165

Trees 159 ó 167

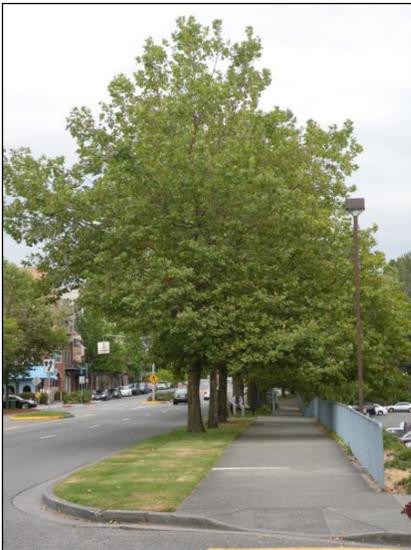
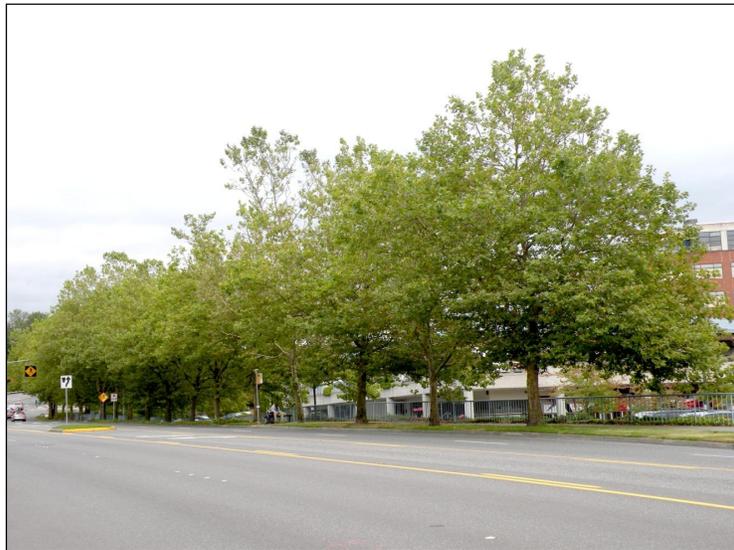
Photos # 9 & 10: Looking east on Central Way at trees # 188 ó 207

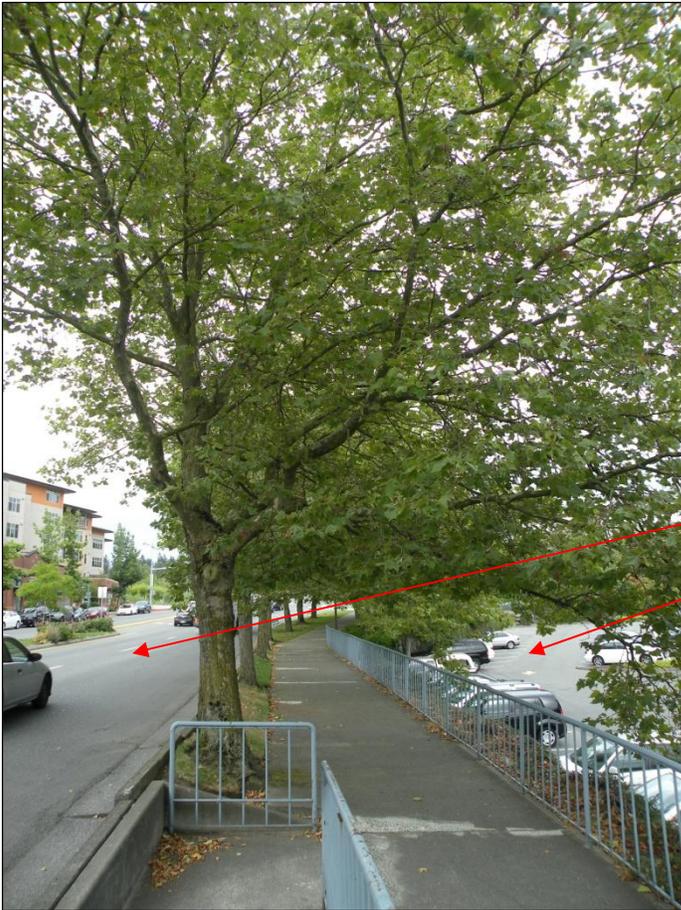
Photo #11: Looking west along Central way

Note the Elevation difference between the street and the parking lot

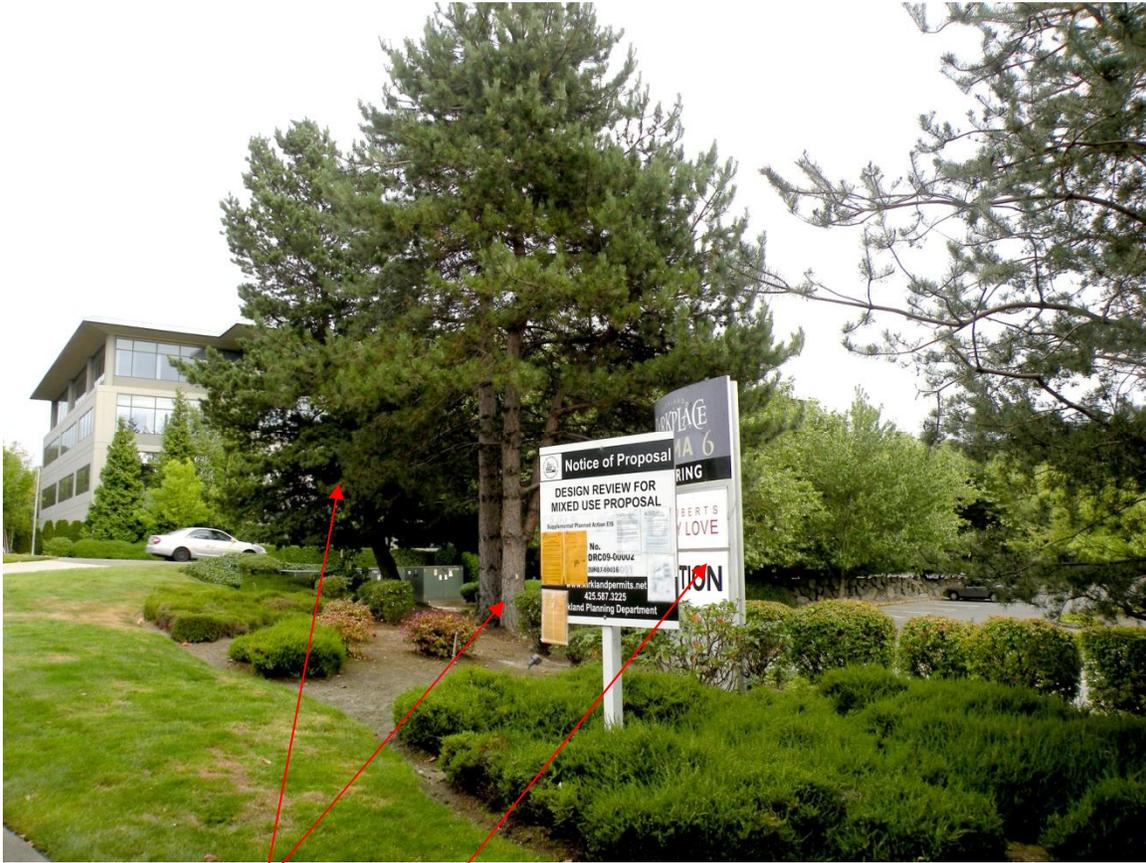
In the planter bed south of the sidewalk that parallels Central Way are trees # 208 to 217. They are growing in an area between the sidewalk and the retaining wall at the edge of the parking lot. There are some utilities and the Parkplace sign is located there.

Photo # 12: trees # 208 ó 210 and the sign in the northeast corner of the property

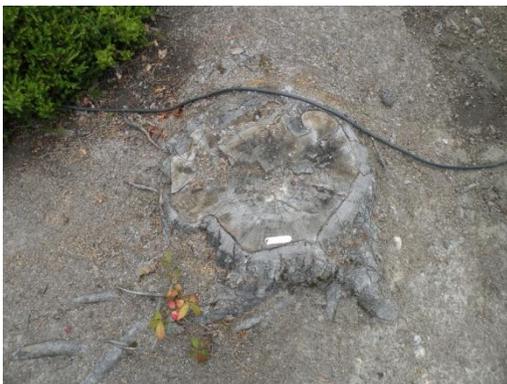
The site plan shows a tree symbol that we have given the number 211. The tree was a pine but, judging from the oxidation of the stump that remains, it was cut down a few years ago. It is included in the inventory to account for the symbol on the site plan.

Photo # 13: the stump of # 211

** Tree # 211 was cut down a few years ago. Only the stump remains.
