Evaluation of Trees AT

1932 Market Street
Kirkland, WA

August 26, 2015

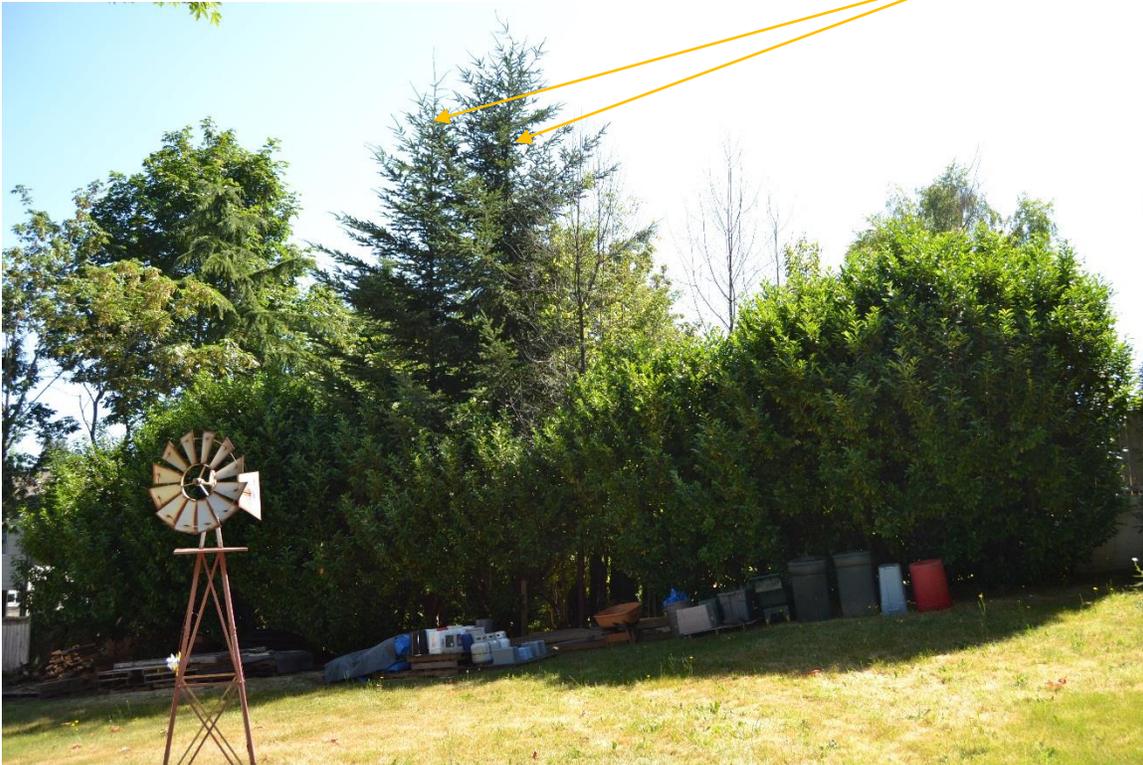
- Trees # 946 and 947 are just east of the east property line.
 - Their canopies overhang the subject property by two to three feet.
 - They can be adequately protected by the minimum “limits of disturbance” fencing on the yard setback.

Photo # 2: Looking north east at the back yard. Trees # 946 & 947 on the adjacent property are located here. These two trees can be adequately protected with a fence 5 feet west of the east property line.

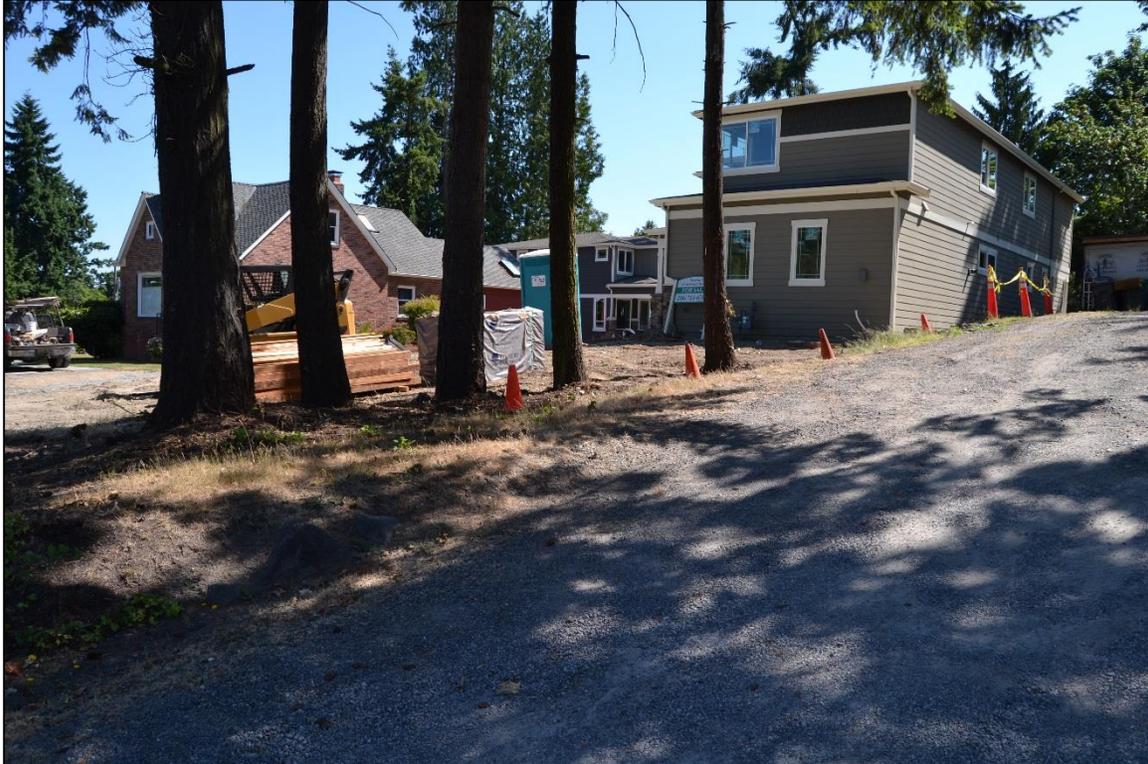
- Trees 950 through 954 are a row of 5 Douglas Fir trees north of the north property line near the northwest property corner.
 - Their bases are very close to the property line.
 - Their canopies overhang the subject property for a significant portion of their driplines.
 - The critical root zones have been impacted by the re-development of the adjacent property at 1936 Market Street.
 - The trees have adapted well to the gravel drive over their critical roots on the south side—that is the driveway for the subject property.
 - They can be adequately protected with a tree protection fence at the edge of the existing gravel driveway.

Photo # 3: Looking from the sidewalk northeast at the row of Douglas Fir trees on the adjacent property to the north. The trees appear to have adapted well to the existing driveway on the subject property. The redevelopment of the adjacent property, specifically the construction of a new house north of the row of trees may have negative consequences for the row of trees.
