**ARBORIST REPORT  
For  
Scrivanich Parcels  
Kirkland, WA**

**April 8<sup>th</sup>, 2014**

American Forest Management, Inc. was contacted by Larry Scrivanich, and was asked to compile an 'Arborist Report' for four parcels located within the City of Kirkland, WA.

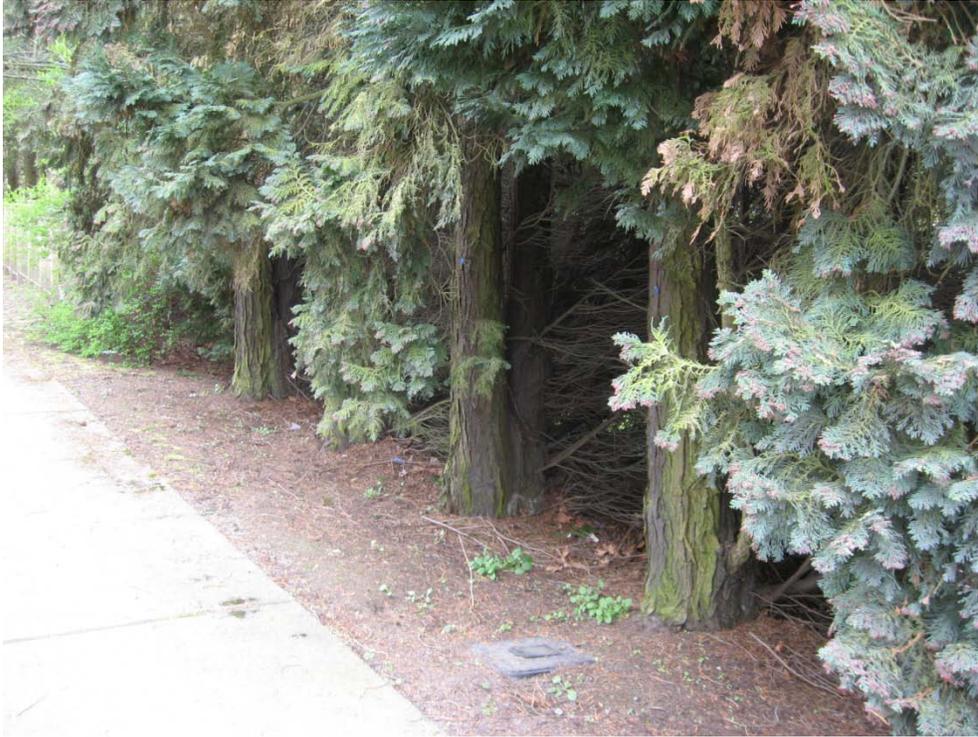
Subject Lawson cypress trees (#214->#219) near north property line

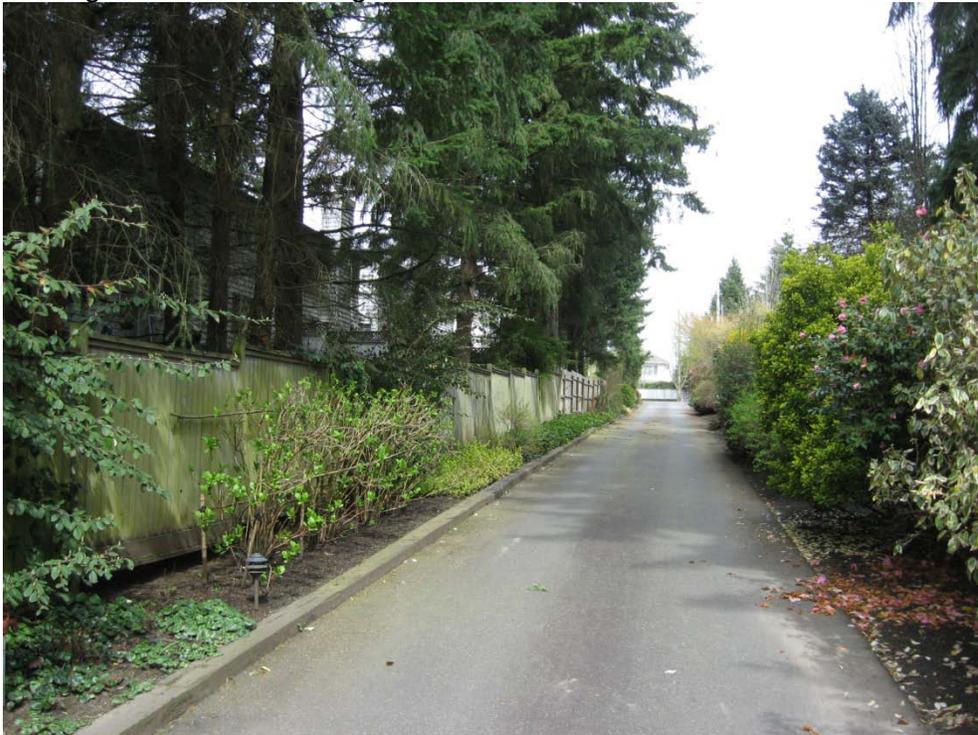
It appears the existing access to the site will be used as the main access into the plat. The access road is in good condition. There is no evidence of lifting or broken pavement from the neighboring trees. In order to protect neighboring trees, the existing pavement should not be altered. New pavement can be laid on top of the existing pavement when the access drive is widened to the east. The 5' planter strip on the west side of the access drive should be maintained and not disturbed to protect neighboring trees. See photos below.

Existing access road looking east to NE 116<sup>th</sup> ST

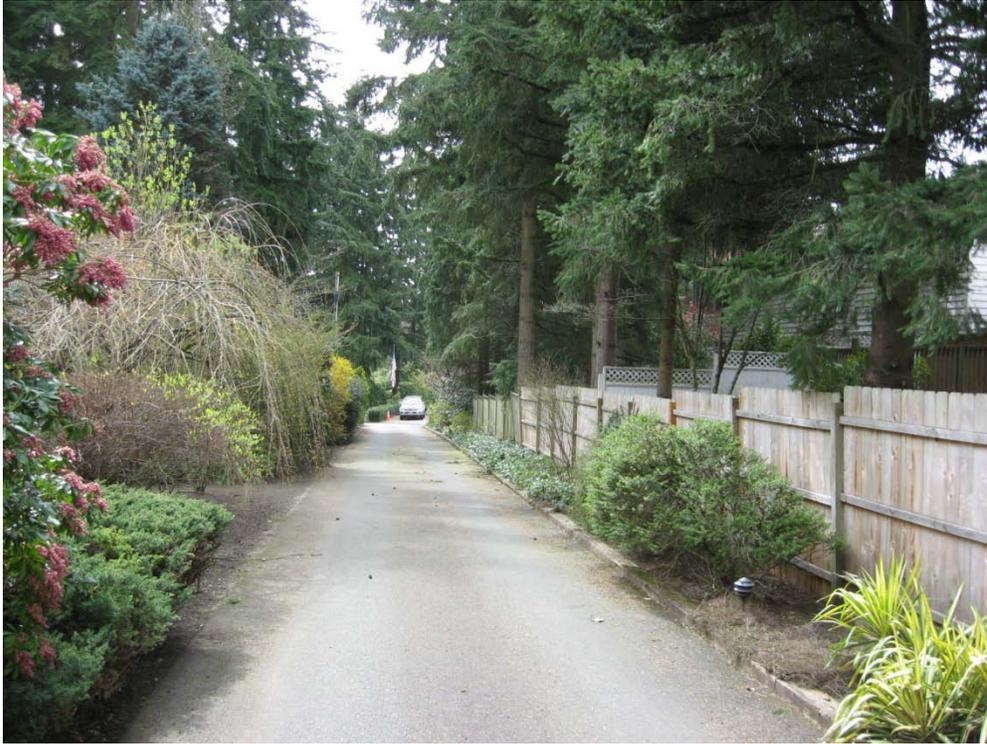
Existing access road looking south toward back parcel

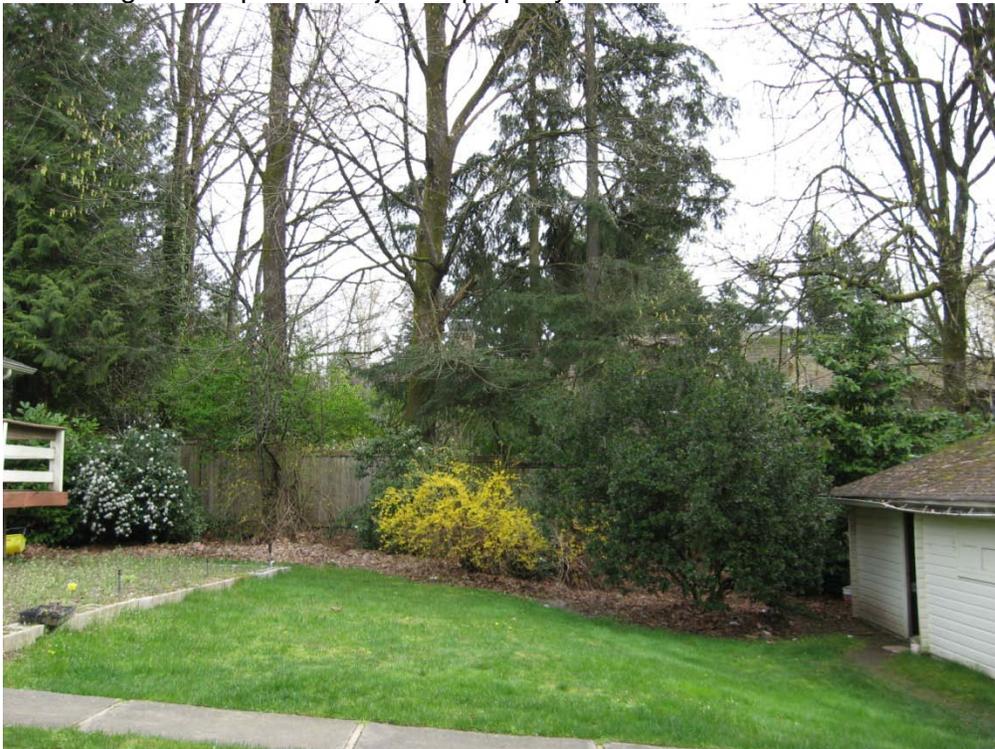
Neighboring trees are primarily comprised of native species as well. On the adjoining property to the east, there are several Douglas-fir trees and big leaf maples trees with drip-lines that encroach upon the subject property. No outward indicators of disease or decline were observed. Trees appear sound and of good vigor.

Mature big leaf maples on adjacent property to east

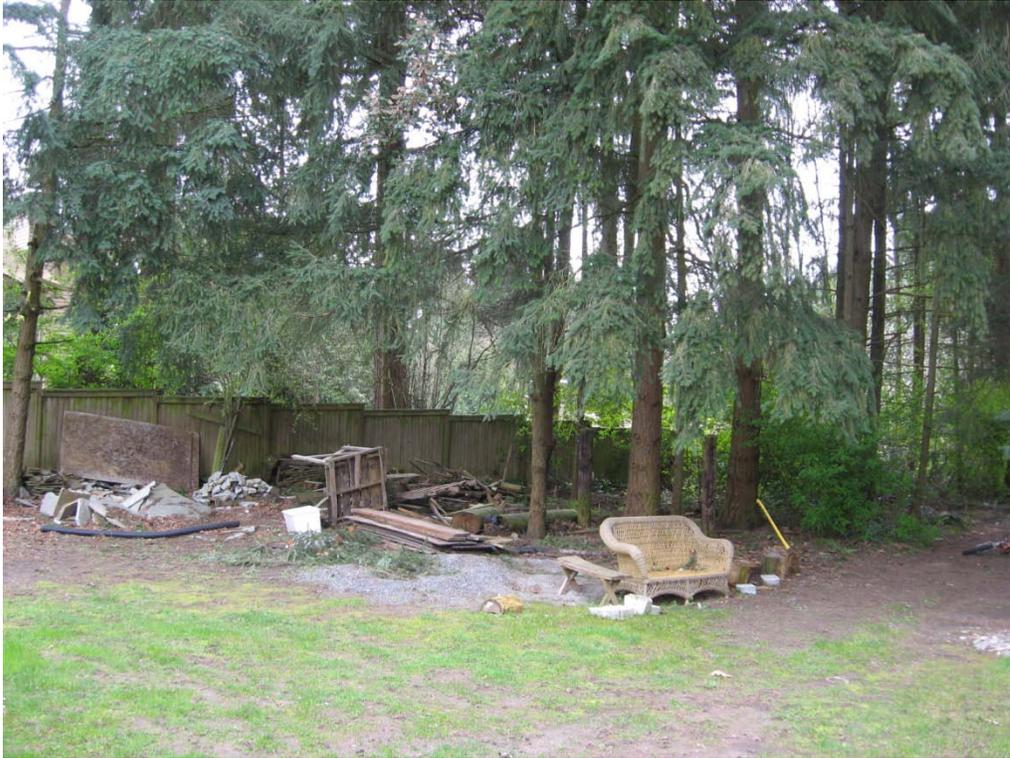
Grove of Douglas-fir on Parcel B

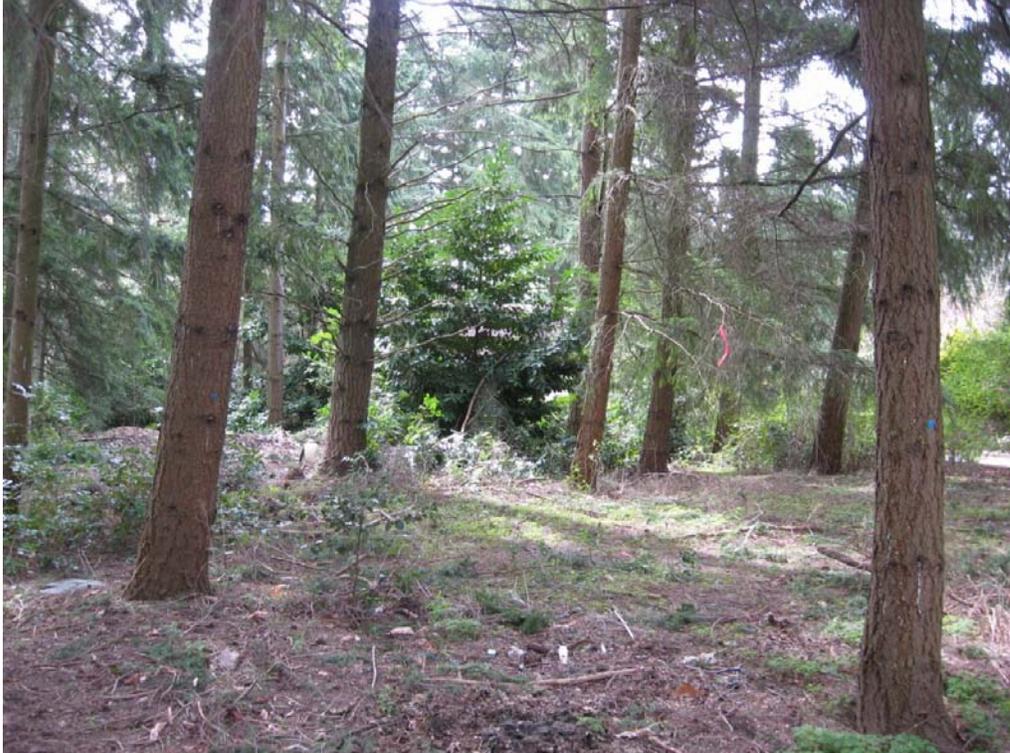
Grove of Douglas-fir on Parcel B – northeast corner

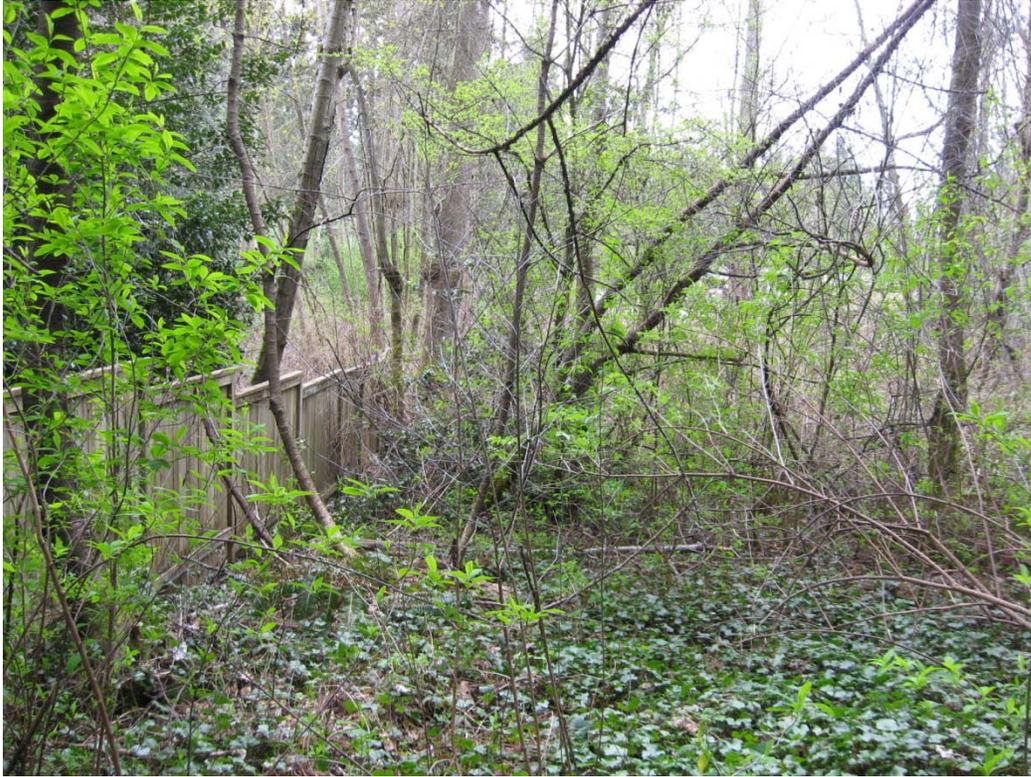
East property line, looking toward the wetland

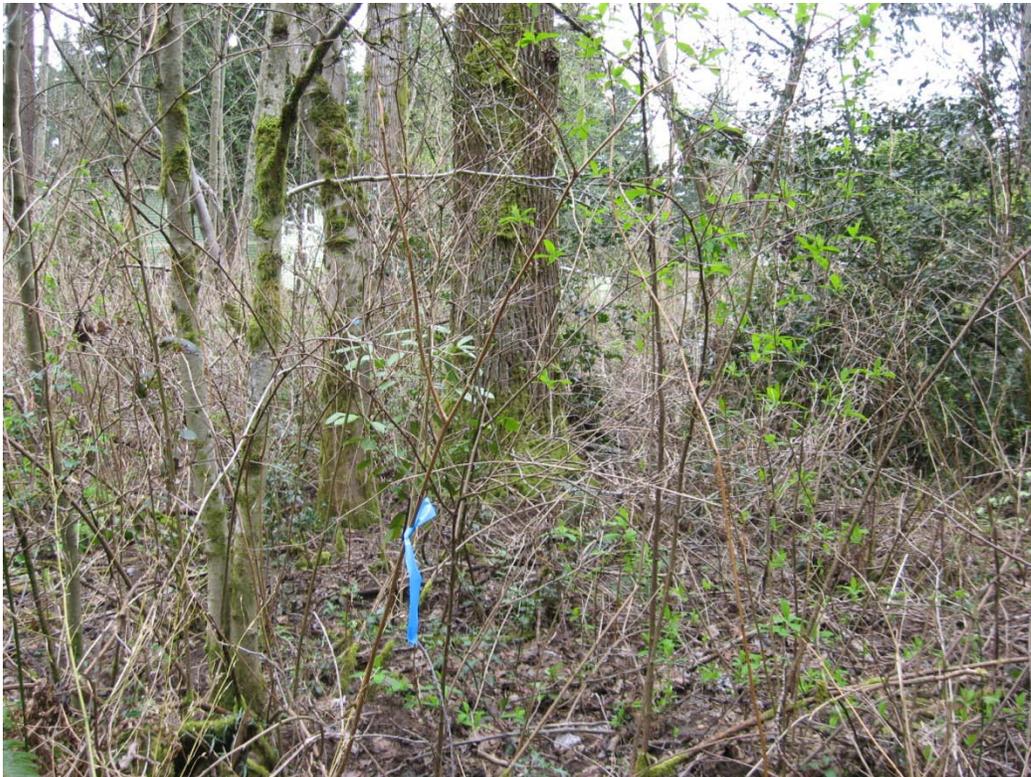
A small wetland exists in the southeast corner of the property. Tree composition in the wetland is primarily red alder and black cottonwood. The red alder here is in poor condition, evidenced by dead and broken tops. These are considered low risk and can be retained for wildlife habitat. Moderate to heavy concentrations of English ivy and Himalayan blackberry were observed within the wetland area and its buffer.

The wetland area has minimal tree cover, over 90% of which is deciduous. There is also a moderate to high component of invasive plant species in the wetland – English ivy and Himalayan blackberry. This area can be enhanced by the establishment of conifer trees and the removal of invasive plants. Western red cedar and Sitka spruce are the recommended species for restoration. If supplemental trees are required as part of the proposal, consider enhancing the wetland and buffer area. There is also a small area of planted bamboo near the wetland buffer. This bamboo should be eradicated before it has a chance to spread into the wetland.

Wetland area

If supplemental trees are required as part of the proposal, consider enhancing the wetland and buffer area, by the establishment of native coniferous species – western red cedar and Sitka spruce; and by removing the invasive plant species.

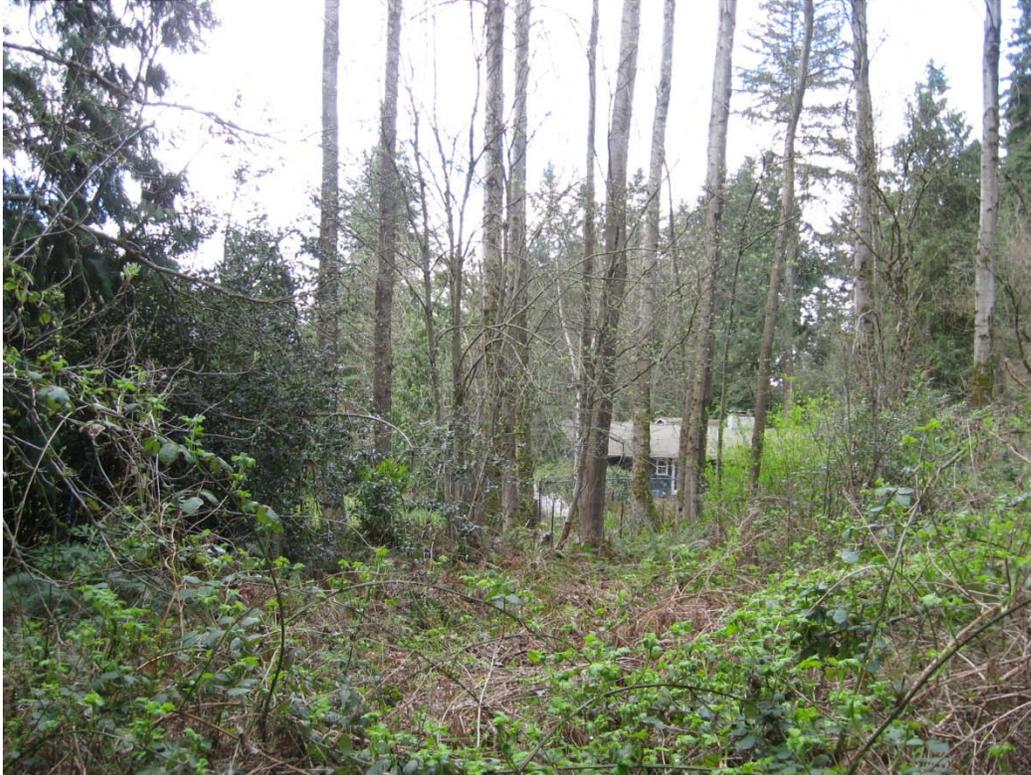
The grouping of cottonwood at the back of the property and which extends off of the property are considered semi-mature. These are situated on higher ground than the cottonwood in the wetland area. They are quite tall and have developed poor trunk taper from heavy competition for sunlight.

Grove of black cottonwood near south perimeter, most trees are off property

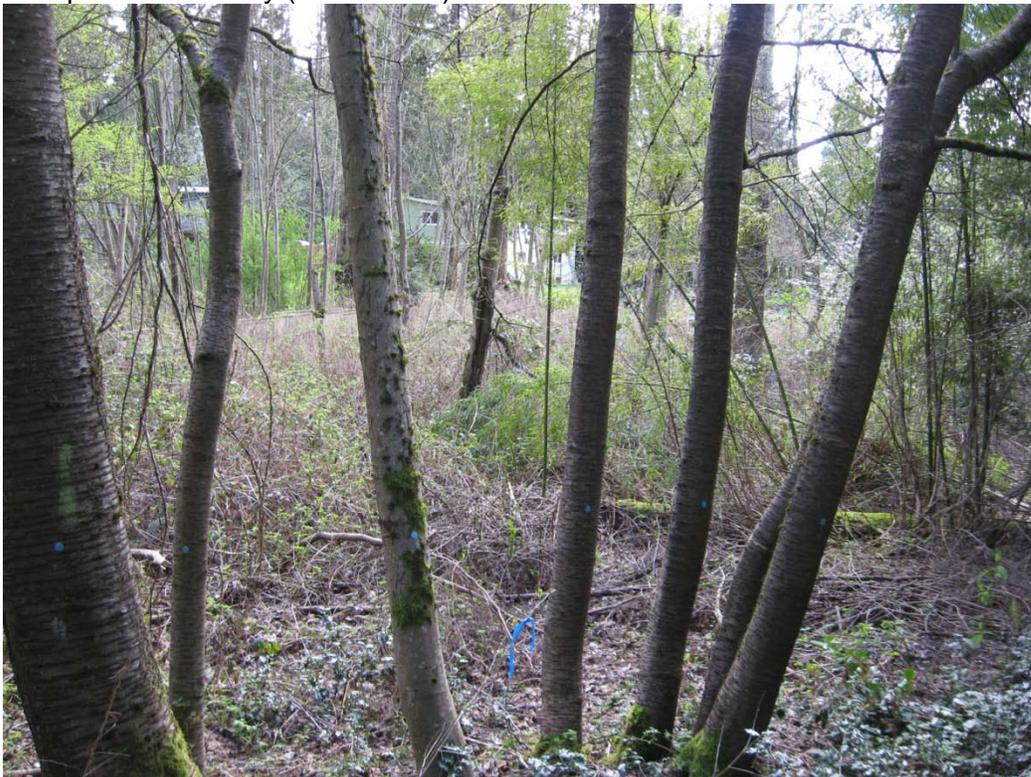
Clump of bitter cherry (#389>#395) outside wetland buffer

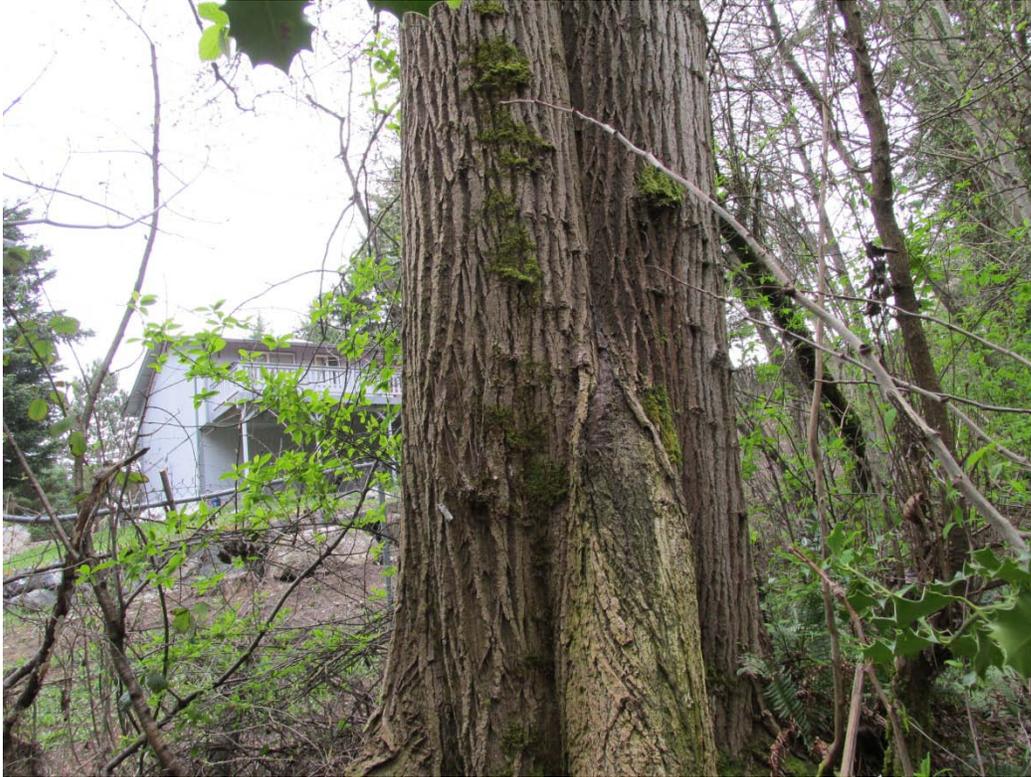
The two mature black cottonwood trees (#452 and #453) in the southwest portion of the property are in poor condition. #452 has large codominant stems which fork low on the trunk. The buildup of included bark between the stems is vast associated with heavy pitching or bleeding. One of these stems is positioned to fall toward the proposed development. This tree is high risk and should be removed. #453 also has a high potential for failure, but leans heavily away from the property toward a vacant wooded area (no target). Retention is feasible so long as the adjacent property to the southwest remains vacant.

Tree #452, codominant stems, excessive included bark/bleeding at fork, high risk tree

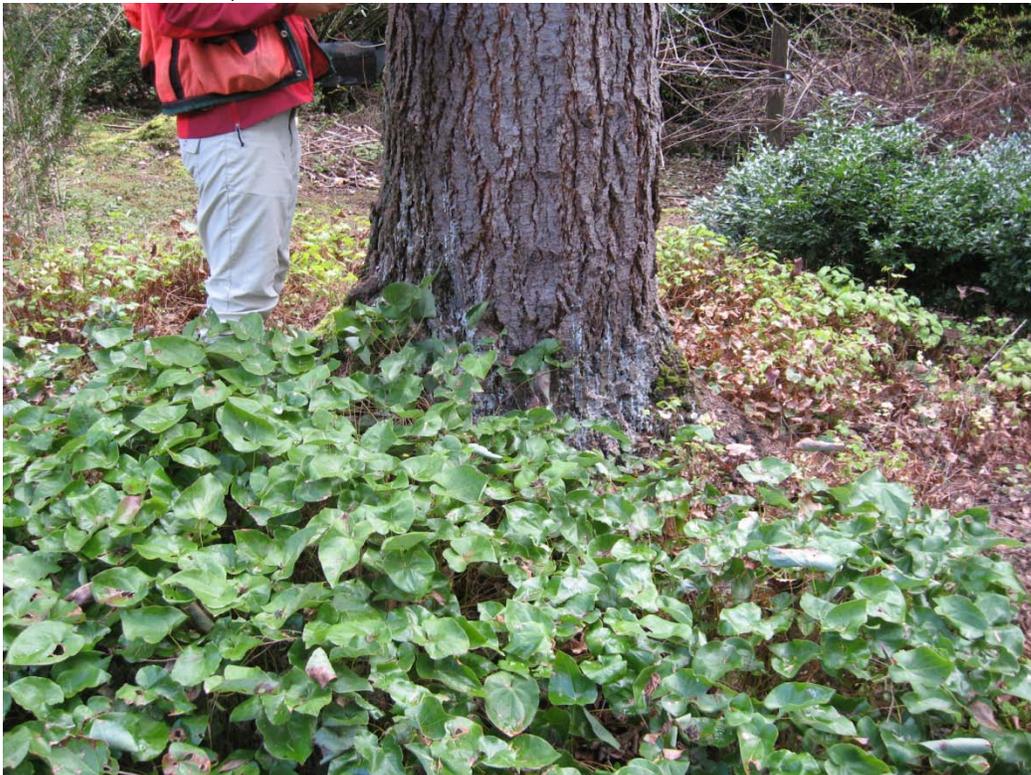
The Douglas-fir trees are concentrated in large groupings along the east portion of the property. The groupings contain several smaller suppressed trees with poor trunk taper, low vigor and past broken tops. Tree #244 has died within the last couple years from root disease. Nearby trees #242 and #243 don't have any outward indications of being infected, but given how the disease spreads (via root contact below ground), there's a good chance they are infected to some degree. Tree #468 is also infected with Laminated root rot, evidenced by resin flows at the base and a thinning crown, see photos below. Tree #469 situated just to the north also has a good chance of being infected.

Base of tree #468, infected with laminated root rot

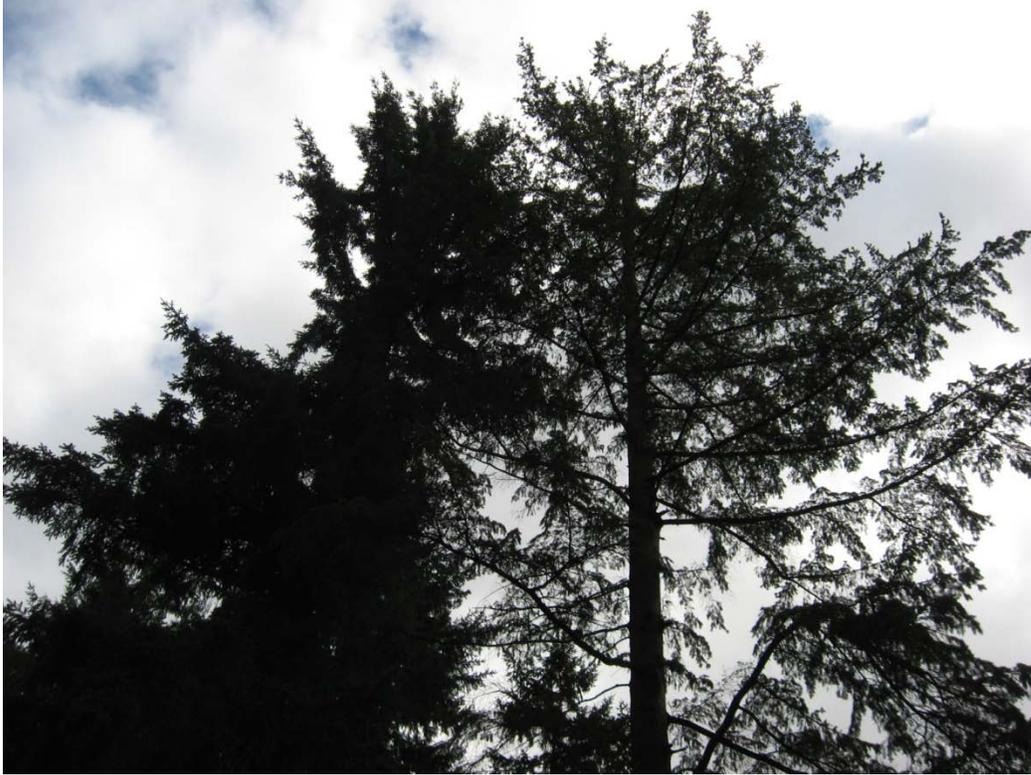
Tree #468 on right (root diseased), Tree #469 on left

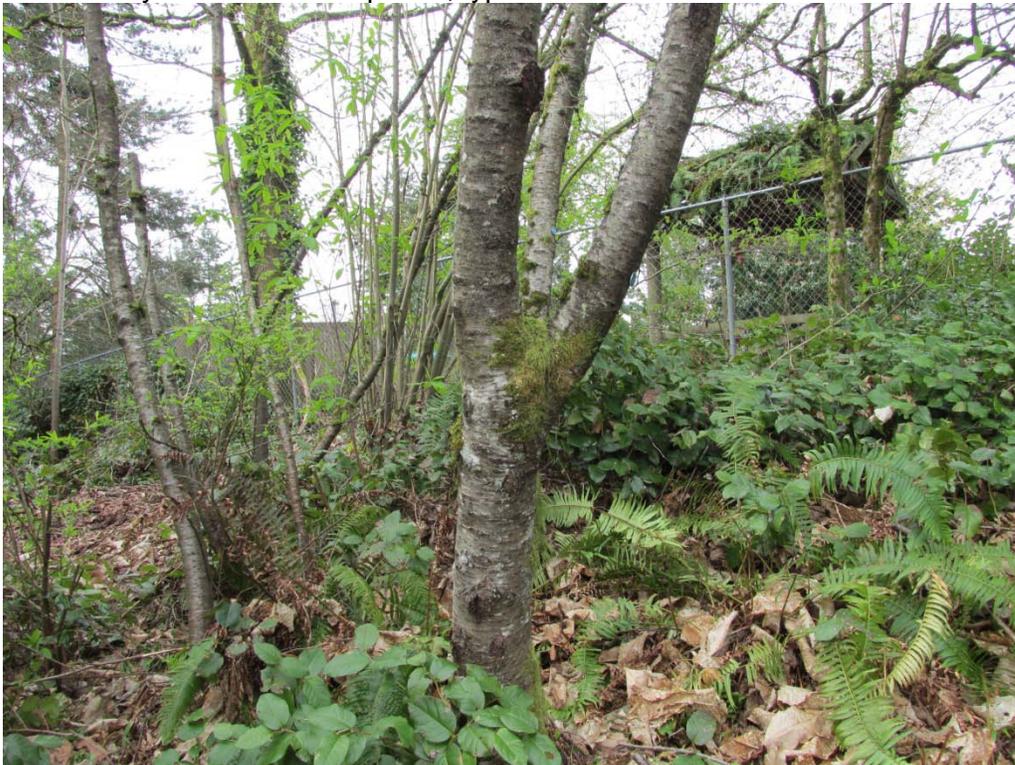
The bitter cherry has developed typical structure. Many trees have poor trunk taper and leans. Overall vigor appears good, even in more mature specimens.

Bitter cherry on west side of parcel, typical form
