ARBORIST REPORT
For
11406 NE 112th Street
Kirkland, WA

October 13th, 2014

The proposed development encompasses the property located at 11406 NE 112th St. Our assignment is to prepare a written report on present tree conditions, which is to be filed with the short plat permit application.

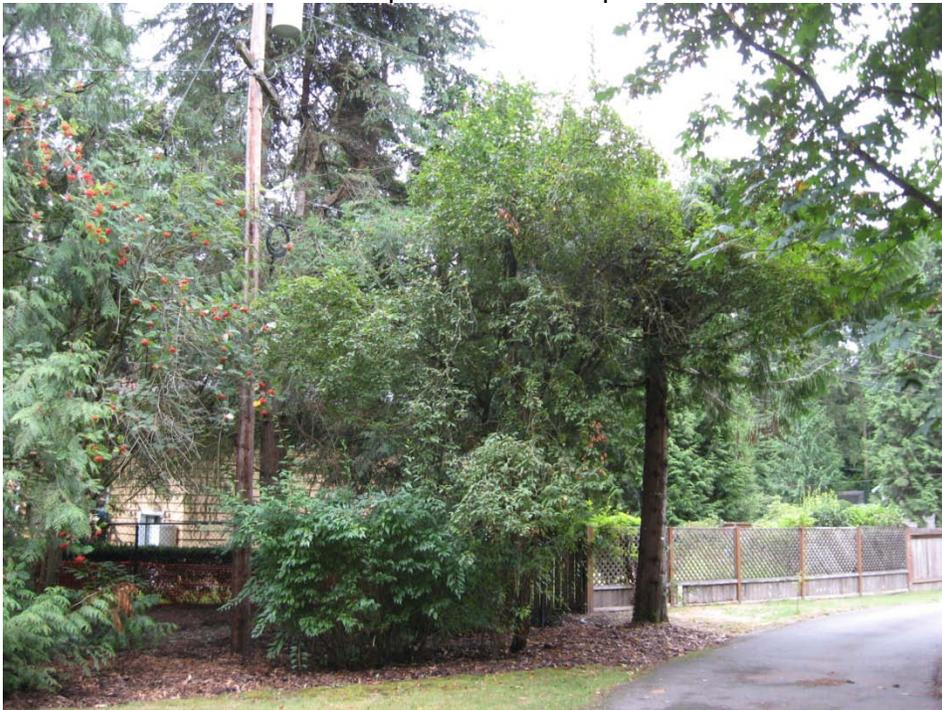
Trees #101 and #102 on east perimeter under power-lines

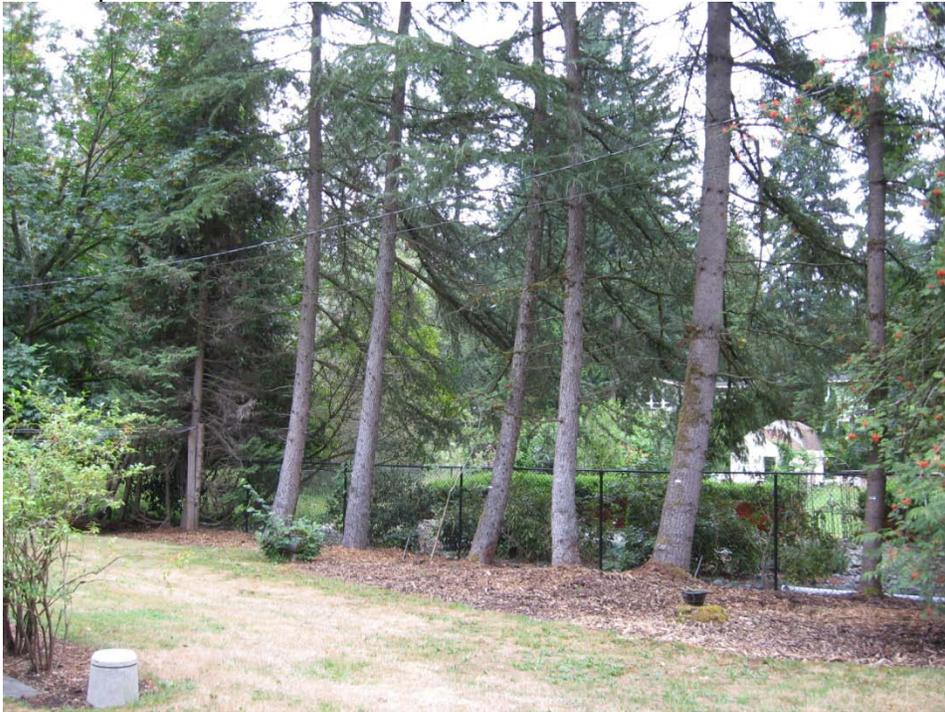
Row of planted Atlas cedar on east perimeter

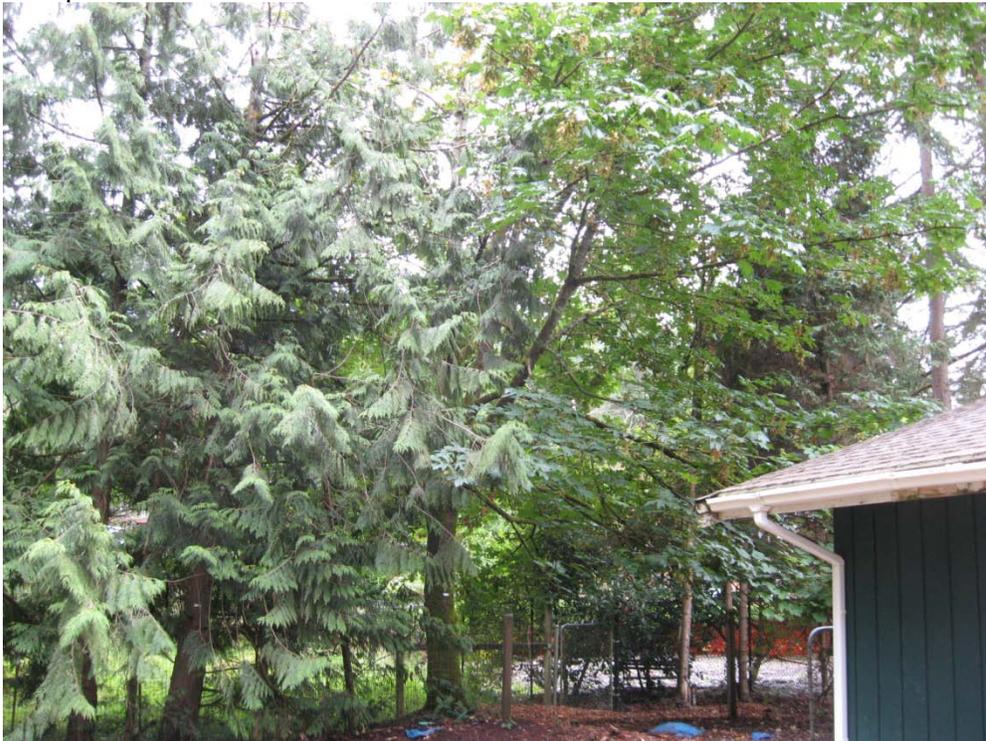
East perimeter

There are no neighboring tree issues on the east perimeter.

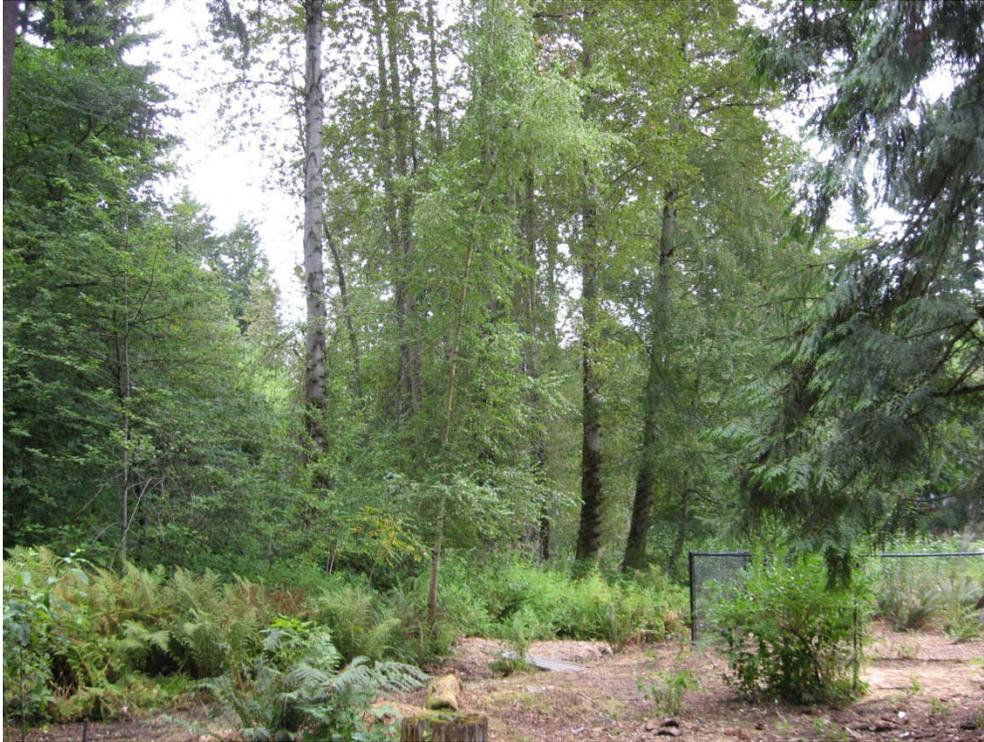
Northeast portion of property, neighboring cottonwood trees

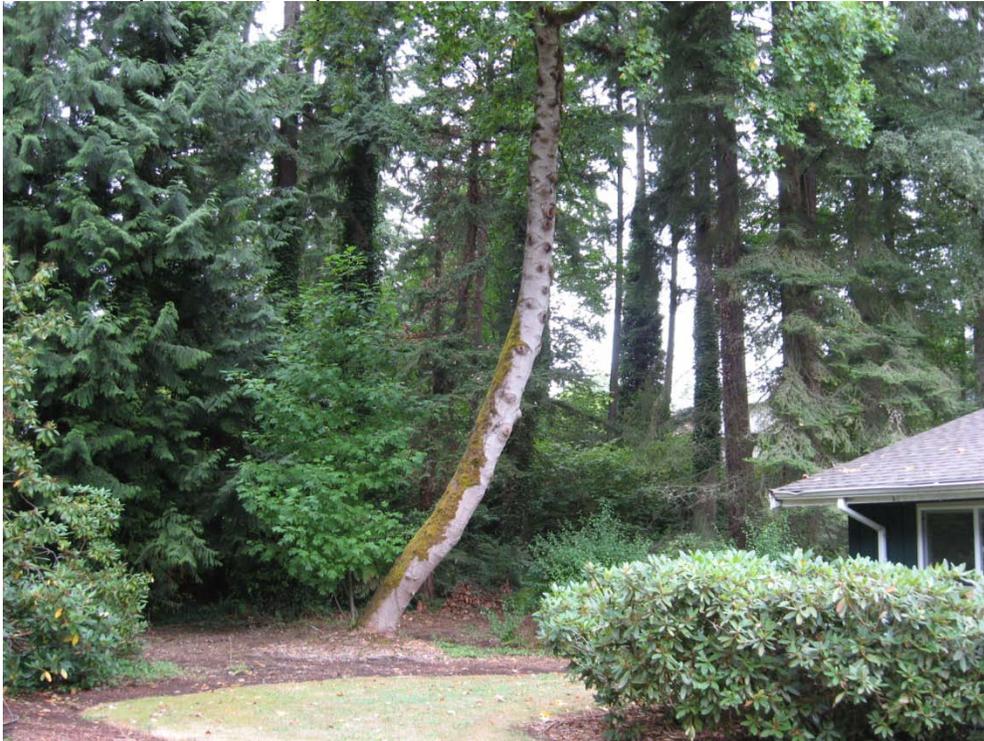
Northwest perimeter, tulip tree in front

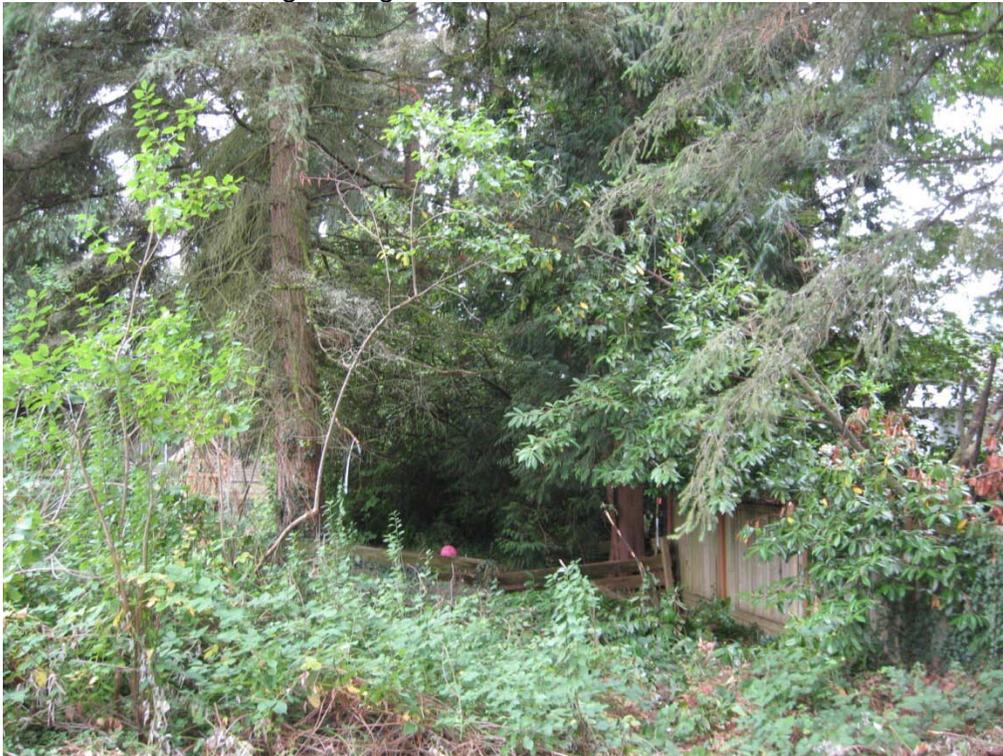
Southwest corner, neighboring trees
