FIELD REPORT – CARILLON POINT BUILDING 4000 – FIELD REPORT

Report Number: 2

Project No. 10-030608K1

4000 Carillon Point
Kirkland, Washington

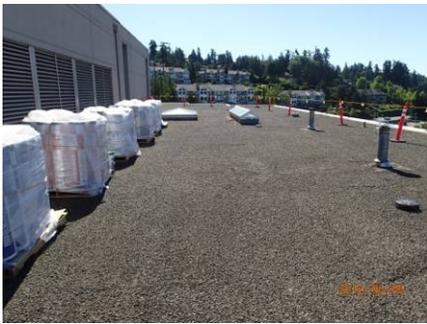
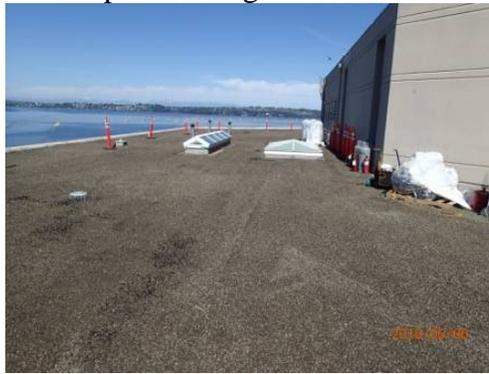
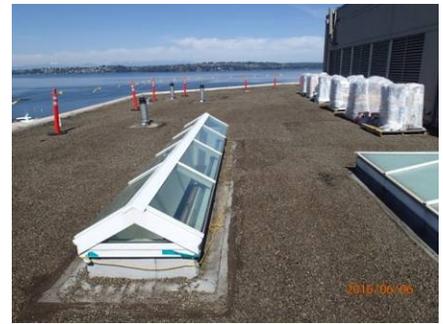
- 2.2 Overview photos depict condition of roof after gravel has been removed. As discussed with Mike (SR), demo of the main roof area is anticipated to begin later in the week.

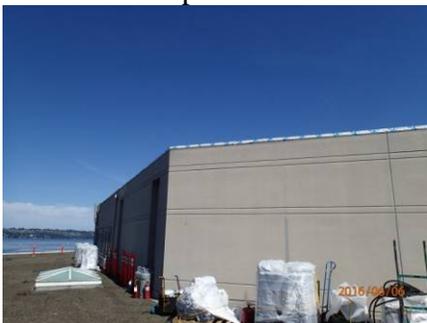
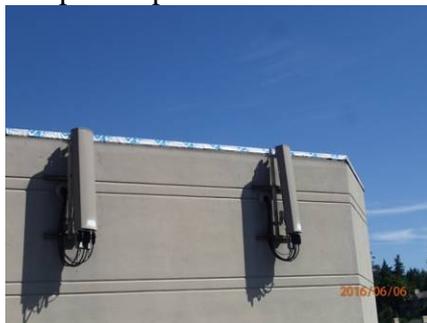
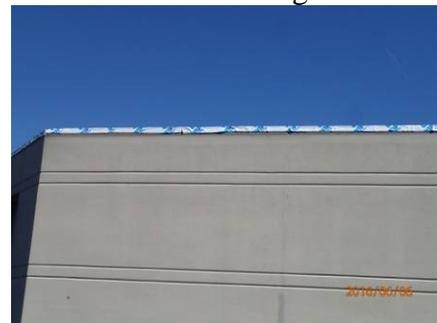
- 2.3 The existing sheet metal coping has been removed at some locations of the screen wall. Carlisle WIP 300HT has been installed at the location where the coping was removed. As discussed with Mike (SR), the substrate was primed with Carlisle 702 primer prior to installation of the self-adhered flashing.

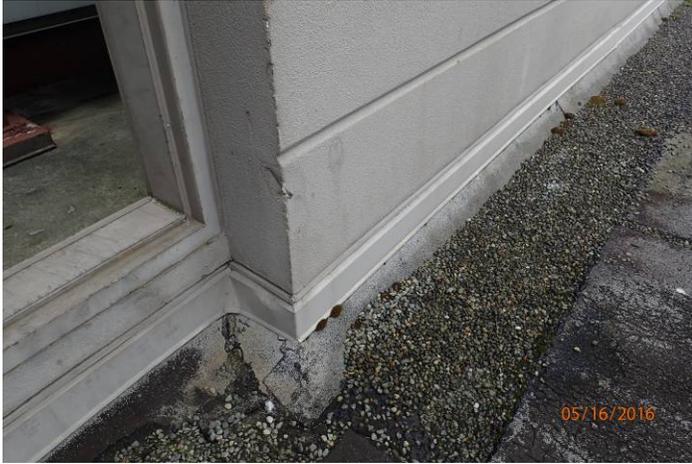
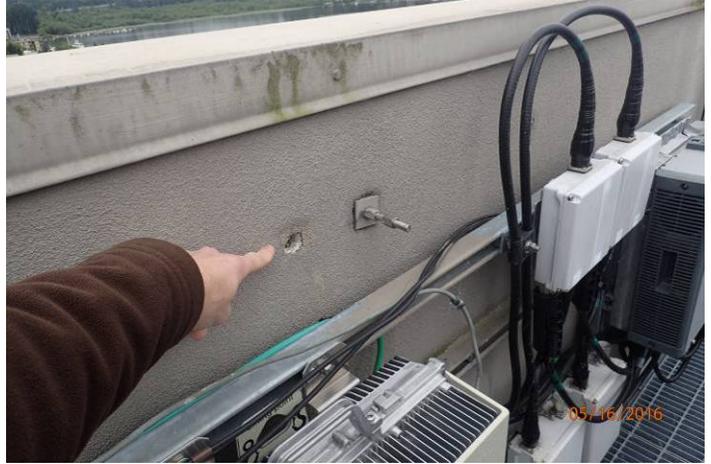
1.6 EIFS on Penthouse Walls: There is existing damage and penetrations to the EIFS on the penthouse walls. A few locations were photographed during the site visit. SR Bldg Services should document all damage prior to work. It is suggested that Carillon Properties repair damaged areas, and areas with penetrations, to help prevent water infiltration.

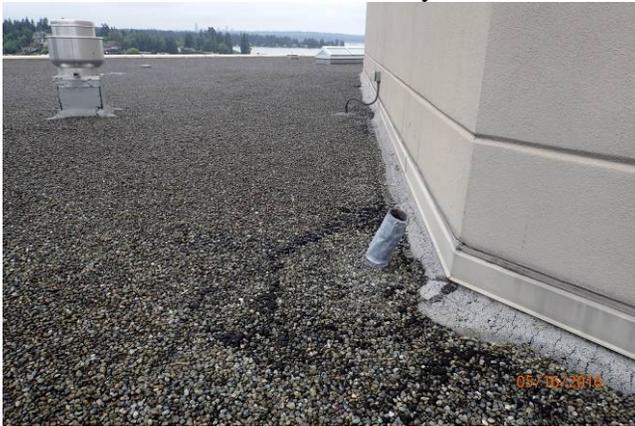
1.7 Soil stack at south end of penthouse is bent over. There appears to be an extension that is not connected to the main pipe. SR Bldg Services to provide new extension that extends 8 inches minimum above new roof surface, and is solidly secured.

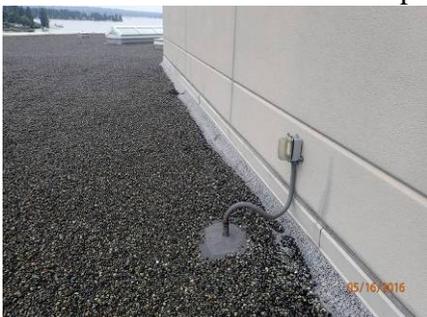
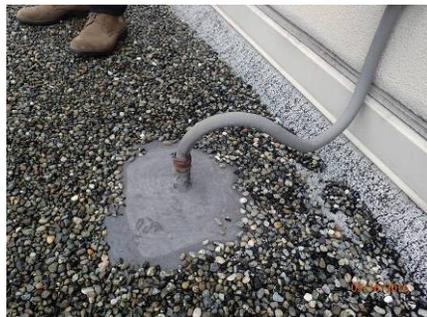
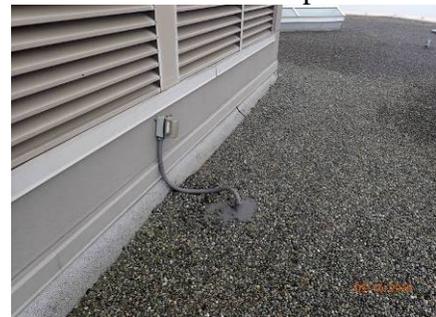
1.8 Short conduit penetrations with flexible conduit above, are present at the north and south ends of the penthouse. These penetrations should be detailed with Parapro, and an EPDM boot at the top edge secured with band clamps that extends onto the flexible conduit above the connection point.

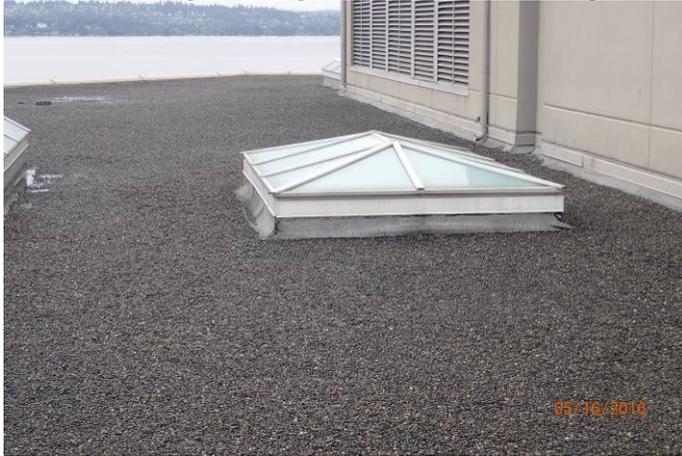
- 1.9 Low Skylight: The large, older, skylight at the west side of the penthouse has sheet metal counterflashing that extends under the skylight frame preventing the new roof membrane from extending minimum 8 inches vertically. As discussed, cut the existing skylight approximately halfway up the width to allow the roof membrane to extend vertically 8 inches. New sheet metal flashing to be inserted up under the existing flashing and riveted to existing flashing.

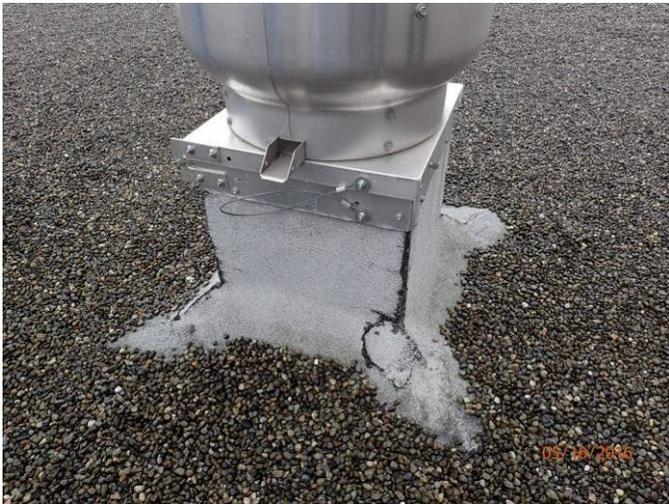
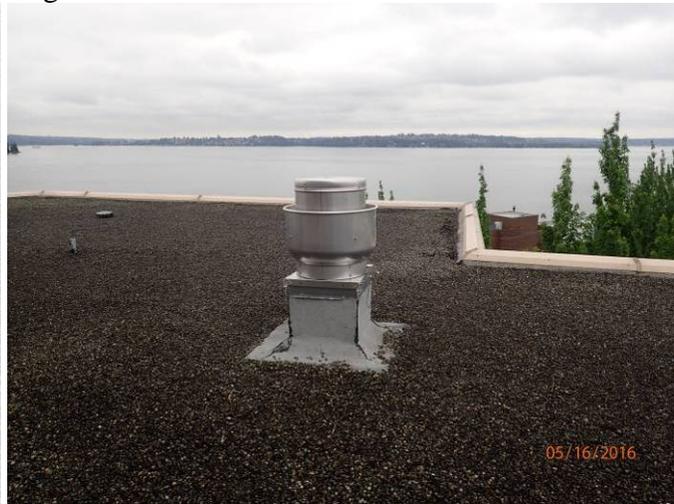
- 1.10 Existing Fan Curbs: Two newer fan curbs are installed on the roof, that appear to have flanges that are tight to the existing roofing. SR to review options to reduce the width of the roofing at the top of the curb, or install sheet metal to tuck under the flange of the unit.
