W E T H E R H O L T A N D A S S O C I A T E S , I N C .

FIELD REPORT – CARILLON POINT BUILDING 4000 – FIELD REPORT

Report Number: 6

Project No. 10-030608K1

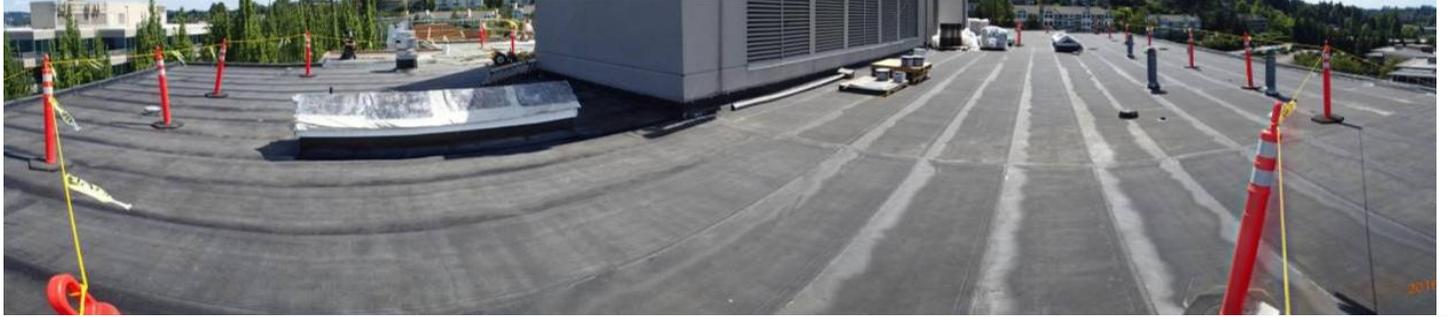
6.1 Overview photo of the southwest roof area where the roof assembly has been installed through the mid ply. Photo was taken at this writer's arrival and depicts progress since the last site visit.

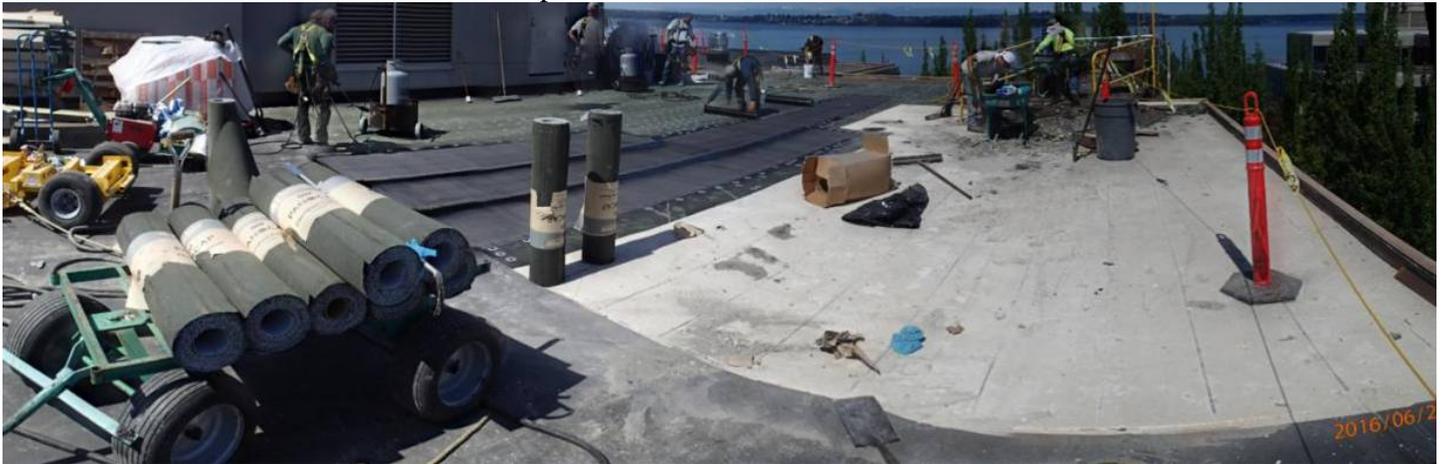
6.2 Overview photo of the northeast roof area as viewed from the east. Photo was taken at this writer's arrival on site and depicts the removal of the existing roof assembly to the lightweight concrete, as well as installation of the base and mid plies.

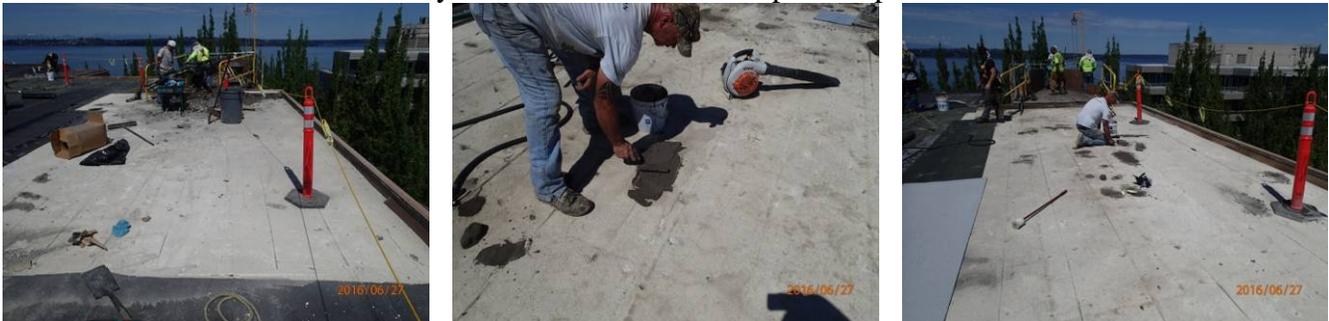
6.3 The existing roof assembly is removed, exposing the existing lightweight concrete substrate. Zono-Patch is mixed as necessary and utilized to fill voids prior to placement of the basesheet.

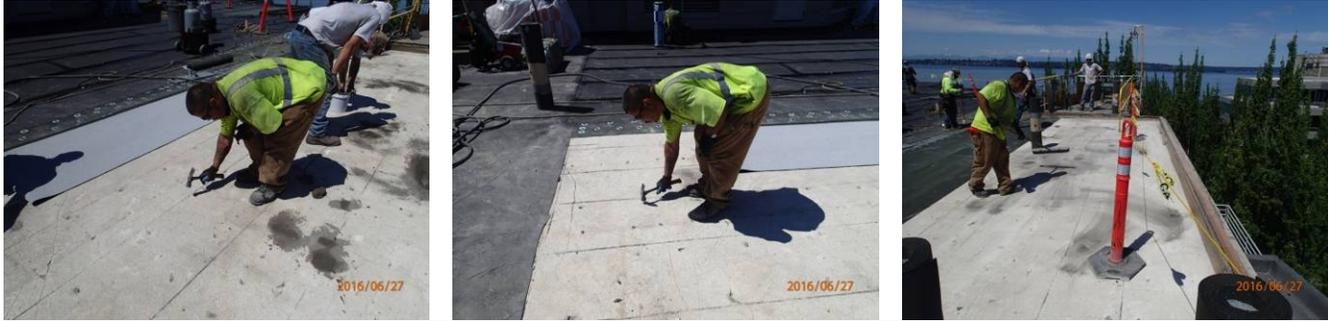
6.4 A hammer is utilized to pound flat any remaining fasteners and the remaining debris is swept off prior to placement of the basesheet.

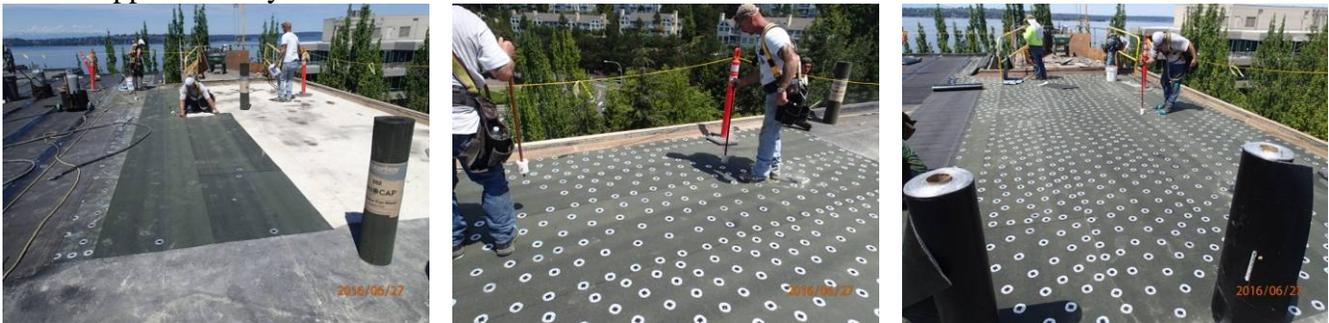
6.5 Malarkey #502 granulated capsheet is installed, inverted, over the lightweight concrete, secured with Zono-Tite fasteners. In the field, the fasteners are installed spaced approximately 9-inches on center at the laps with 3 rows at 12-inches on center in the field of the sheet. At the perimeters, the fasteners are installed spaced approximately 6-inches on center at the laps with 4 rows at 9-inches on center in the field of the sheet. At the corners, the fasteners are installed with 6 rows of fasteners spaced approximately 6-inches on center.

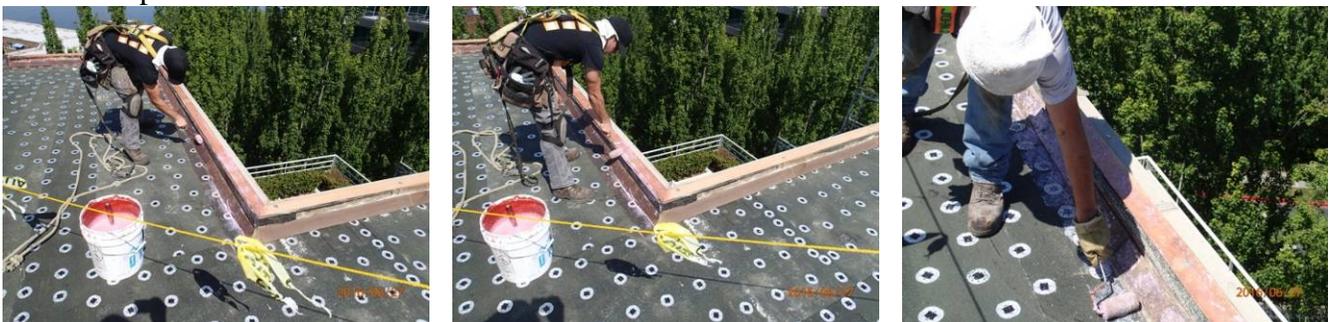
6.6 At the base of the penthouse walls and at the perimeter curbs, TA-119 primer is roller applied to the cant strip and curb and is allowed to tack off.

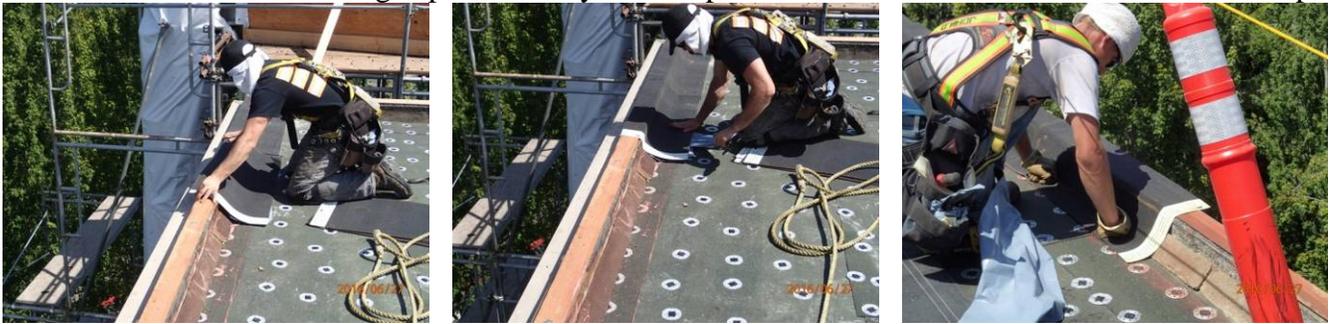
6.7 The polyolefin release film is removed from the underside of Paradiene 20 SA and the sheet is adhered to the cant strip and curb. At the perimeter curbs, the sheet laps up and over, terminating on the outer face. The baseflashing is pressed in by hand to promote adhesion to the substrate and at the laps.

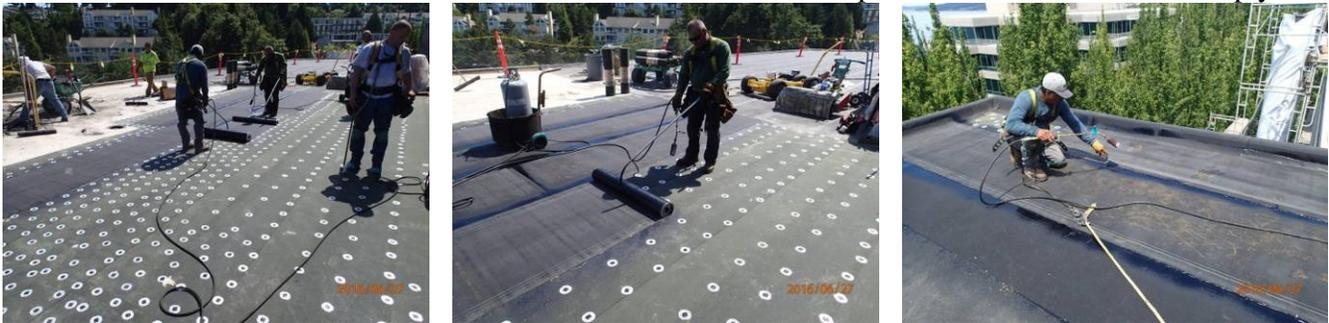
6.8 Siplast Paradiene 20 TG is rolled out utilizing a shepherd's crook and torch applied over the basesheet. Adjacent to the perimeter the field sheet laps up onto the curb, where the baseflashing was previously installed, terminating at the top of the cant. The laps are pressed in by trowel to promote adhesion. A gas leaf blower was utilized to remove debris from the basesheet, prior to installation of the mid ply.

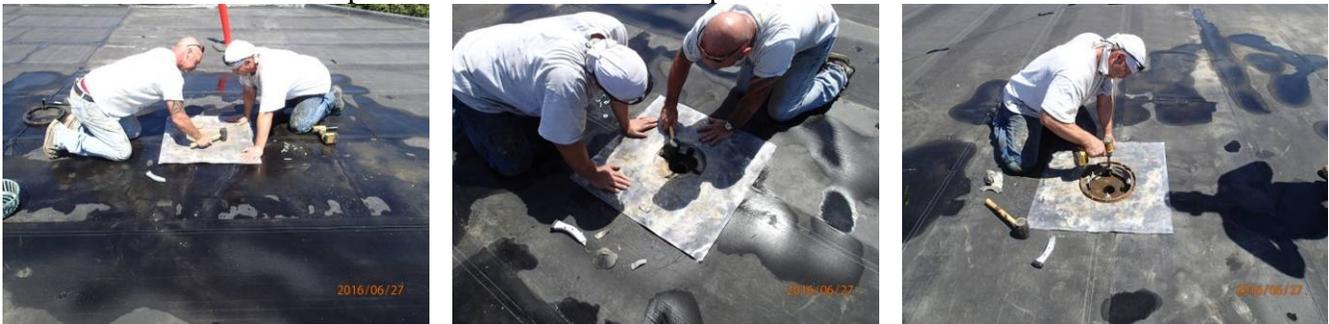
6.9 At the roof drains lead flashings are formed to fit for later installation. The flashings are formed with a rubber mallet to fit the contours of the drain bowls. The clamping rings are installed over the leads to maintain a watertight assembly. It was indicated that the leads would be primed and set in a continuous bed of roof cement prior to installation of the capsheet.

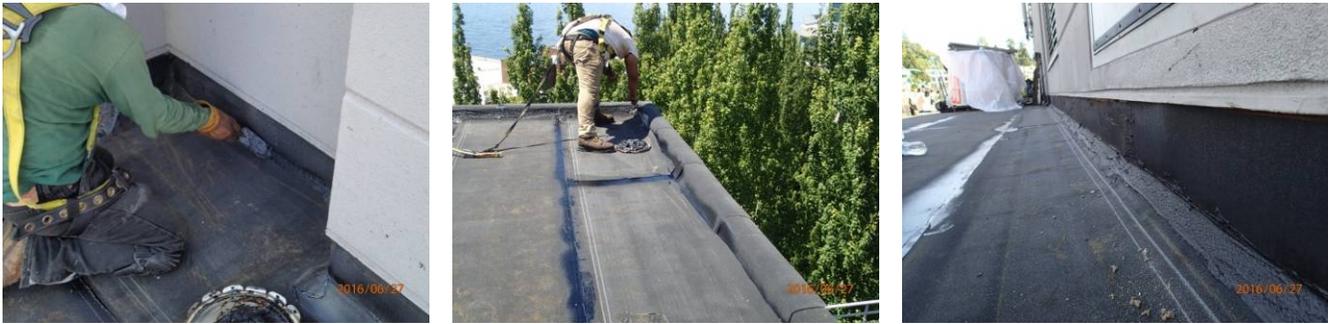
6.10 At the end of the day the installed roof assembly is made temporarily weathertight with Siplast PA-1021 Plastic Roof Cement. The plastic cement is applied at the base of the penthouse walls and perimeter curb.

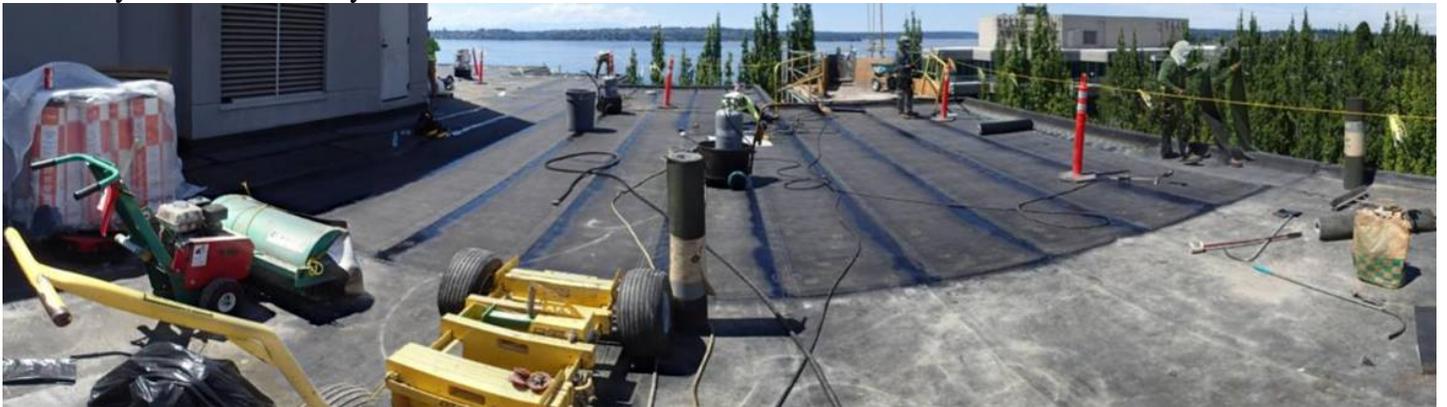
6.11 Overview photo of the northeast roof area as viewed from the east. Photo was taken at this writer's departure and depicts progress. It was indicated that the roof would be made temporarily weathertight by the end of the day.

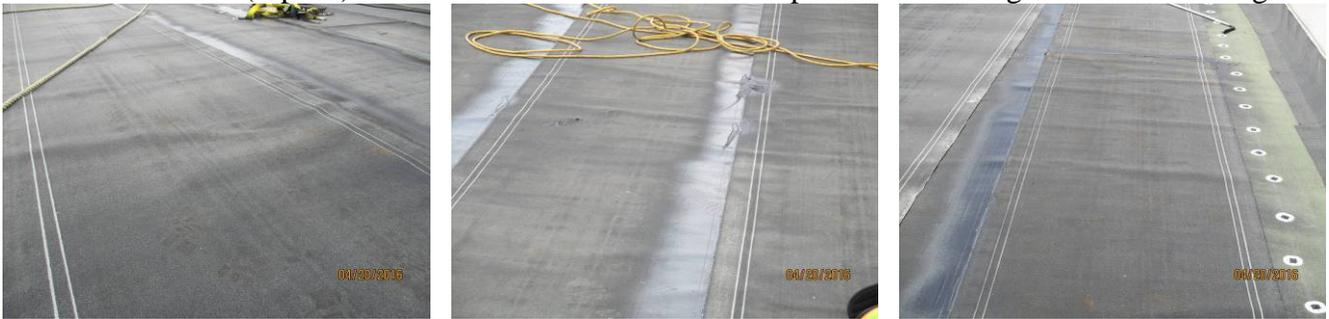
5.13 Wrinkles were observed in the interply sheet of Paradiene 20 TG. As discussed over the phone with Brad Viles (Siplast) the wrinkles should be sliced and patched according to manufacturers guidelines.

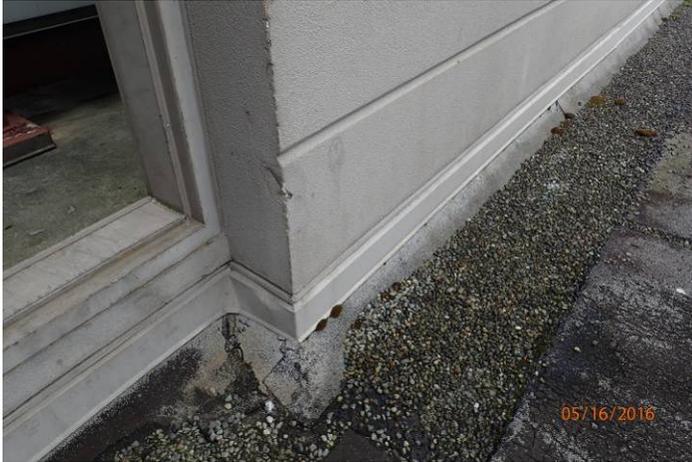
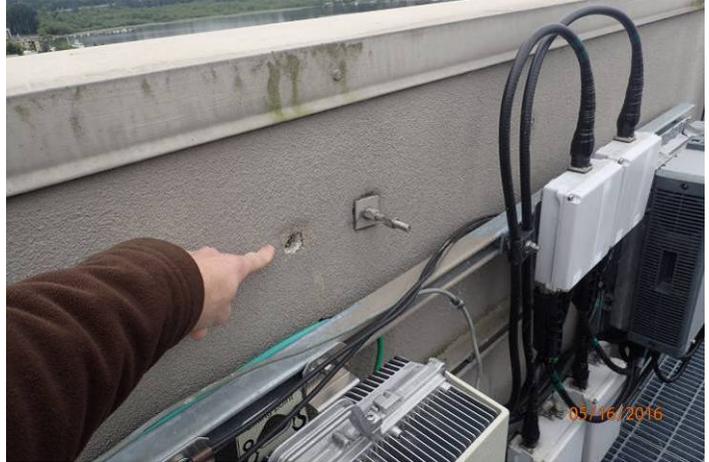
1.6 EIFS on Penthouse Walls: There is existing damage and penetrations to the EIFS on the penthouse walls. A few locations were photographed during the site visit. SR Bldg Services should document all damage prior to work. It is suggested that Carillon Properties repair damaged areas, and areas with penetrations, to help prevent water infiltration.

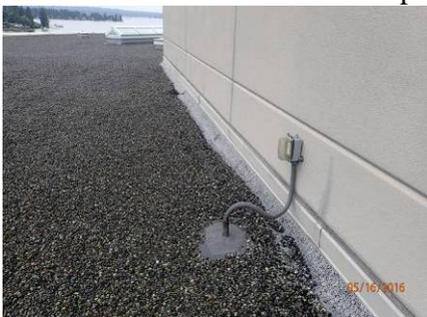
1.8 Short conduit penetrations with flexible conduit above, are present at the north and south ends of the penthouse. These penetrations should be detailed with Parapro, and an EPDM boot at the top edge secured with band clamps that extends onto the flexible conduit above the connection point.

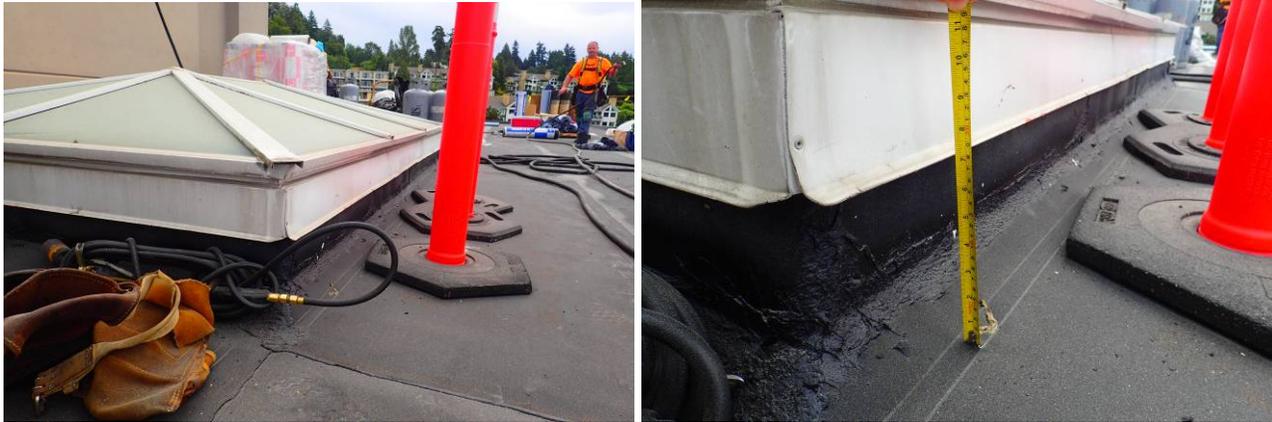
1.9 Low Skylight: The large, older, skylight at the west side of the penthouse has sheet metal counterflashing that extends under the skylight frame preventing the new roof membrane from extending minimum 8 inches vertically. As discussed, cut the existing skylight approximately halfway up the width to allow the roof membrane to extend vertically 8 inches. New sheet metal flashing to be inserted up under the existing flashing and riveted to existing flashing.

Update Rep #5, 6/20/16: The new roof membrane was tucked under the existing flashing and appears to be extended 8 inches off the finished roof surface. It appears the existing metal can be left and new skirt flashing metal installed under the existing metal, without cutting the existing metal.

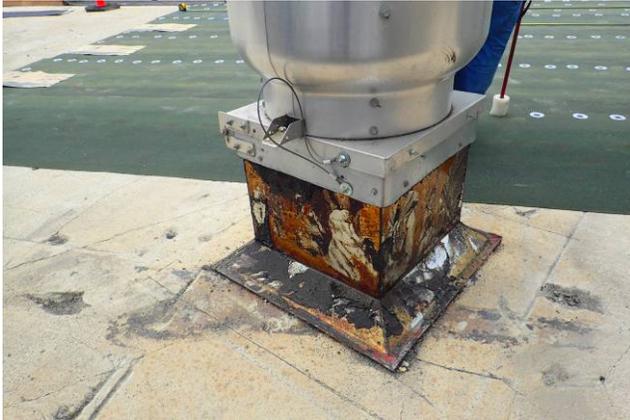
1.10 Existing Fan Curbs: Two newer fan curbs are installed on the roof, that appear to have flanges that are tight to the existing roofing. SR to review options to reduce the width of the roofing at the top of the curb, or install sheet metal to tuck under the flange of the unit.

Update Rep #5, 6/20/16: The existing curbs are metal. SR plans to install new sheet metal under the existing flange. Screws will need to be removed and reinstalled.
