FIELD REPORT – CARILLON POINT BUILDING 4000 – FIELD REPORT

Report Number: 7

Project No. 10-030608K1

4000 Carillon Point
Kirkland, Washington

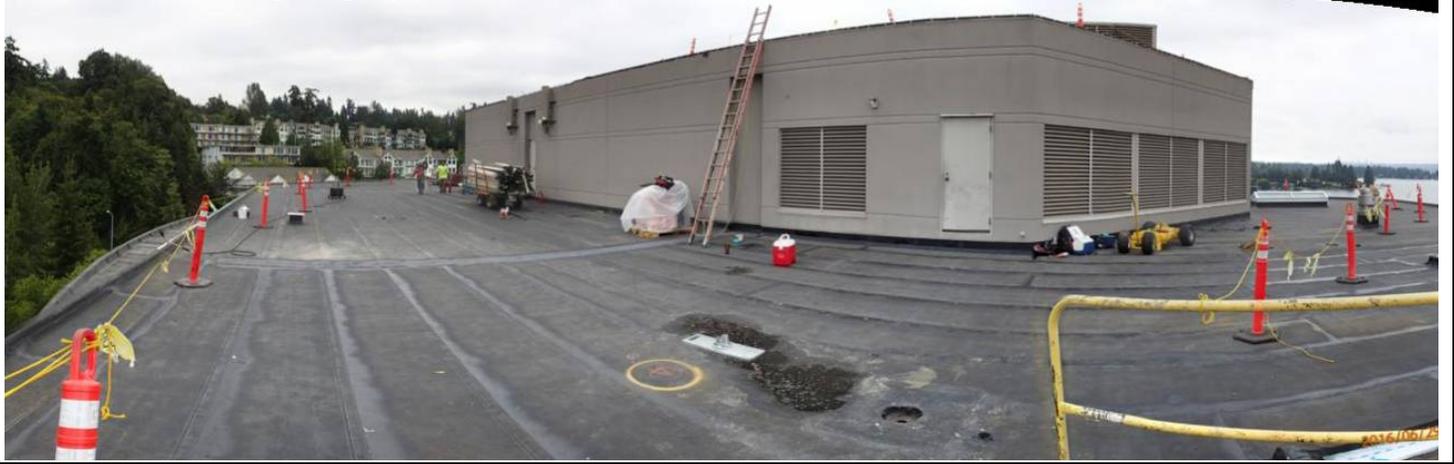
7.1 Overview photo of the northeast roof area as viewed from the northeast. Photo was taken at this writer's arrival and depicts progress since the last site visit.

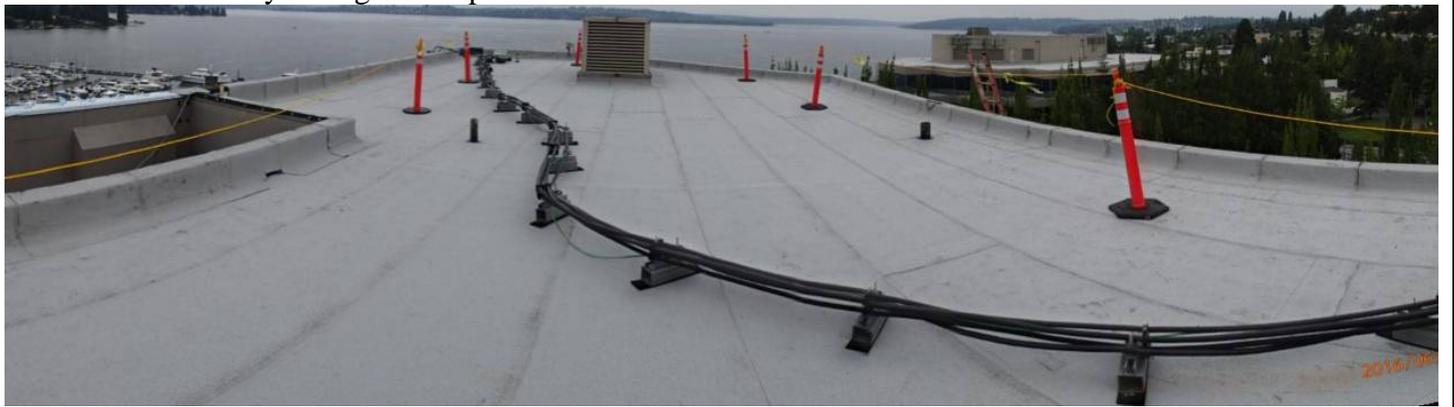
7.2 Overview photo of the penthouse roof as viewed from the east. Photo depicts installed condition of the roof assembly through the capsheet.

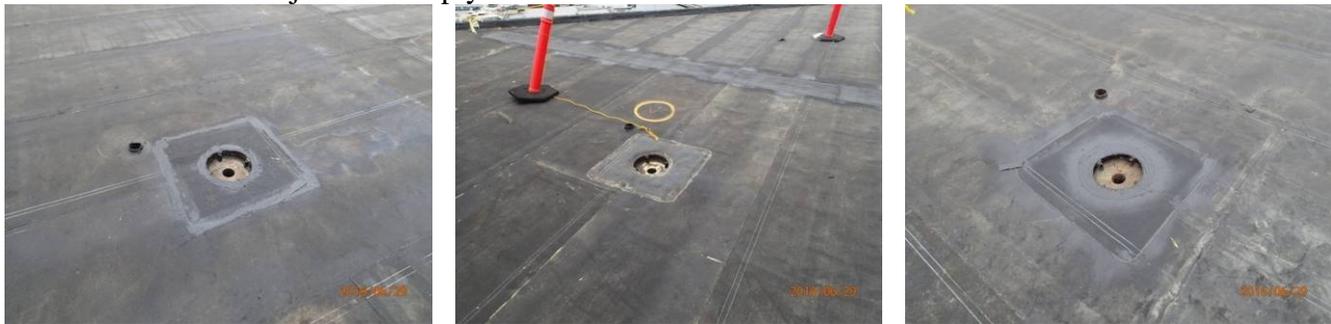
7.3 At the roof drains, the lead flashings are installed lapping over the previously installed interply. It was indicated that the lead flashings were primed with PA-1125 Asphalt Primer and set in a continuous bed of PA-1021 Plastic Roof Cement. The flashing is stripped in with a second ply of interply, extending out onto the adjacent field ply.

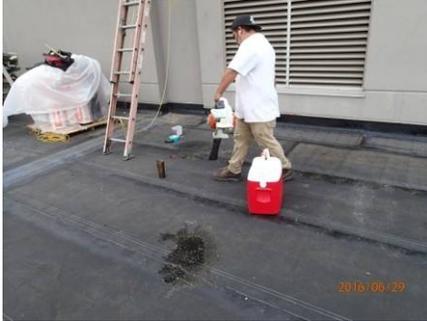
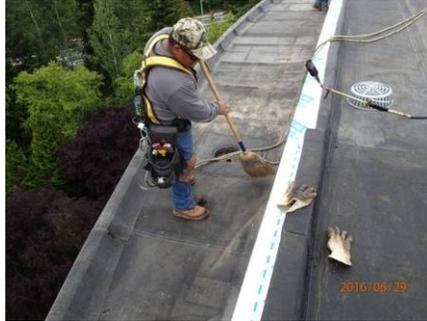
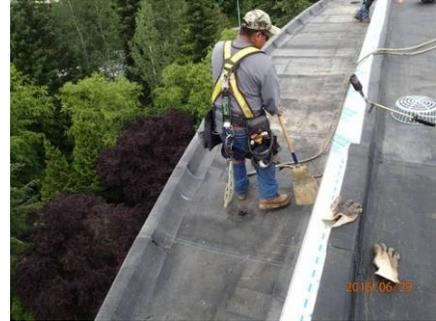
7.4 A broom and gas blower are utilized to remove debris from the installed interply prior to installation of the capsheet.

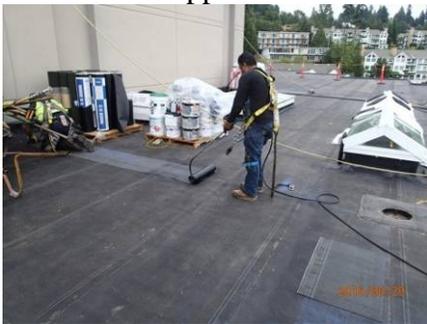
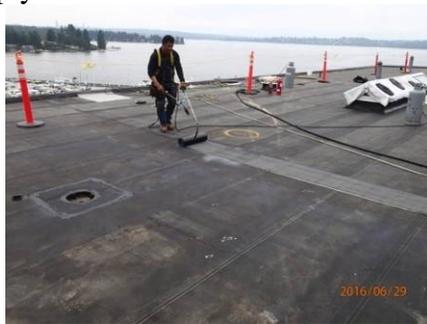
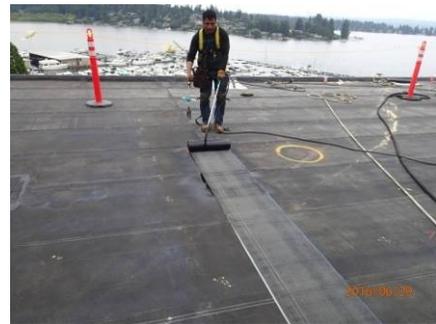
7.5 At the laps in the field where the temporary night tie-offs were installed at the end of each day, an additional half-width ply of Paradiene 20 TG is installed, rolled out utilizing a shepherd's crook and torch applied over the interply.

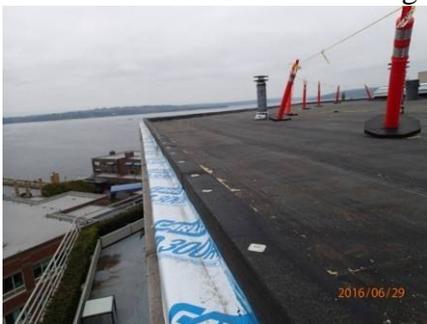
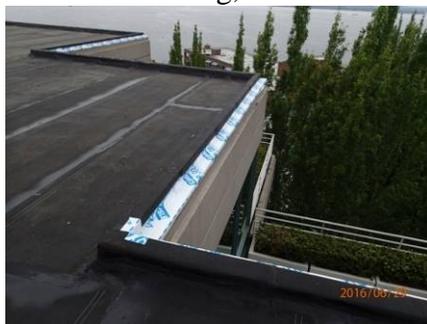
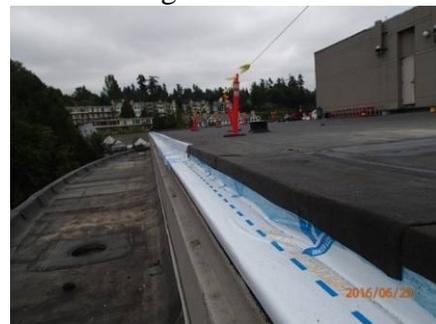
7.6 At the outer perimeter, a strip of Carlisle WIP300HT is installed, extending from the top of the nailer, down onto the remaining sheet metal flashing, where the new metal flashing will be installed.

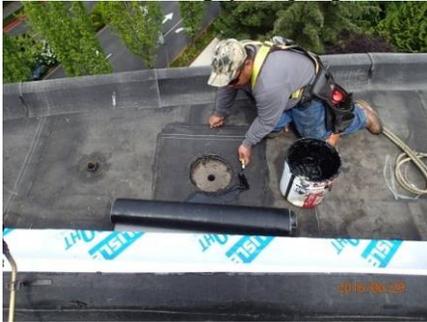
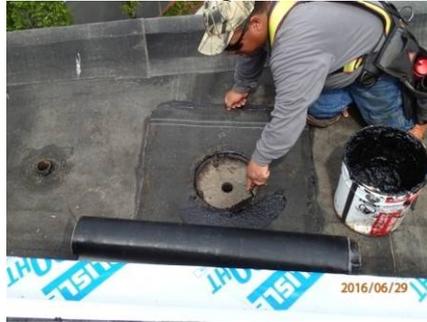
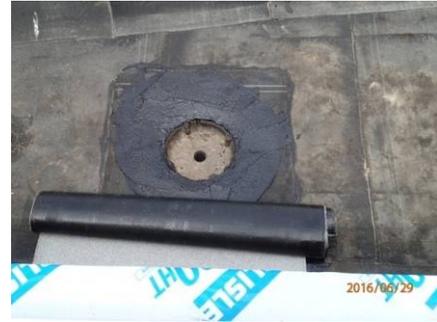
7.7 Around the roof drains, a continuous bed of PA-1021 Plastic Roof Cement is trowel applied prior to installation of the capsheet. The roof cement extends approximately 6-inches out beyond the bowl onto the interply target patch over the lead flashing.

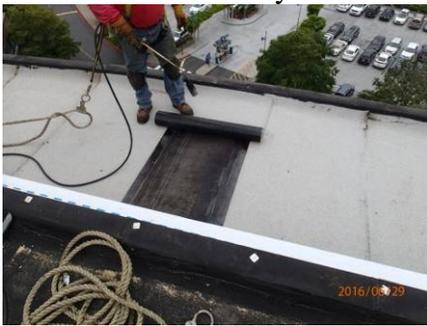
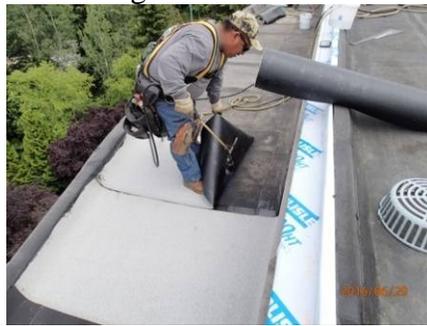
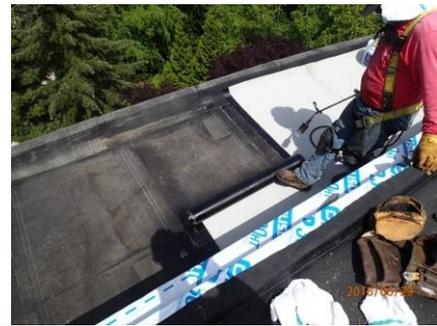
7.8 At the eyebrow roofs, Siplast Paradiene 30 TG is installed torch applied over the interply. The capsheet is rolled out by hand and trowel during installation.

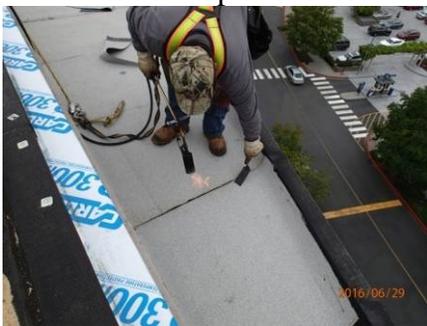
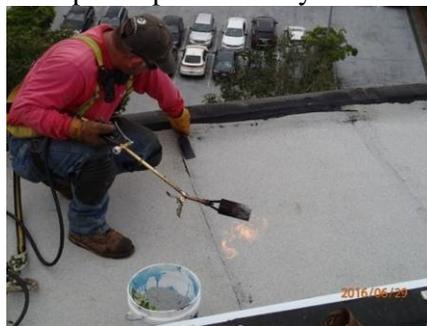
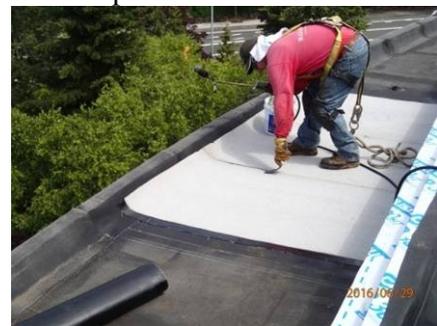
7.9 As the capsheet is installed the laps are pressed in by trowel and hand to promote adhesion.

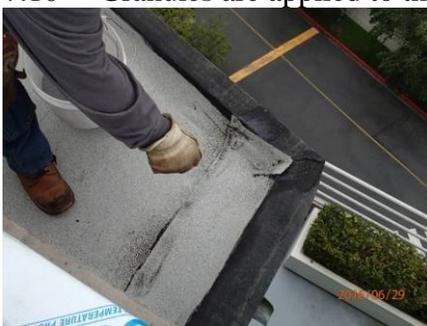
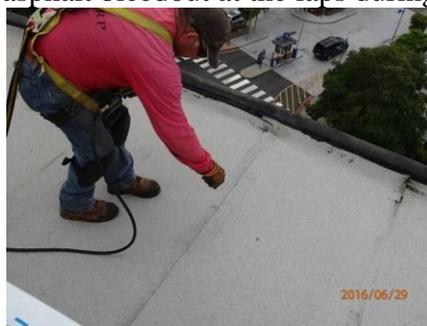
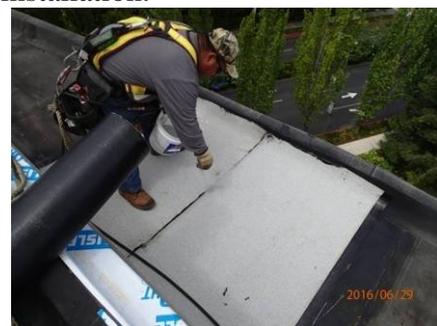
7.10 Granules are applied to the asphalt bleedout at the laps during installation.

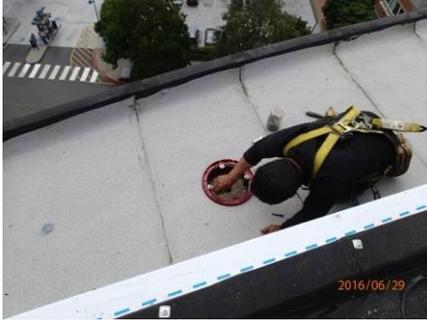
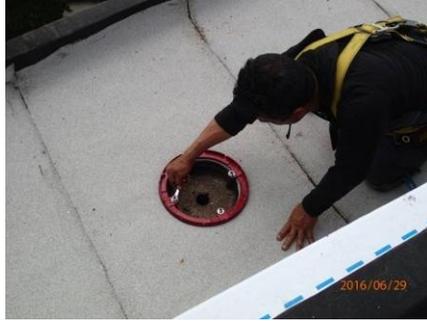
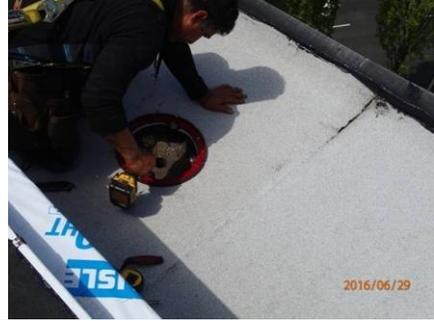
7.11 The clamping rings are installed and bolted tightly over the capsheet to maintain a watertight assembly.

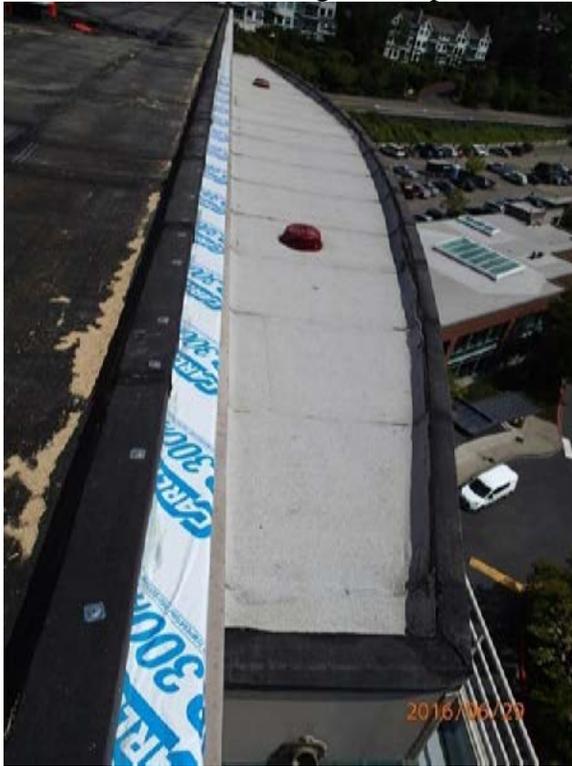
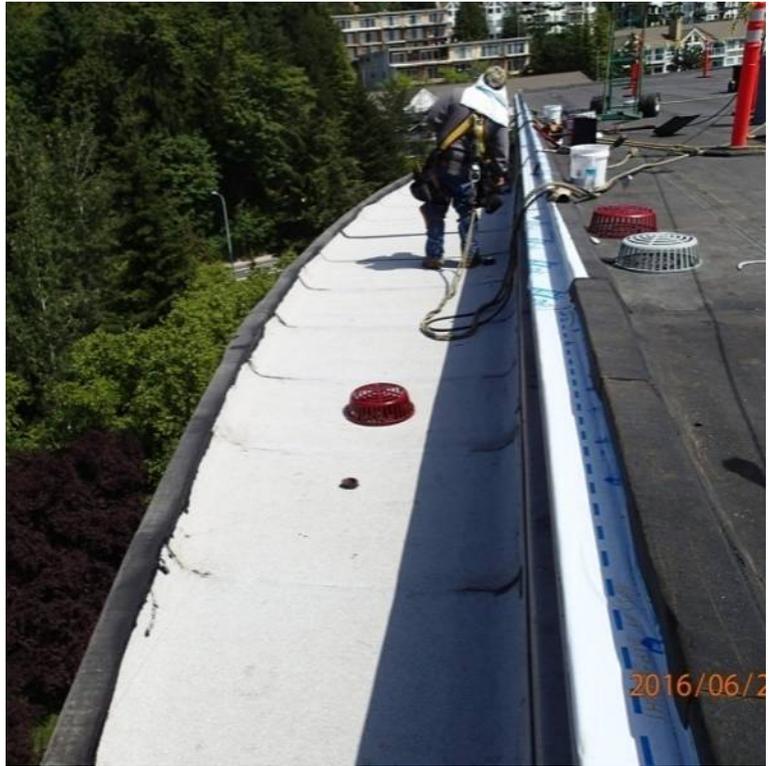
7.12 Overview photos of the eyebrow roofs. Photos were taken at this writer's departure and depict installation through the capsheet.

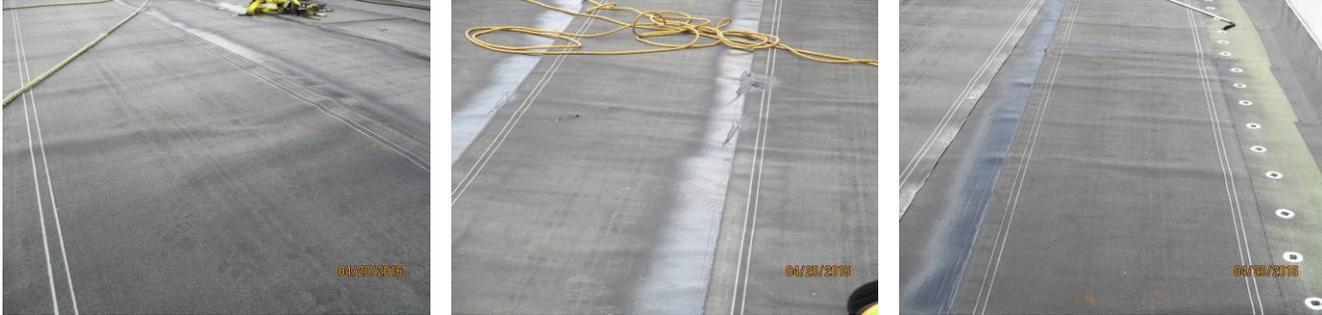
5.13 Wrinkles were observed in the interply sheet of Paradiene 20 TG. As discussed over the phone with Brad Viles (Siplast) the wrinkles should be sliced and patched according to manufacturers guidelines.

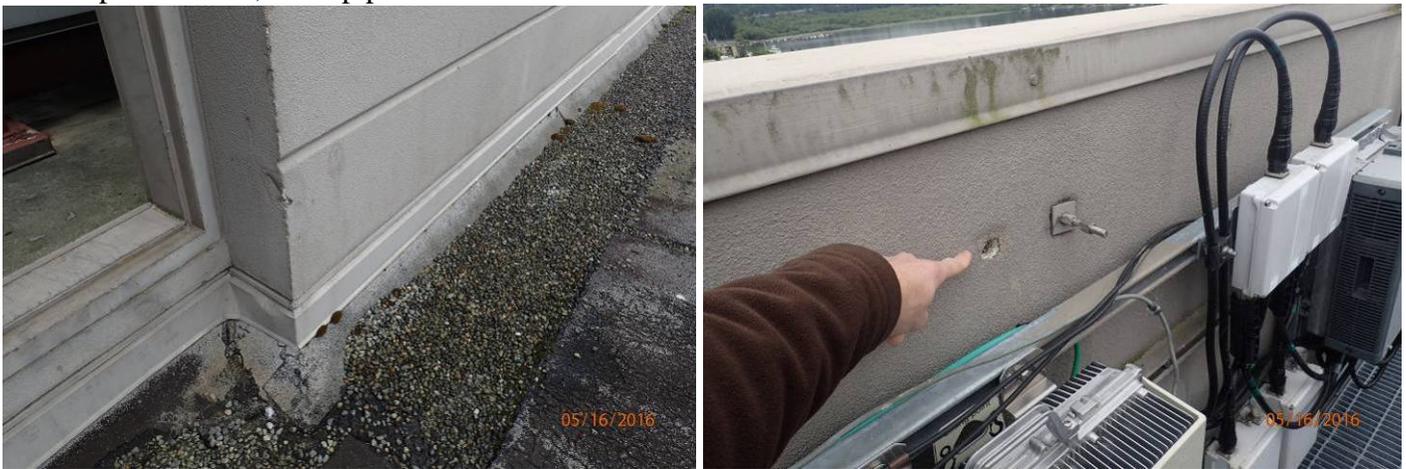
1.6 EIFS on Penthouse Walls: There is existing damage and penetrations to the EIFS on the penthouse walls. A few locations were photographed during the site visit. SR Bldg Services should document all damage prior to work. It is suggested that Carillon Properties repair damaged areas, and areas with penetrations, to help prevent water infiltration.

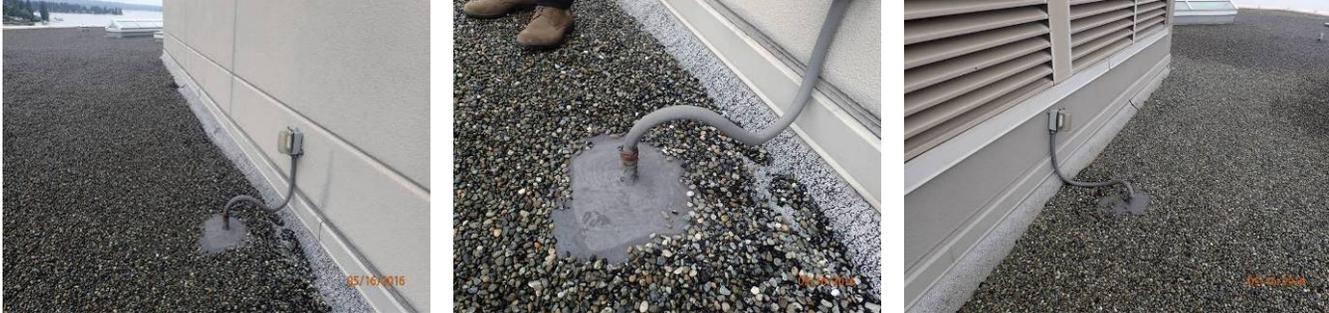
- 1.8 Short conduit penetrations with flexible conduit above, are present at the north and south ends of the penthouse. These penetrations should be detailed with Parapro, and an EPDM boot at the top edge secured with band clamps that extends onto the flexible conduit above the connection point.

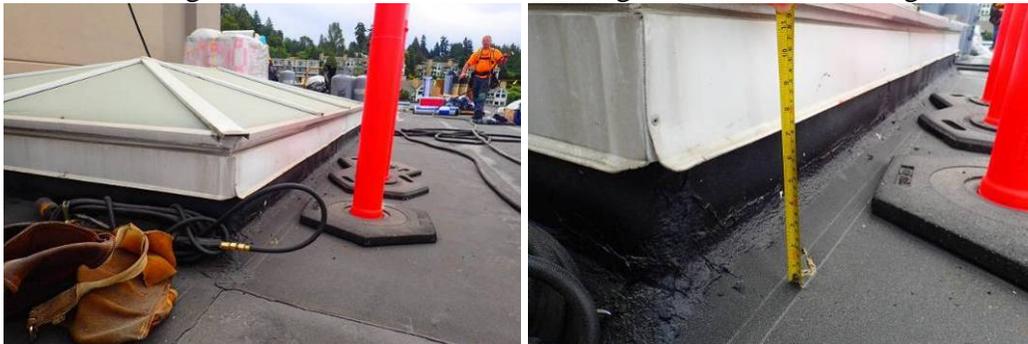
- 1.9 Low Skylight: The large, older, skylight at the west side of the penthouse has sheet metal counterflashing that extends under the skylight frame preventing the new roof membrane from extending minimum 8 inches vertically. As discussed, cut the existing skylight approximately halfway up the width to allow the roof membrane to extend vertically 8 inches. New sheet metal flashing to be inserted up under the existing flashing and riveted to existing flashing.

Update Rep #5, 6/20/16: The new roof membrane was tucked under the existing flashing and appears to be extended 8 inches off the finished roof surface. It appears the existing metal can be left and new skirt flashing metal installed under the existing metal, without cutting the existing metal.

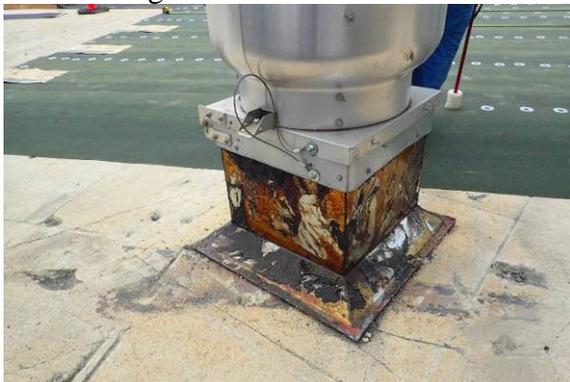
- 1.10 Existing Fan Curbs: Two newer fan curbs are installed on the roof, that appear to have flanges that are tight to the existing roofing. SR to review options to reduce the width of the roofing at the top of the curb, or install sheet metal to tuck under the flange of the unit.

Update Rep #5, 6/20/16: The existing curbs are metal. SR plans to install new sheet metal under the existing flange. Screws will need to be removed and reinstalled.
