FIELD REPORT – CARILLON POINT BUILDING 4000 – FIELD REPORT

Report Number: 5

Project No. 10-030608K1

4000 Carillon Point
Kirkland, Washington

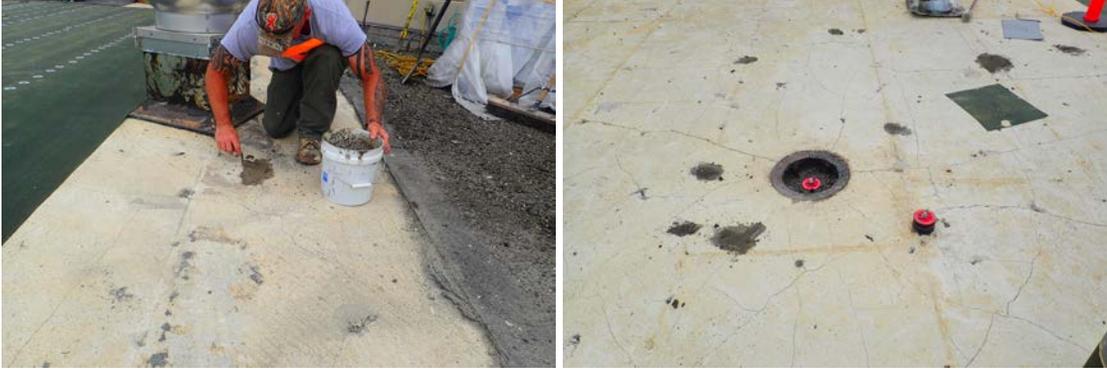
5.1 The existing lightweight concrete substrate was being patched with Zono-Patch where divots were present from removal of existing fasteners.

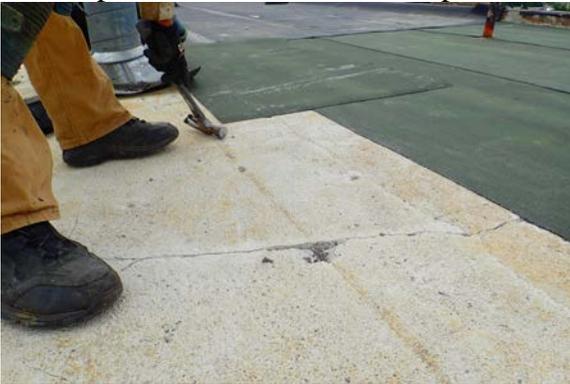
5.2 Where existing fasteners were partially left in the lightweight concrete, workers used hammers to recess the top of the fasteners below the surface of the substrate. It was indicated that this procedure had been performed at all roof areas prior to installing the inverted capsheet.

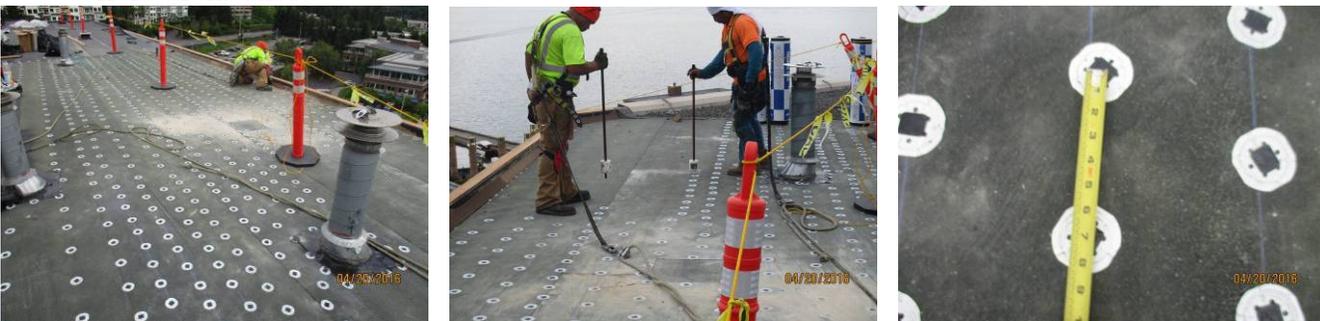
5.3 The existing roof assembly was removed to the lightweight concrete and Malarkey #502 granulated capsheet is installed, inverted, secured with Zono-Tite fasteners. At the perimeters, the fasteners are installed spaced approximately 6-inches on center at the laps with 3 rows at 9-inches on center in the field of the sheet.

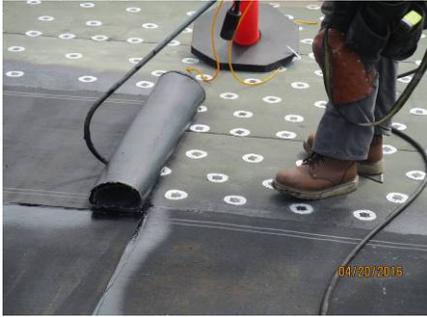
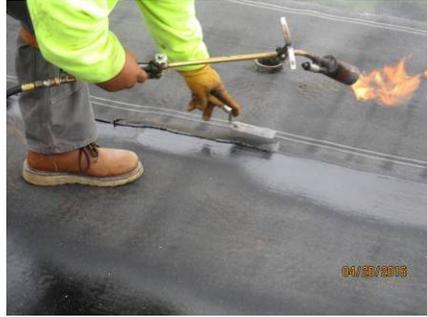
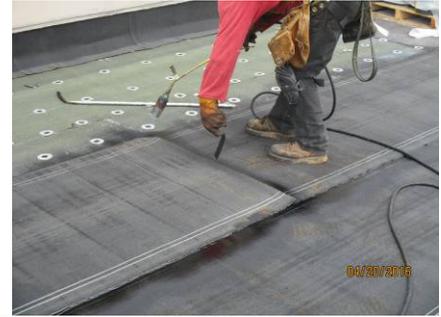
5.4 Siplast Paradiene 20 TG is rolled out utilizing a shepherd's crook and torch applied over the basesheet. The laps are pressed in by trowel to promote adhesion

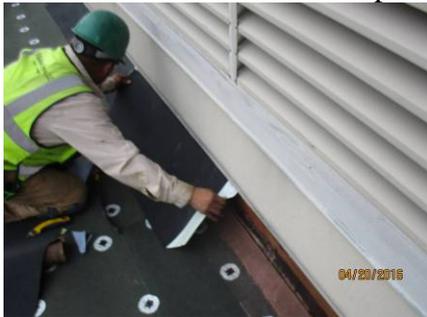
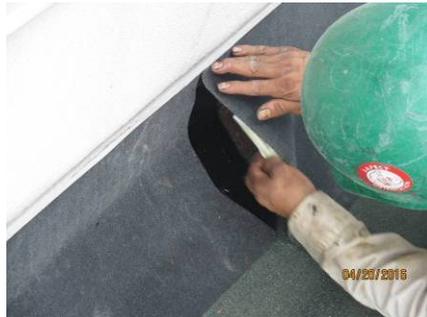
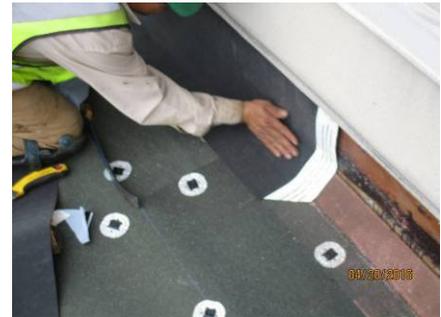
5.5 At the base of the penthouse walls, TA-119 primer is roller applied to the cant strip and is allowed to tack off. The polyolefin release film is removed from the underside of Paradiene 20 SA and the sheet is adhered to the cant strip and wall. The baseflashing is pressed in by hand to promote adhesion to the substrate and at the laps.

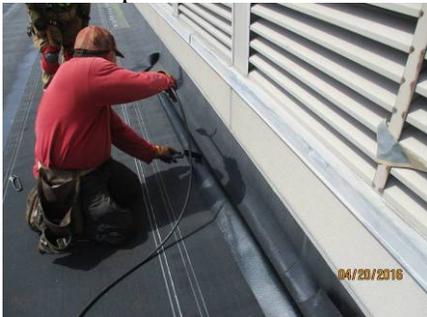
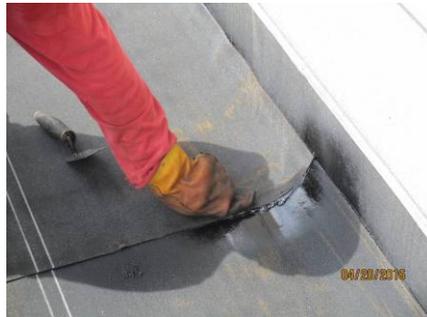
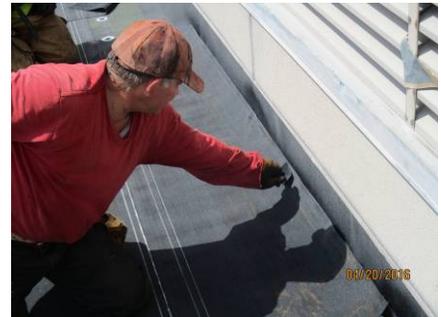
5.6 At the base of the penthouse walls, Paradiene 20 TG is installed torch applied lapping up onto the adjacent basesheet. The laps of the baseflashing are pressed by hand, and/or trowel to promote adhesion between the laps.

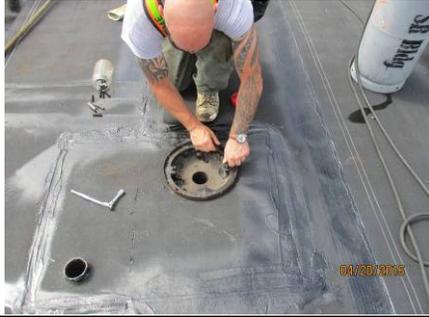
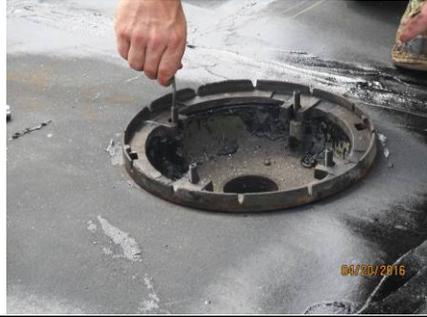
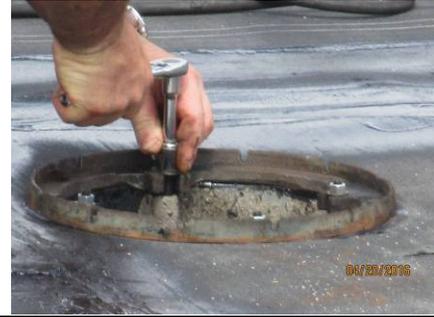
5.7 Where the roof assembly is installed through the interply, the clamping rings are set into place and the bolts are fastened into the drain bowl to secure the ring.

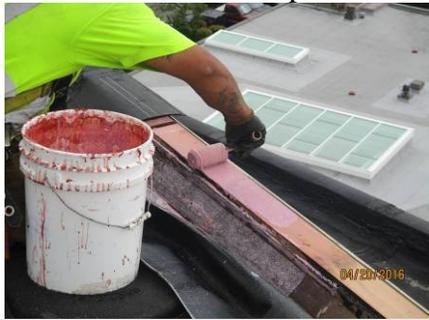
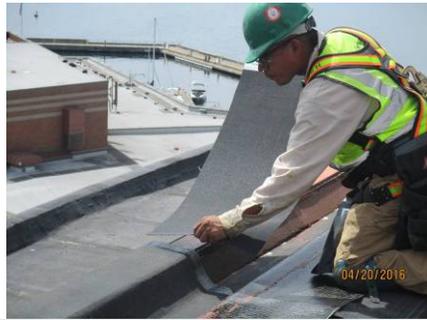
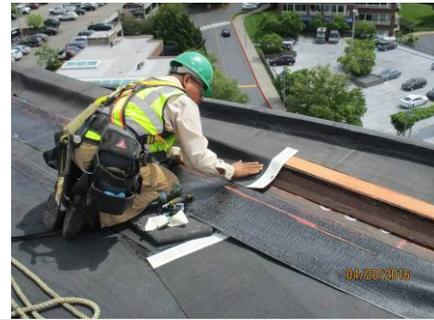
5.8 At the perimeter, TA-119 primer is roller applied to the cant strip and wood nailer and allowed to tack off. Paradiene 20 SA is installed. The polyolefin release film is removed and the baseflashing is adhered to the perimeter curb.

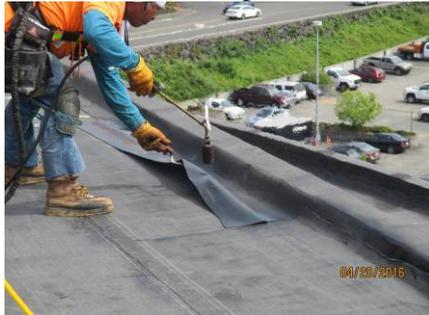
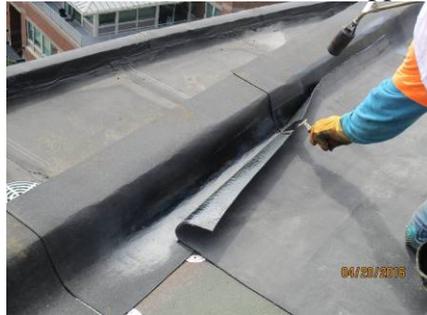
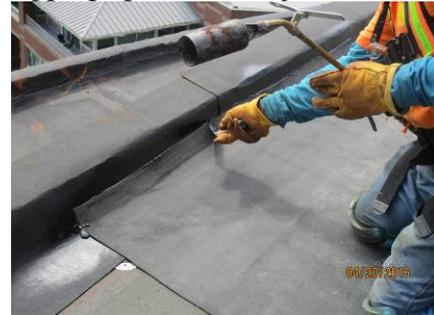
5.9 At the roof perimeter, Paradiene 20 TG is installed torch applied lapping up onto the adjacent baseflashing.

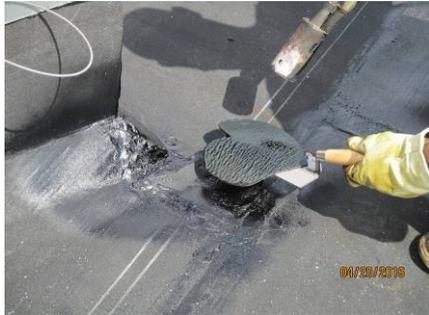
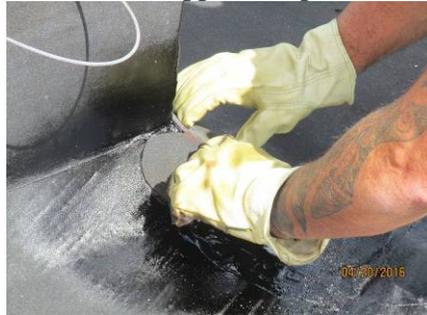
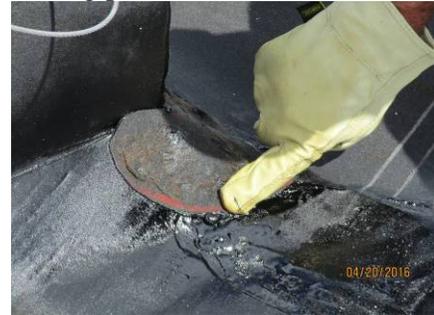
5.10 At the outside corners, footballs are torch applied as part of the detailing process of the installed interply.

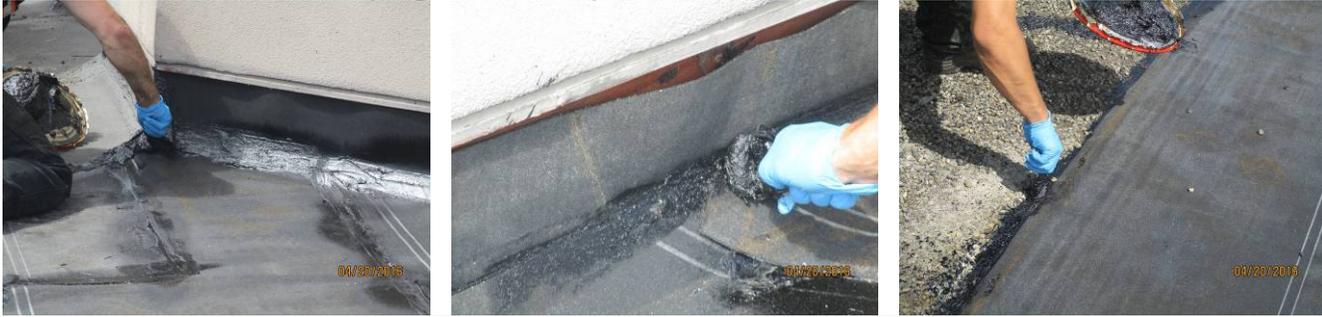
5.11 At the end of the day the installed roof assembly is made temporarily weathertight with Siplast PA-1021 Plastic Roof Cement. The plastic cement is applied at the base of the penthouse walls as well as where the new roof assembly laps onto the adjacent existing roof assembly.

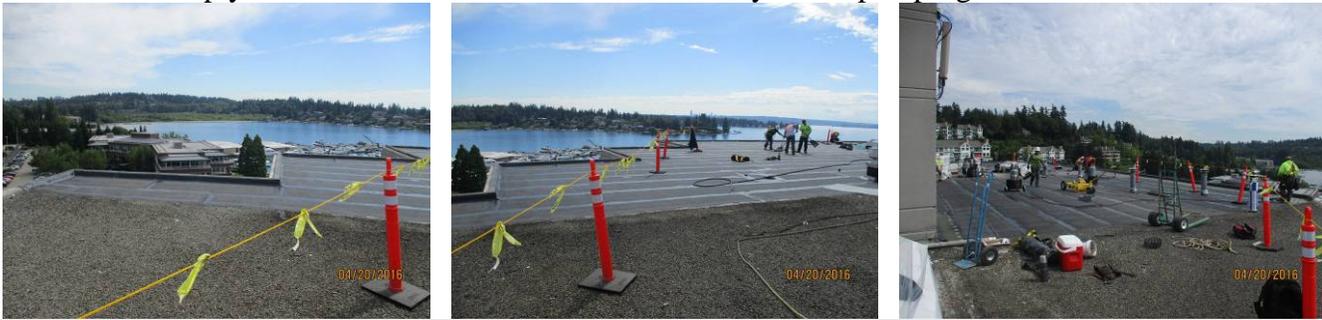
5.12 Overview photos of the southwest area of the Main Roof where the roof assembly is installed through the interply. Photos were taken at the end of the day and depict progress.

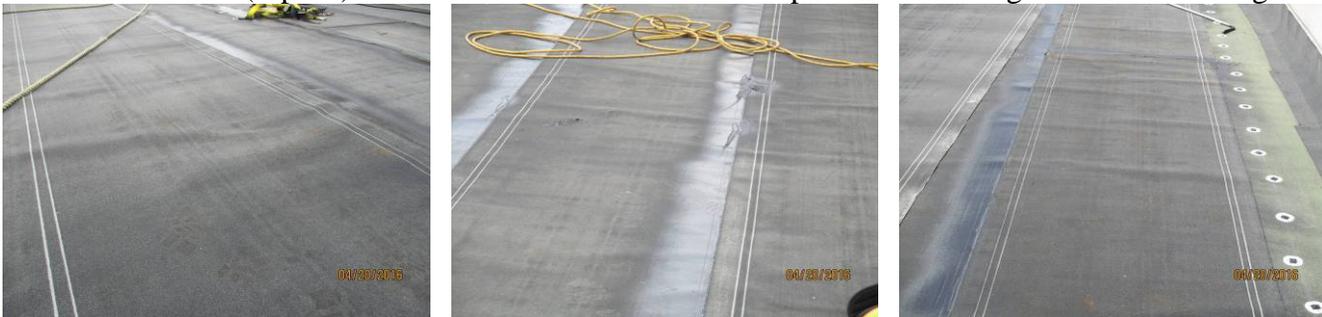
5.13 Wrinkles were observed in the interply sheet of Paradiene 20 TG. As discussed over the phone with Brad Viles (Siplast) the wrinkles should be sliced and patched according to manufacturers guidelines.

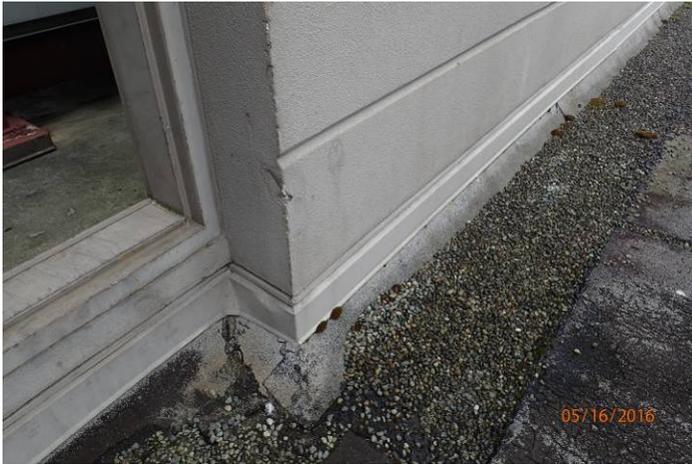
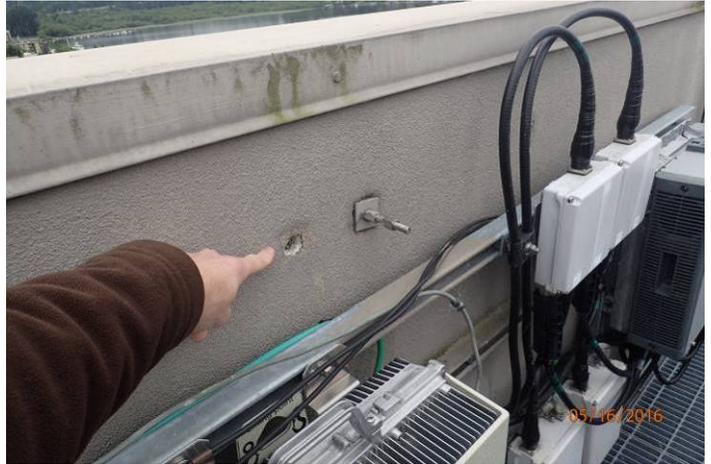
1.6 EIFS on Penthouse Walls: There is existing damage and penetrations to the EIFS on the penthouse walls. A few locations were photographed during the site visit. SR Bldg Services should document all damage prior to work. It is suggested that Carillon Properties repair damaged areas, and areas with penetrations, to help prevent water infiltration.

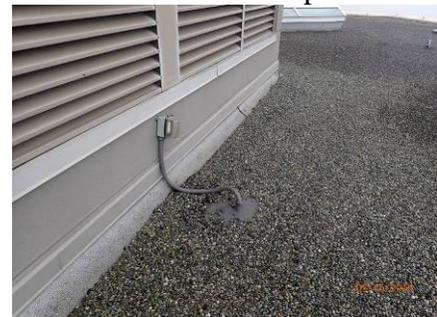
1.8 Short conduit penetrations with flexible conduit above, are present at the north and south ends of the penthouse. These penetrations should be detailed with Parapro, and an EPDM boot at the top edge secured with band clamps that extends onto the flexible conduit above the connection point.

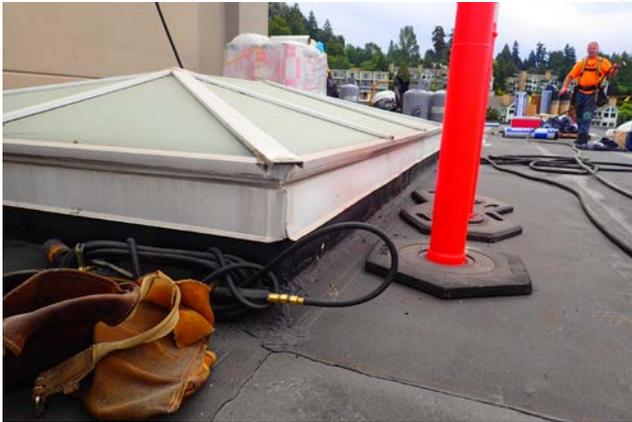
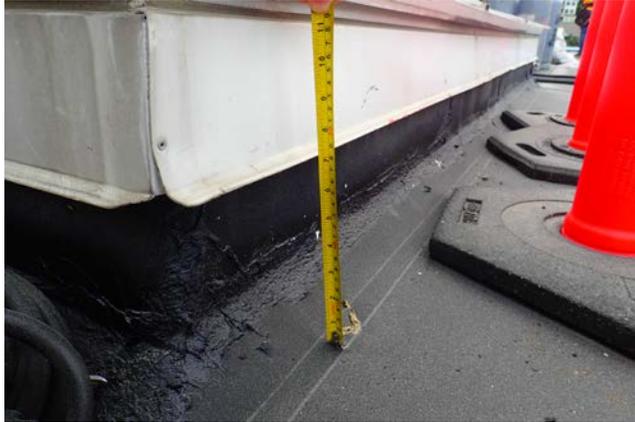
1.9 Low Skylight: The large, older, skylight at the west side of the penthouse has sheet metal counterflashing that extends under the skylight frame preventing the new roof membrane from extending minimum 8 inches vertically. As discussed, cut the existing skylight approximately halfway up the width to allow the roof membrane to extend vertically 8 inches. New sheet metal flashing to be inserted up under the existing flashing and riveted to existing flashing.

Update Rep #5, 6/20/16: The new roof membrane was tucked under the existing flashing and appears to be extended 8 inches off the finished roof surface. It appears the existing metal can be left and new skirt flashing metal installed under the existing metal, without cutting the existing metal.

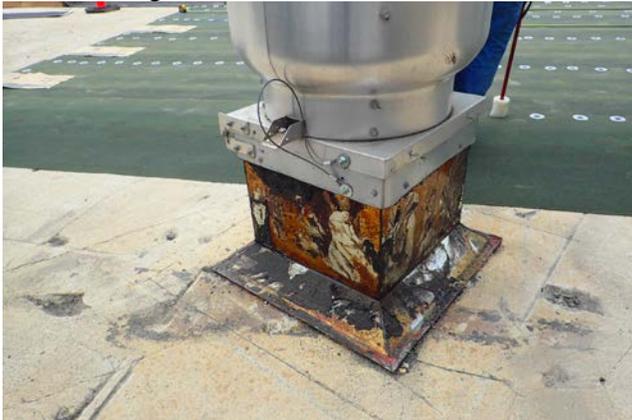
1.10 Existing Fan Curbs: Two newer fan curbs are installed on the roof, that appear to have flanges that are tight to the existing roofing. SR to review options to reduce the width of the roofing at the top of the curb, or install sheet metal to tuck under the flange of the unit.

Update Rep #5, 6/20/16: The existing curbs are metal. SR plans to install new sheet metal under the existing flange. Screws will need to be removed and reinstalled.
