W E T H E R H O L T   A N D   A S S O C I A T E S ,   I N C .

**FIELD REPORT – CARILLON POINT BUILDING 4000 – FIELD REPORT**

**Report Number: 9**

**Project No.** 10-030608K1

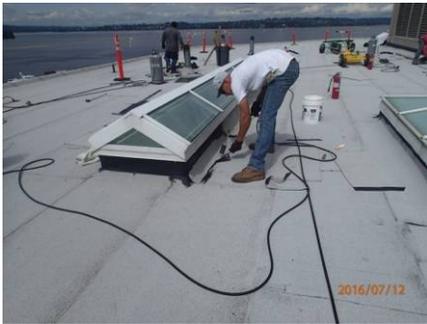
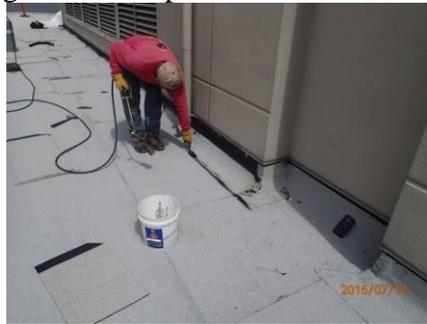
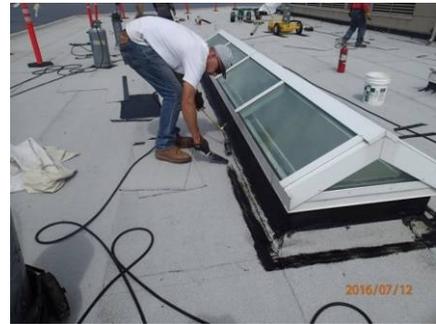
9.1 At the perimeter of the main roof, base of the rising wall and around the skylight and mechanical curbs, prior to installation of the capsheet baseflashing, the capsheet where the baseflashing will lap onto is heated with a torch and the granules are pressed in with a trowel.

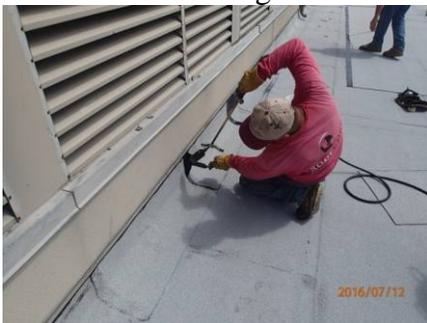
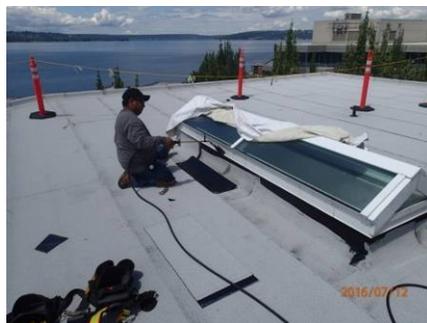
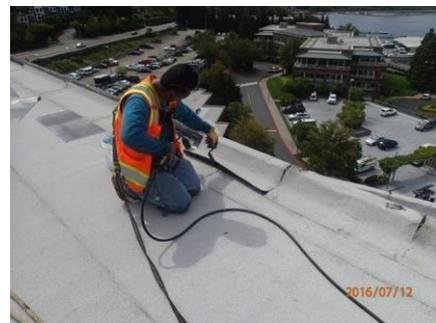
9.2 Siplast Paradiene 40 FR TG is installed torch applied over the capsheet in the field and self-adhered baseflashing at the curbs and rising wall. The sheet is heated with a torch and rolled out by hand and trowel during installation.

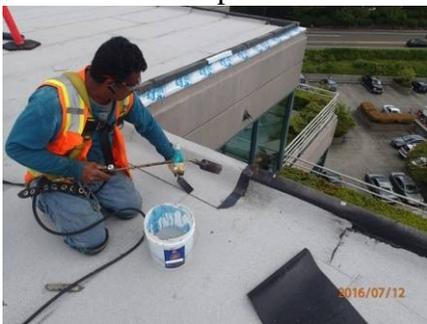
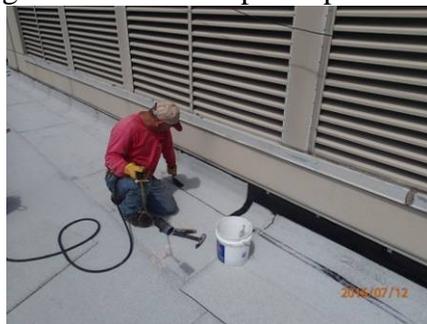
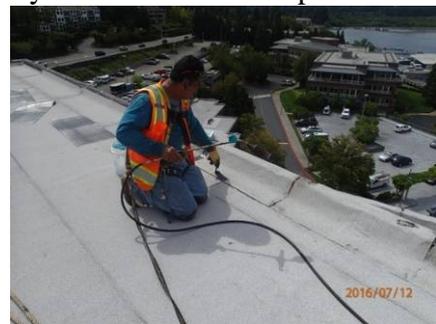
9.3 As the capsheet baseflashing is installed the laps are pressed in by trowel and hand to promote adhesion.

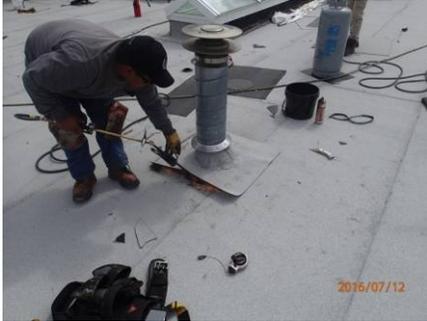
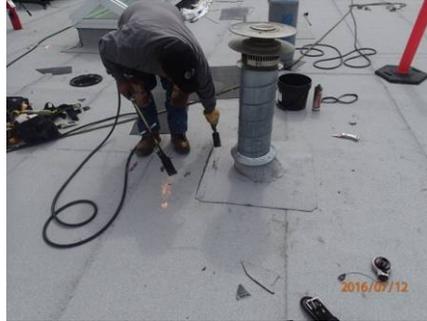
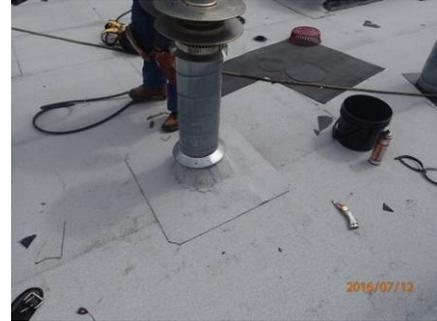
9.4 At the base of the vent stacks, a target of cap sheet is installed torch applied to the adjacent capsheet. The laps are pressed in by trowel and hand to promote adhesion.

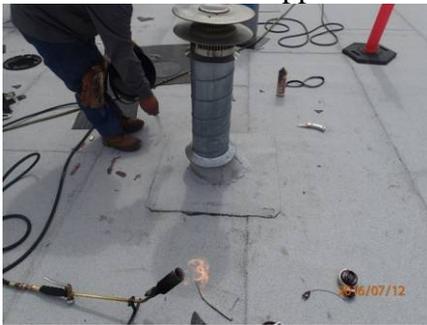
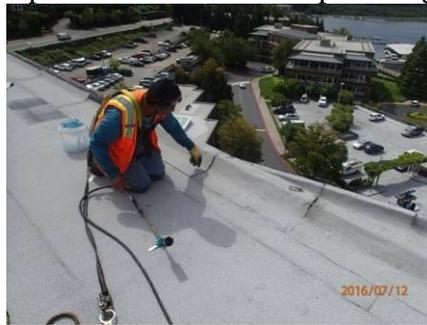
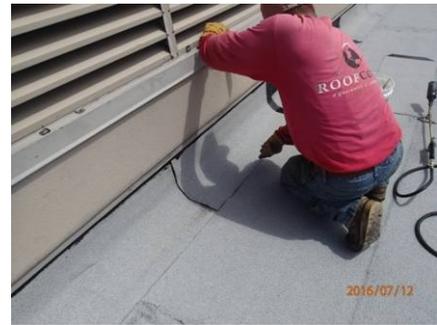
9.5 Granules are applied to the asphalt bleedout at the laps during installation.

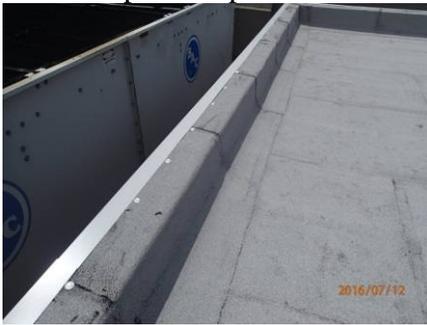
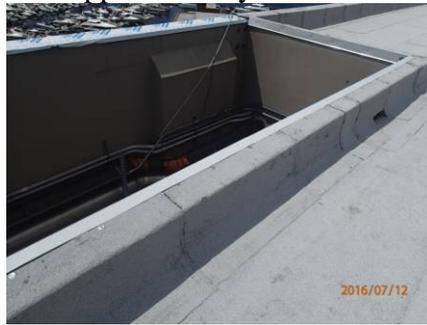
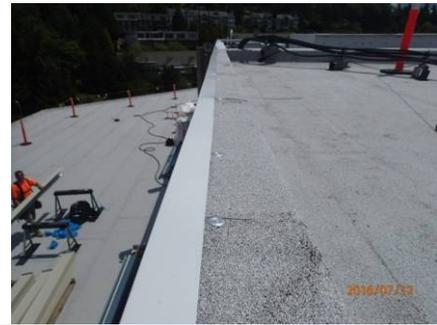
9.6 Where the baseflashing capsheet is installed, 7/8-inch EG Metal Round Cap nails are installed along the top of the perimeter curb spaced approximately 12-inches on center.

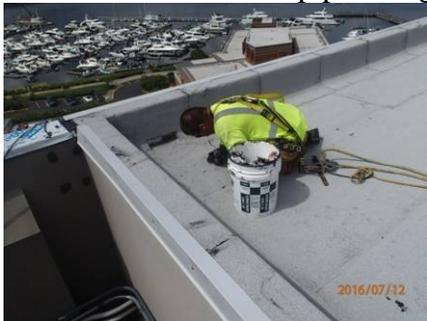
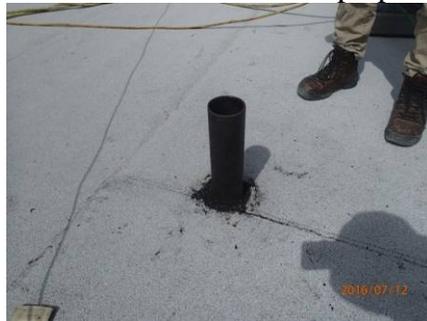
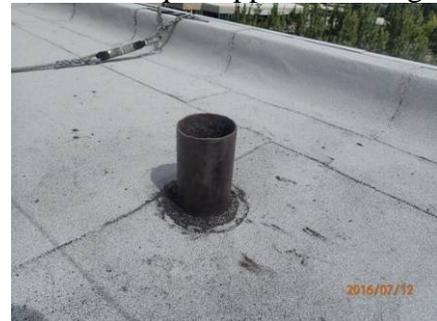
9.7 The metal vent pipes are ground with a wire wheel in preparation for the liquid applied flashing.

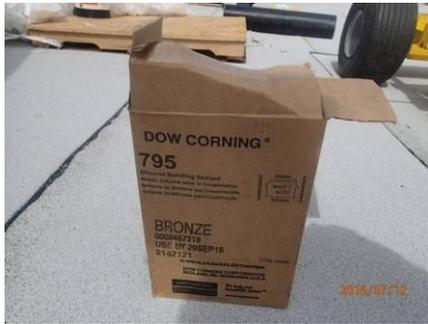
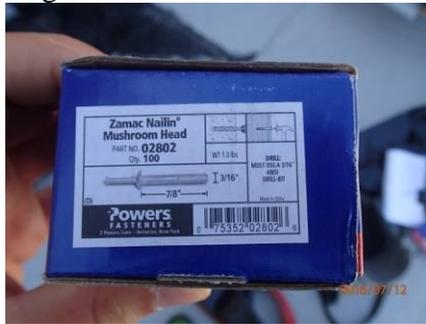
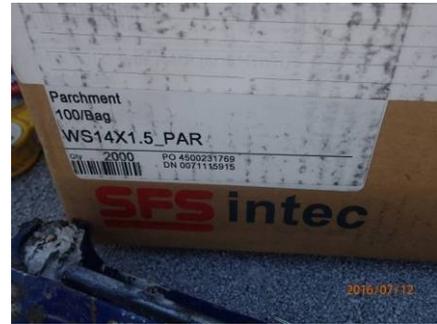
9.8 The following sheet metal related products were observed on site for future installation: DOW Corning 795 Silicone Building Sealant Bronze color, Powers Fasteners Zamac Nailin Mushroom Head  $\frac{7}{8}$ -x  $\frac{3}{16}$ -inch and SFS intec WS14x1.5 gasketed fasteners in Parchment.

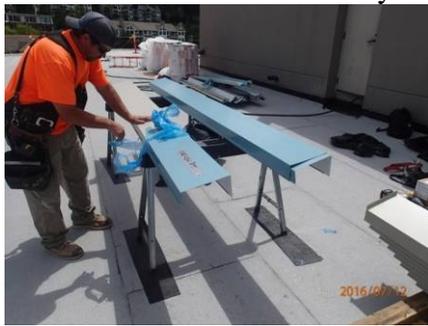
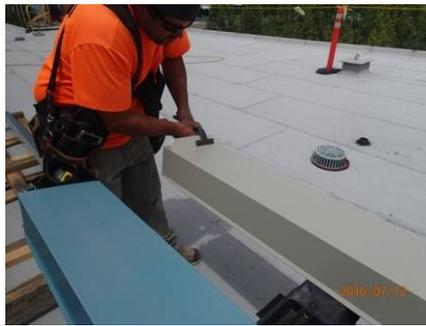
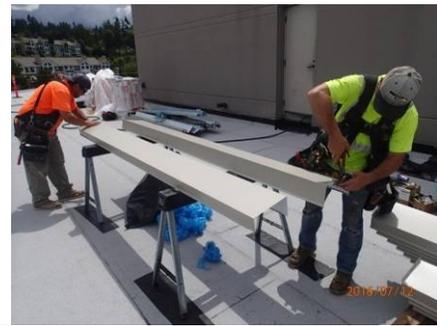
9.9 The protective release film is removed from the sheet metal standing seam coping which is then cut and fabricated as necessary in the field.

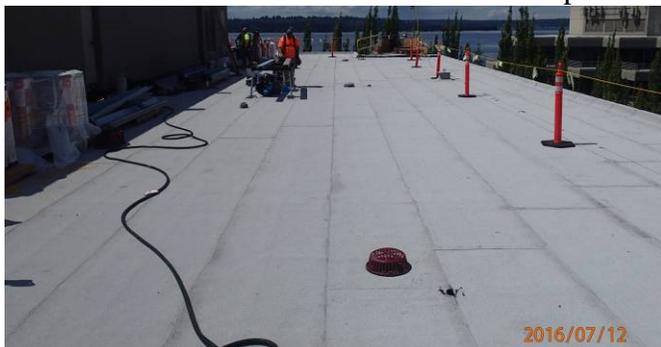
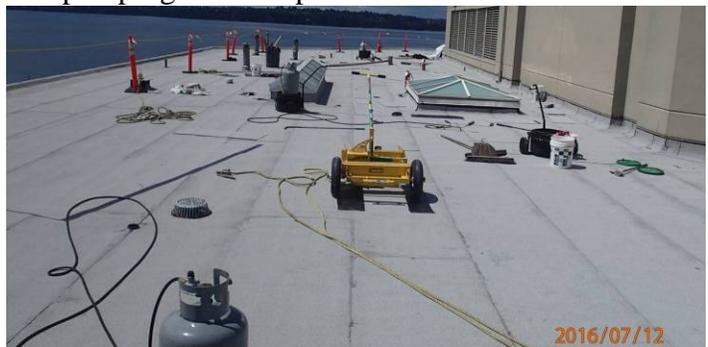
9.10 Overview photos of the northeast and southwest roof areas, respectively, as viewed from the south. Photos were taken at this writer's departure and depict progress of capsheet installation.

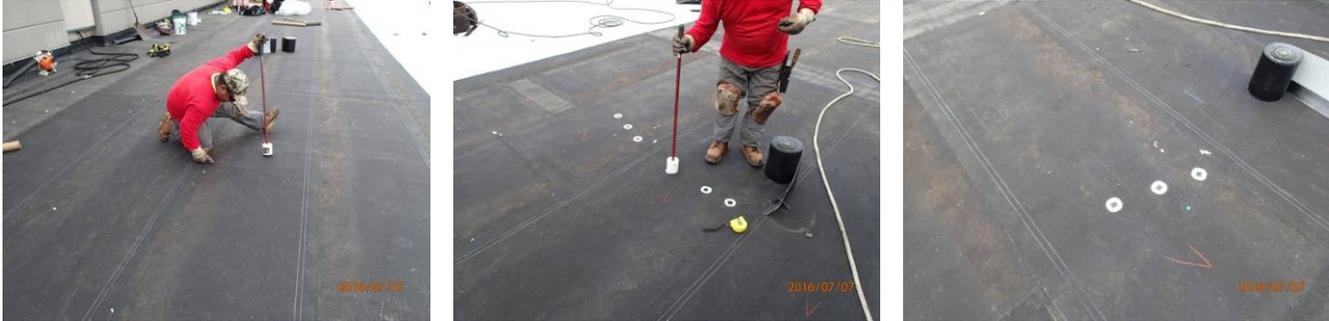
5.13 Wrinkles were observed in the interply sheet of Paradiene 20 TG. As discussed over the phone with Brad Viles (Siplast) the wrinkles should be sliced and patched according to manufacturers guidelines. Update 07/07/16 Report #08: Prior to installation of the capsheet, the wrinkles are cut and laid flat. Zono-Tite fasteners are applied along the cut wrinkle. It was indicated that an additional ply of interply would be torch applied over the cut and fasteners prior to installation of the capsheet. . Update 07/12/16 Report #9: The remainder of the capsheet has been installed. It appears that the wrinkles were addressed prior to installation of the capsheet. **Item Closed.**

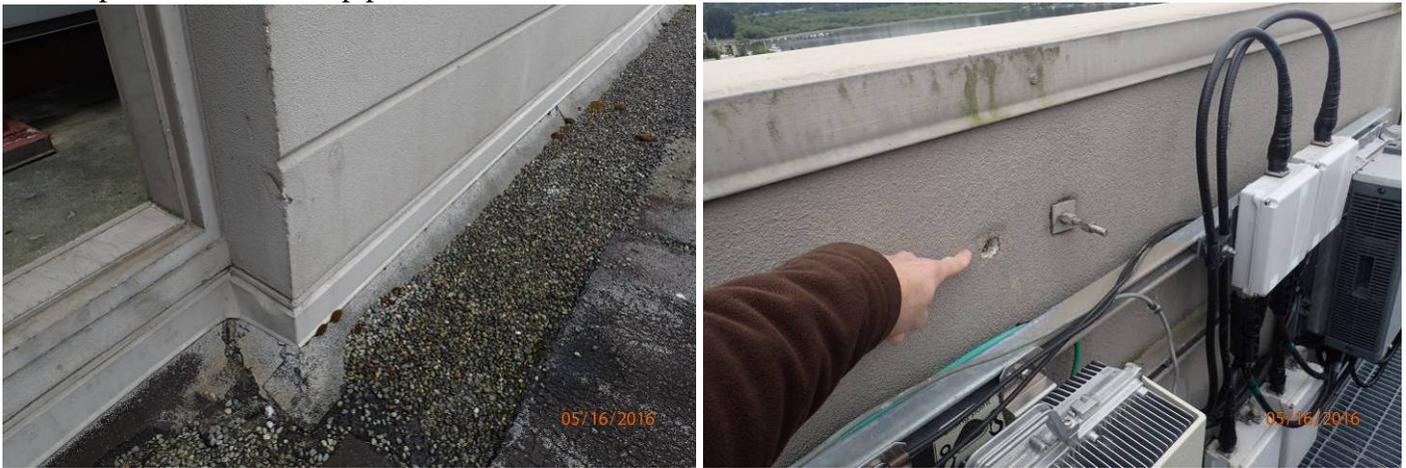
1.6 EIFS on Penthouse Walls: There is existing damage and penetrations to the EIFS on the penthouse walls. A few locations were photographed during the site visit. SR Bldg Services should document all damage prior to work. It is suggested that Carillon Properties repair damaged areas, and areas with penetrations, to help prevent water infiltration.

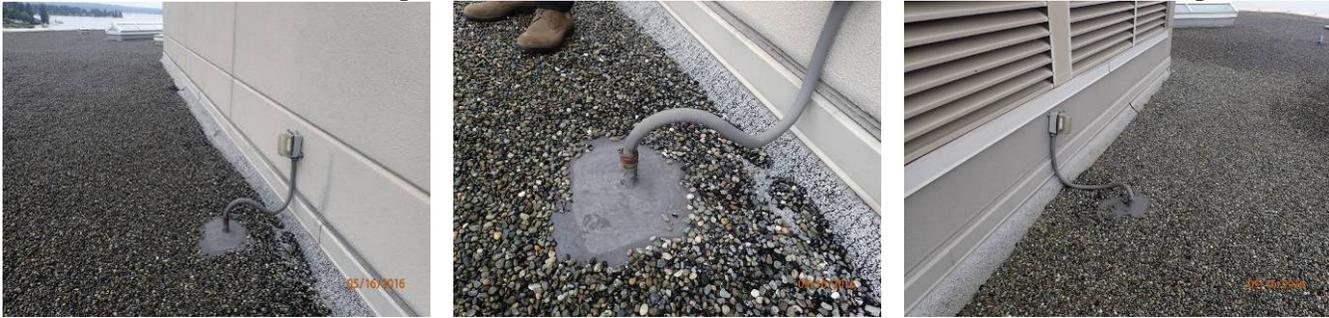
- 1.8 Short conduit penetrations with flexible conduit above, are present at the north and south ends of the penthouse. These penetrations should be detailed with Parapro, and an EPDM boot at the top edge secured with band clamps that extends onto the flexible conduit above the connection point.

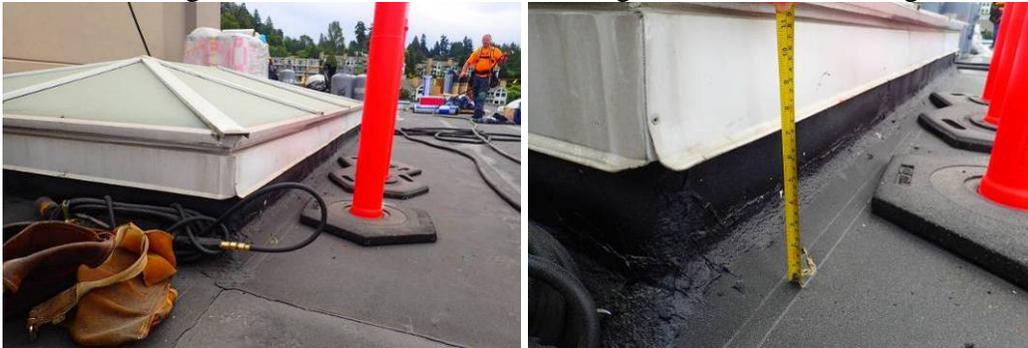
- 1.9 Low Skylight: The large, older, skylight at the west side of the penthouse has sheet metal counterflashing that extends under the skylight frame preventing the new roof membrane from extending minimum 8 inches vertically. As discussed, cut the existing skylight approximately halfway up the width to allow the roof membrane to extend vertically 8 inches. New sheet metal flashing to be inserted up under the existing flashing and riveted to existing flashing.

Update Rep #5, 6/20/16: The new roof membrane was tucked under the existing flashing and appears to be extended 8 inches off the finished roof surface. It appears the existing metal can be left and new skirt flashing metal installed under the existing metal, without cutting the existing metal.

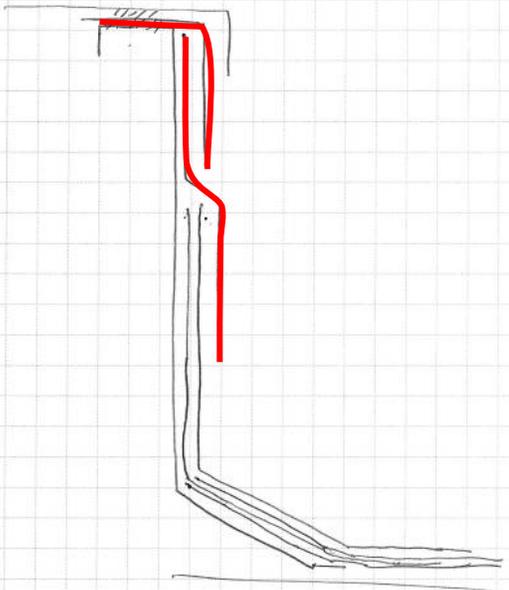
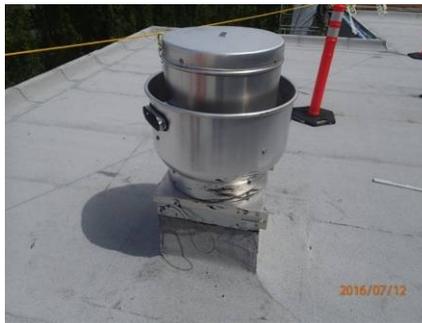
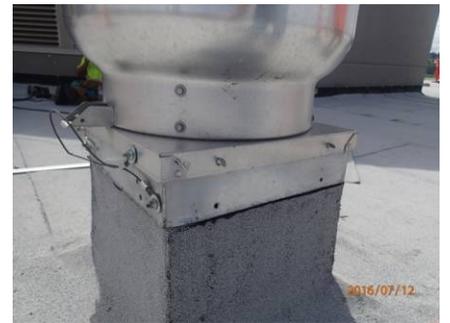
1.10 Existing Fan Curbs: Two newer fan curbs are installed on the roof, that appear to have flanges that are tight to the existing roofing. SR to review options to reduce the width of the roofing at the top of the curb, or install sheet metal to tuck under the flange of the unit.

Update Rep #5, 6/20/16: The existing curbs are metal. SR plans to install new sheet metal under the existing flange. Screws will need to be removed and reinstalled.

**Update 07/12/16 Report #9:** The As discussed with Dustin (ASM), the existing sheet metal flashing around the base of the roof top mechanical fan units does not have enough space to tuck the new counterflashing under. It is suggested that the unit be removed, the installed capsheet baseflashing is terminated approximately 8-inches above the deck and the remainder above is removed. Liquid applied flashing (depicted in red) can then be installed from the top of the curb and lap down onto the baseflashing and the unit can be reinstated and properly secured to the curb. *A sketch is attached for reference.*

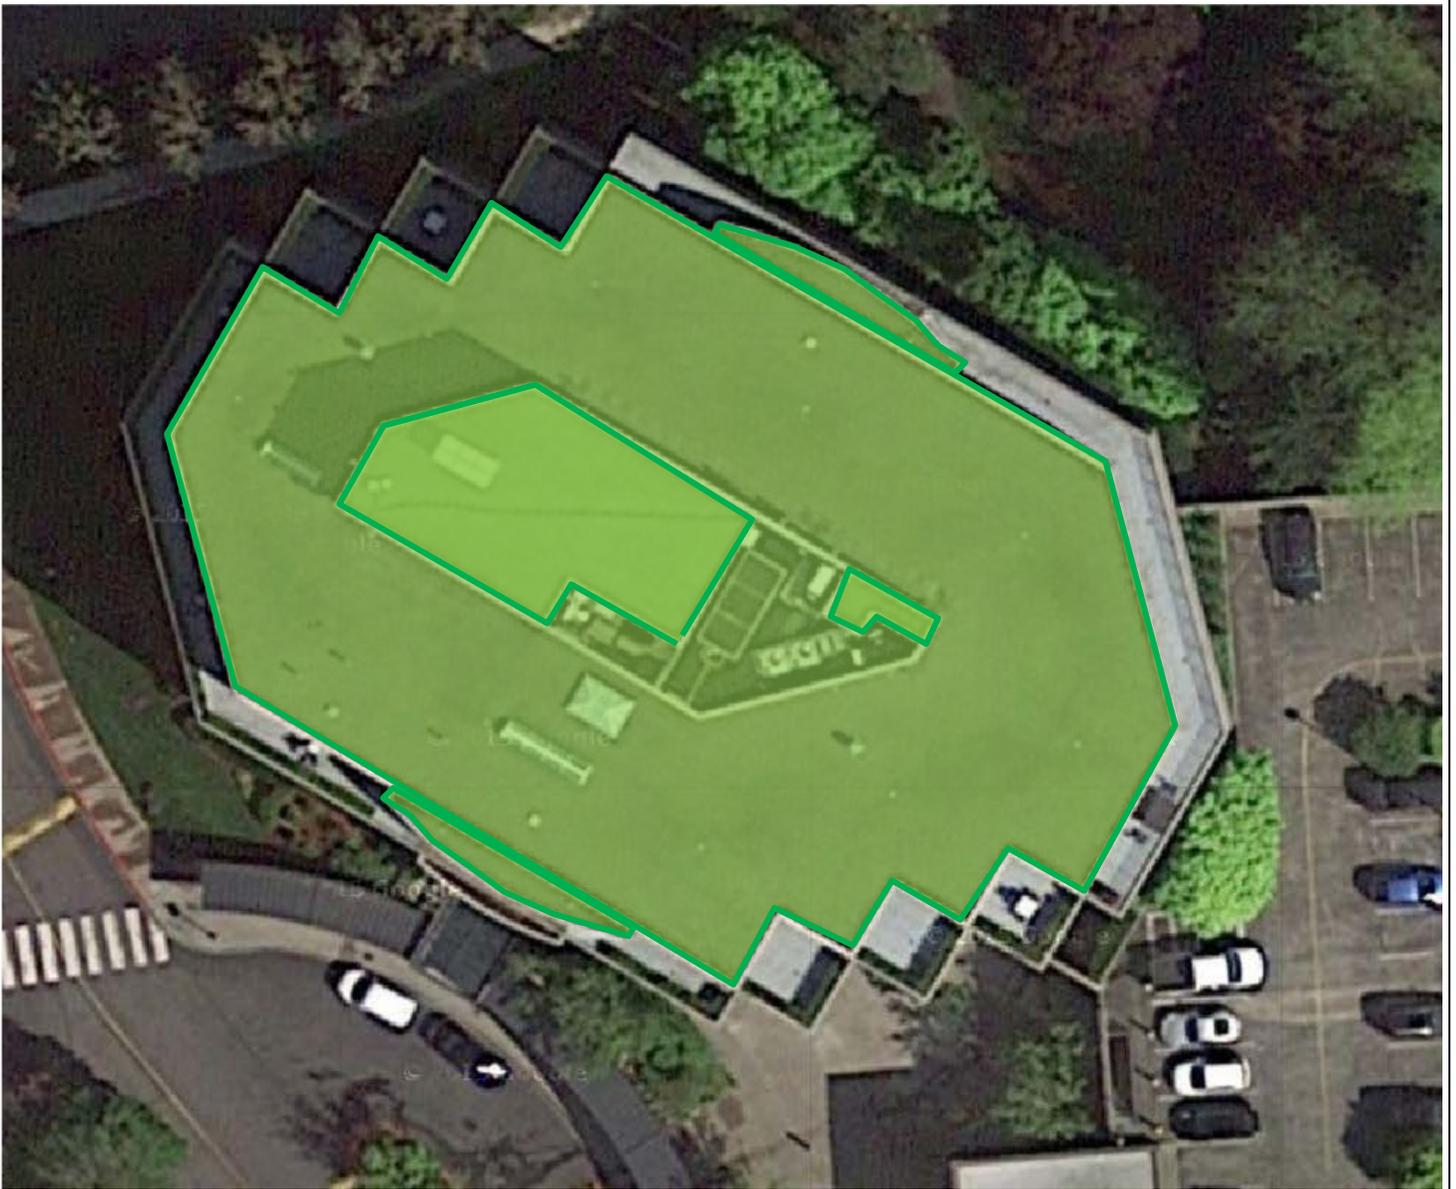
**Roof Plan:**

Location of roof assembly installed through capsheet
