FIELD REPORT – CARILLON POINT BUILDING 4000 – FIELD REPORT

Report Number: 8

Project No. 10-030608K1

4000 Carillon Point
Kirkland, Washington

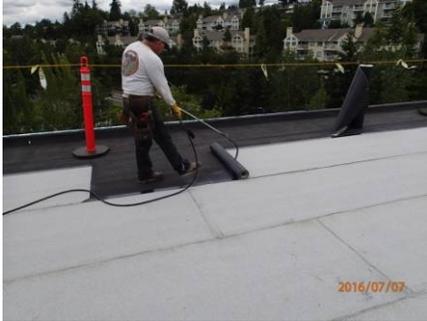
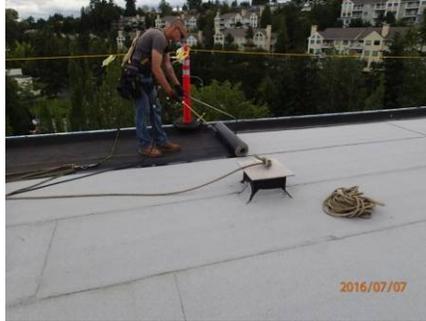
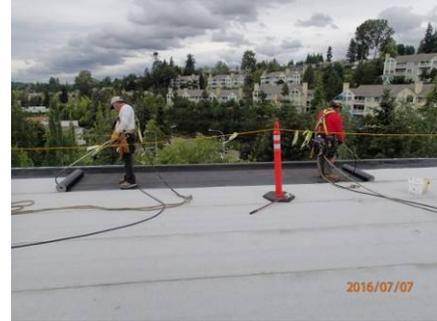
8.1 At the eyebrow roofs, Siplast Paradiene 30 TG is installed torch applied over the interply. The capsheet is rolled out utilizing a shepherd's crook and torch applied.

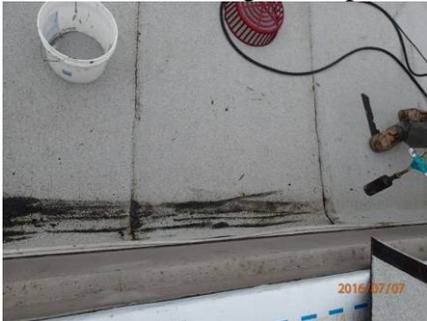
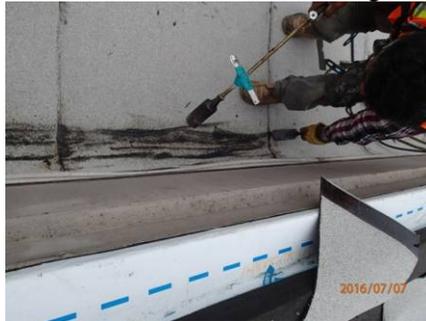
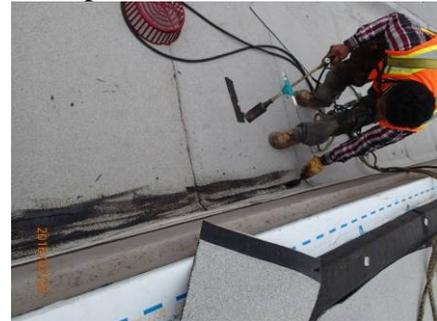
8.2 At the eyebrow roofs, prior to installation of the capsheet baseflashing, the capsheet where the baseflashing will lap onto is heated with a torch and the granules are pressed in with a trowel.

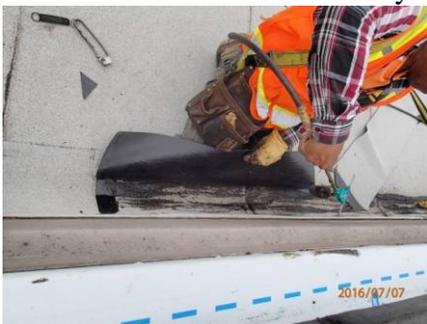
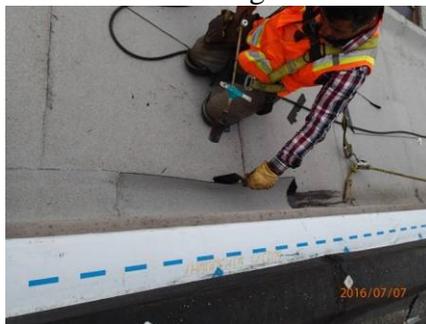
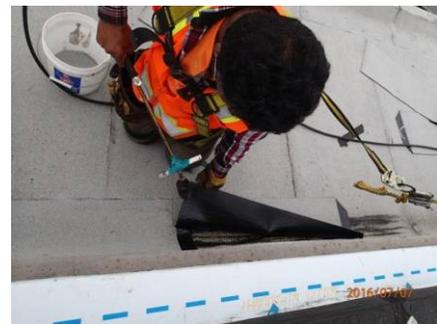
8.3 At the perimeter of the eyebrow roof, Siplast Paradiene 40 FR TG is installed torch applied over the capsheet in the field and self-adhered baseflashing at the curbs and rising wall. The sheet is heated with a torch and rolled out by hand and trowel during installation.

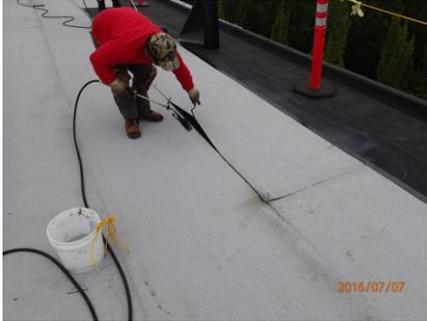
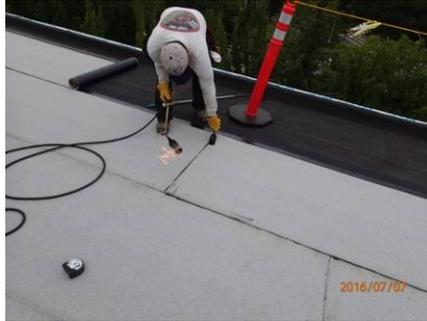
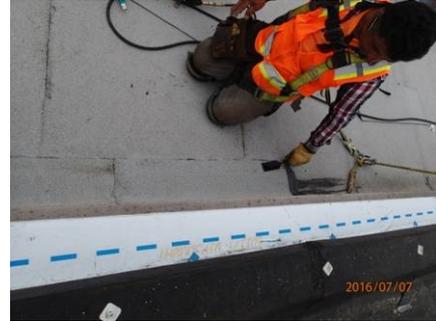
8.4 As the capsheet and capsheet baseflashing is installed the laps are pressed in by trowel and hand to promote adhesion.

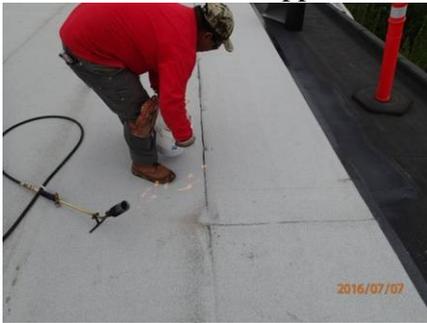
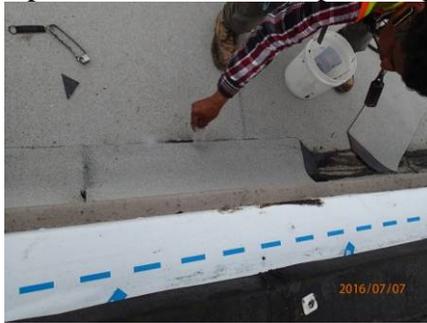
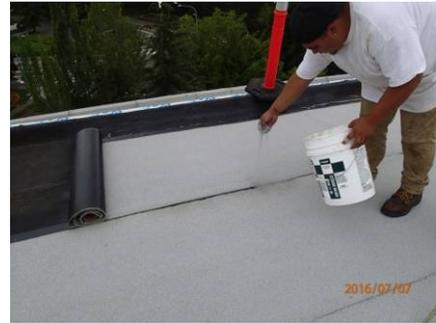
8.5 Granules are applied to the asphalt bleedout at the laps during installation.

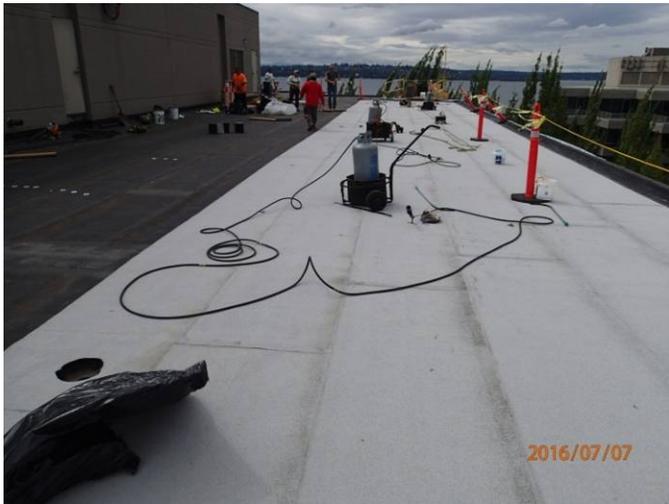
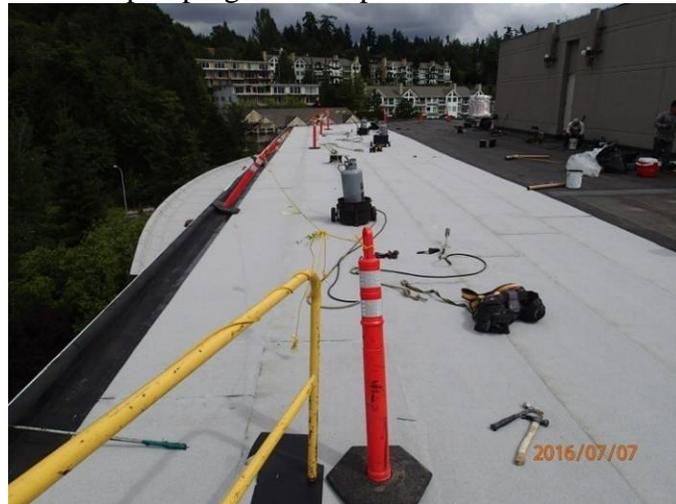
8.6 Overview photo of the northeast main roof area as viewed from the southeast and northeast, respectively. Photos were taken at the end of this writer's visit and depict progress of capsheet installation.

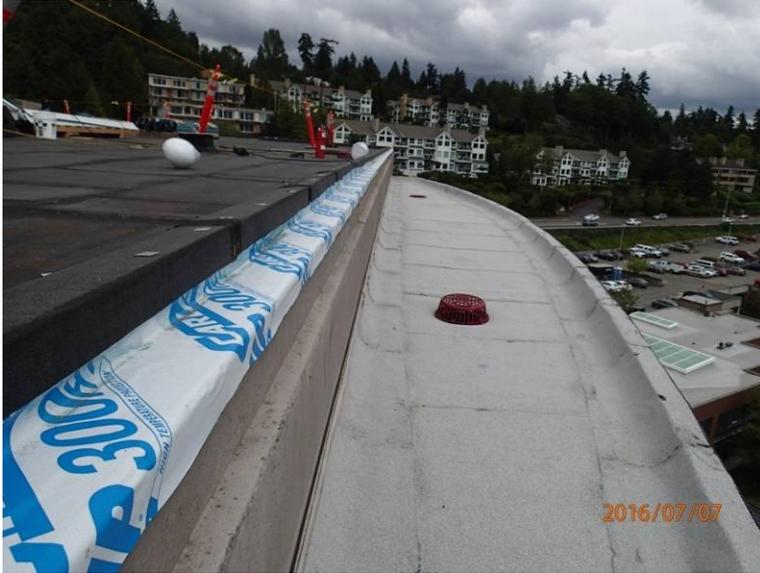
8.7 Overview photo of the south eyebrow roof. Photo depicts installed condition of the roof assembly through the capsheet and capsheet baseflashing.

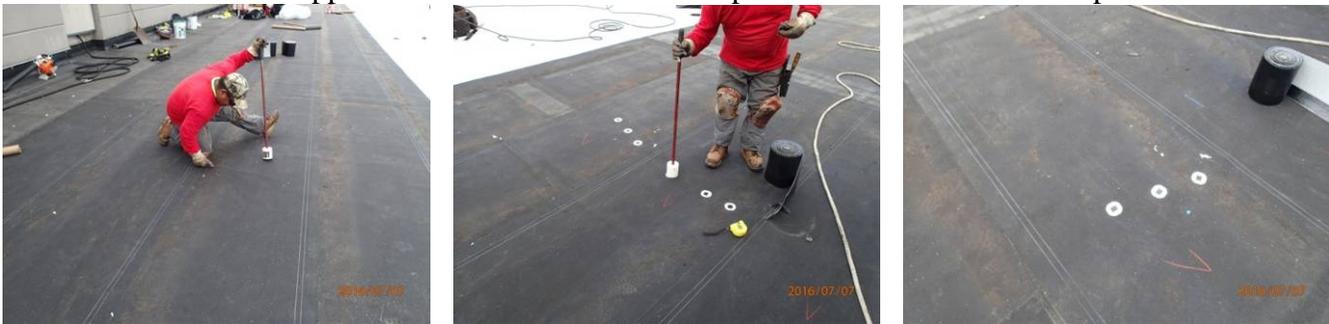
5.13 Wrinkles were observed in the interply sheet of Paradiene 20 TG. As discussed over the phone with Brad Viles (Siplast) the wrinkles should be sliced and patched according to manufacturers guidelines. **Update 07/07/16 Report #08:** Prior to installation of the capsheet, the wrinkles are cut and laid flat. Zono-Tite fasteners are applied along the cut wrinkle. It was indicated that an additional ply of interply would be torch applied over the cut and fasteners prior to installation of the capsheet.

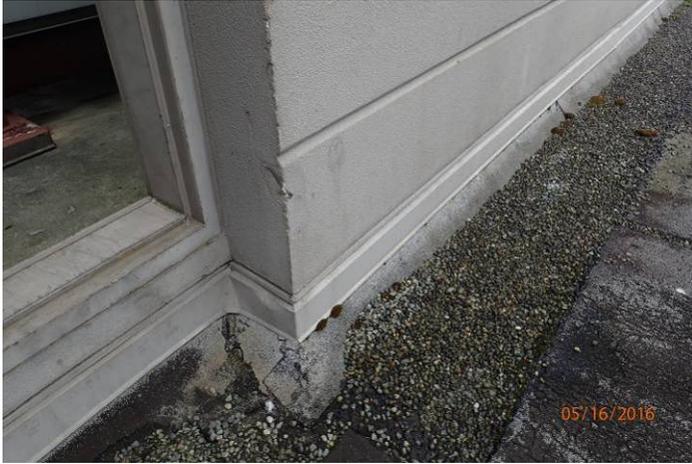
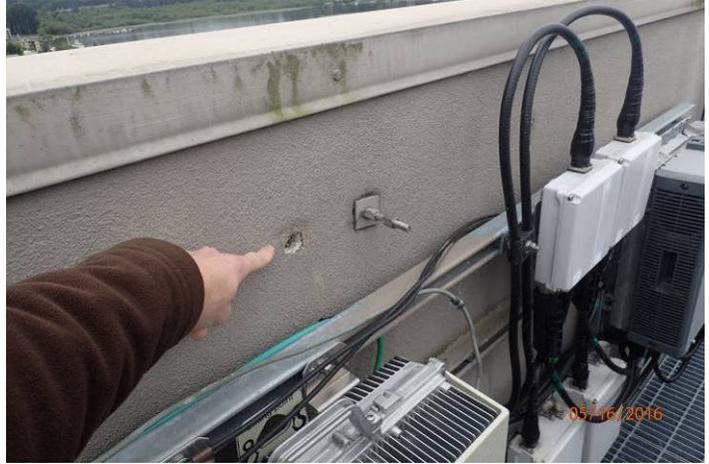
1.6 EIFS on Penthouse Walls: There is existing damage and penetrations to the EIFS on the penthouse walls. A few locations were photographed during the site visit. SR Bldg Services should document all damage prior to work. It is suggested that Carillon Properties repair damaged areas, and areas with penetrations, to help prevent water infiltration.

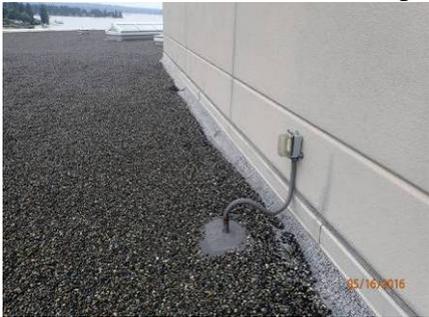
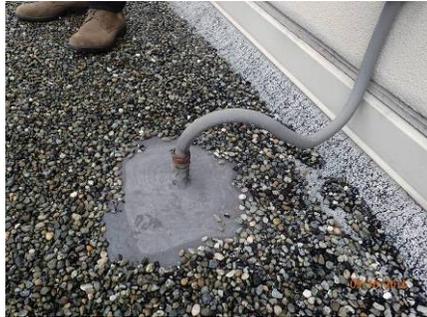
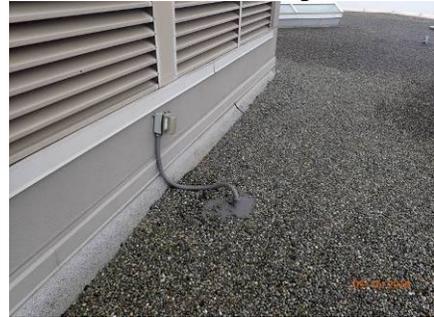
1.7 Soil stack at south end of penthouse is bent over. There appears to be an extension that is not connected to the main pipe. SR Bldg Services to provide new extension that extends 8 inches minimum above new roof surface, and is solidly secured.

1.8 Short conduit penetrations with flexible conduit above, are present at the north and south ends of the penthouse. These penetrations should be detailed with Parapro, and an EPDM boot at the top edge secured with band clamps that extends onto the flexible conduit above the connection point.

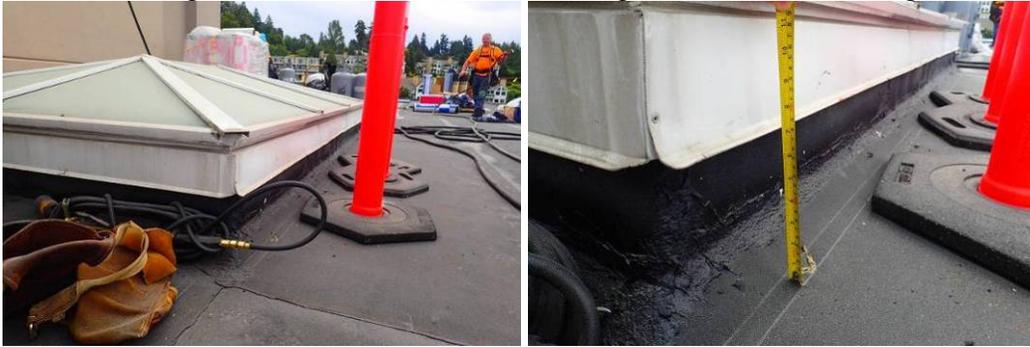
1.9 Low Skylight: The large, older, skylight at the west side of the penthouse has sheet metal counterflashing that extends under the skylight frame preventing the new roof membrane from extending minimum 8 inches vertically. As discussed, cut the existing skylight approximately halfway up the width to allow the roof membrane to extend vertically 8 inches. New sheet metal flashing to be inserted up under the existing flashing and riveted to existing flashing.

Update Rep #5, 6/20/16: The new roof membrane was tucked under the existing flashing and appears to be extended 8 inches off the finished roof surface. It appears the existing metal can be left and new skirt flashing metal installed under the existing metal, without cutting the existing metal.

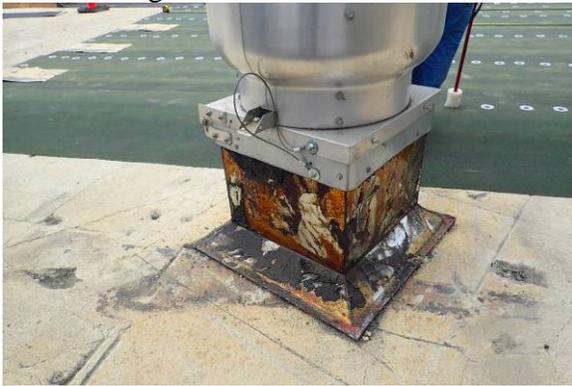
1.10 Existing Fan Curbs: Two newer fan curbs are installed on the roof, that appear to have flanges that are tight to the existing roofing. SR to review options to reduce the width of the roofing at the top of the curb, or install sheet metal to tuck under the flange of the unit.

Update Rep #5, 6/20/16: The existing curbs are metal. SR plans to install new sheet metal under the existing flange. Screws will need to be removed and reinstalled.
