FIELD REPORT – CARILLON POINT BUILDING 4000 – FIELD REPORT

Report Number: 11

Project No. 10-030608K1

4000 Carillon Point
Kirkland, Washington

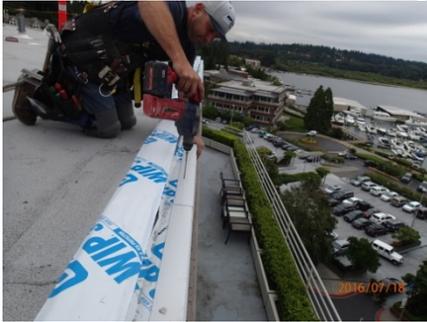
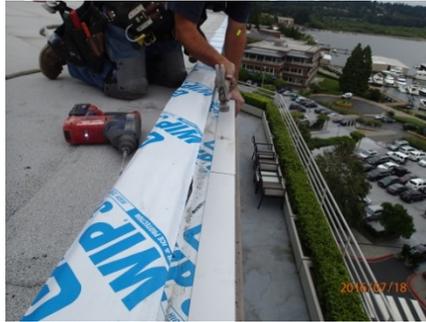
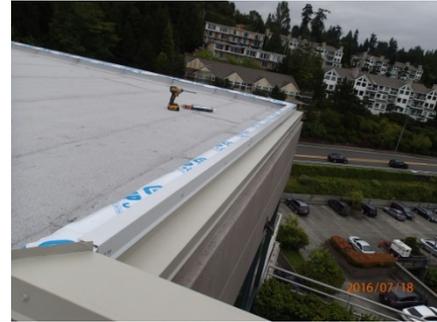
11.1 The continuous sheet metal L-clip is installed on the step down of the outer curb and along the top of the curb. A hammer drill is utilized to drill the clip and concrete and concrete fasteners are installed, securing the clip, spaced approximately 24-inches on center. A separate L-metal clip is installed at the top outside corner of the parapet to secure the coping metal.

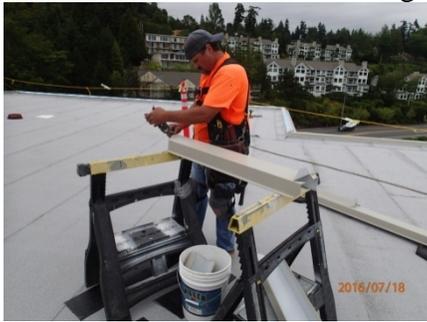
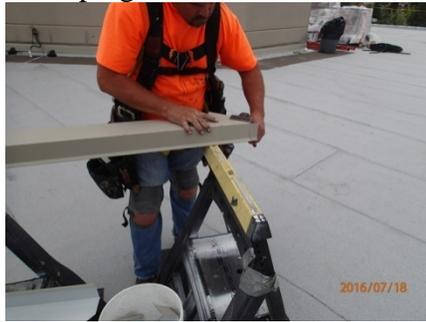
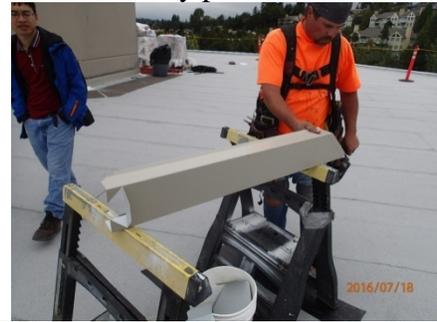
11.2 The sheet metal standing seam coping is cut and bent in the field as necessary prior to installation.

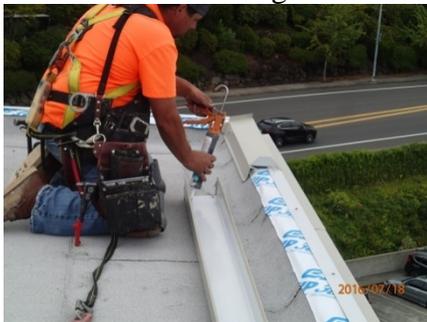
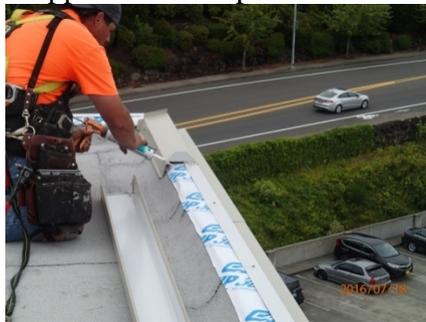
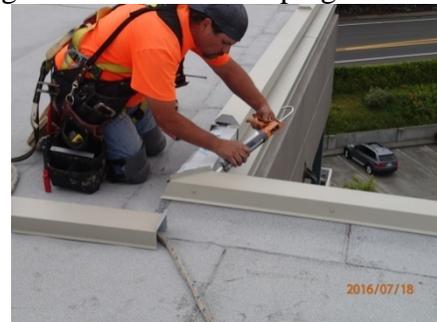
11.3 DOW Corning 795 Sealant is applied at the laps of the standing seam sheet metal coping.

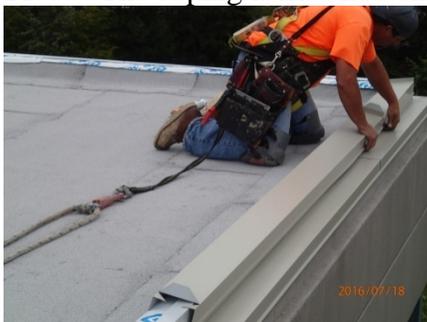
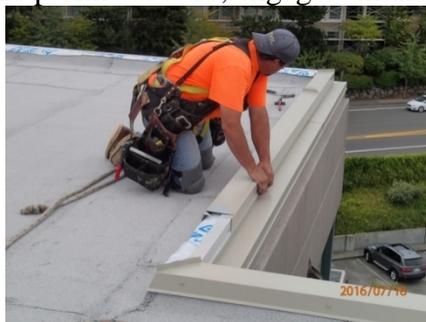
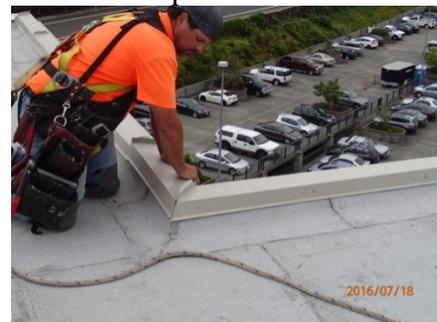
11.4 The coping is installed on the perimeter curb, engaged on the continuous clip.

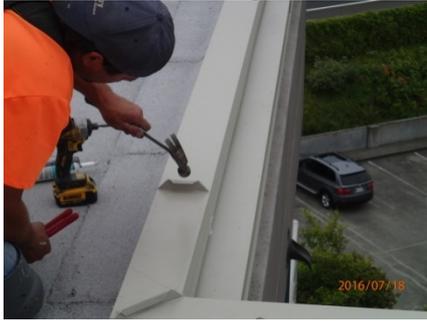
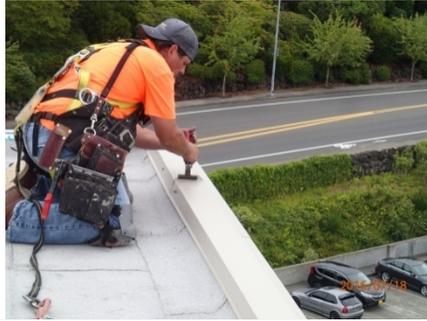
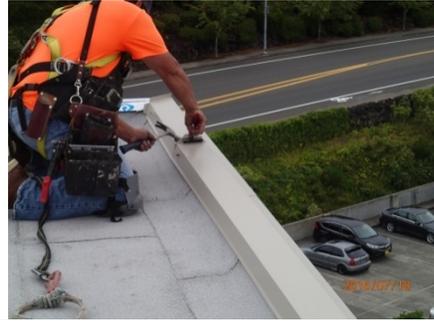
11.5 The standing seams are folded over with a hammer and tongs.

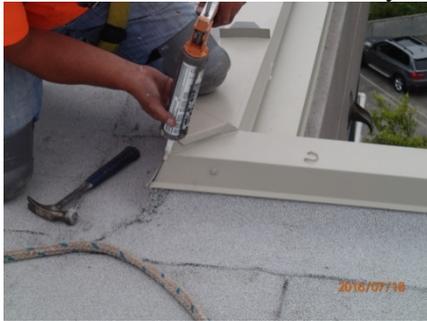
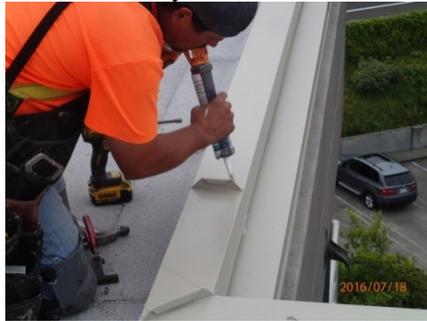
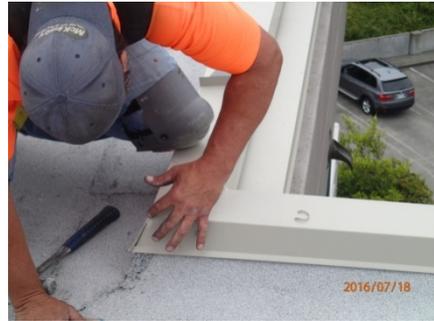
11.6 DOW Corning 795 sealant is applied at the corners of the installed coping and at the standing seams. The sealant is tooled by hand as necessary.

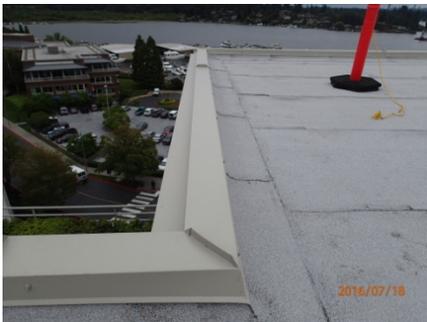
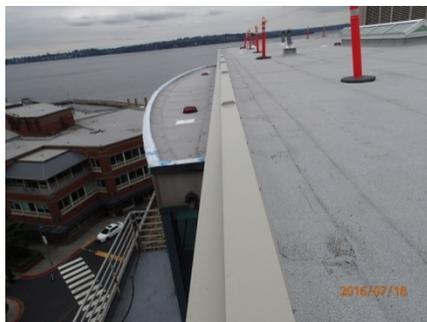
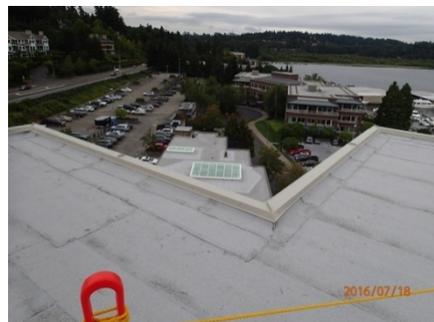
11.7 Photos depict installed condition of the standing seam sheet metal coping along the perimeter of the roof. The coping is secured with gasketed fasteners spaced approximately 24-inches on center along the interior face.

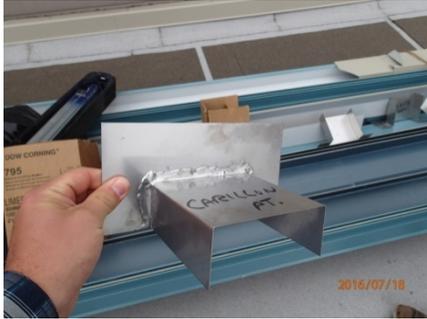
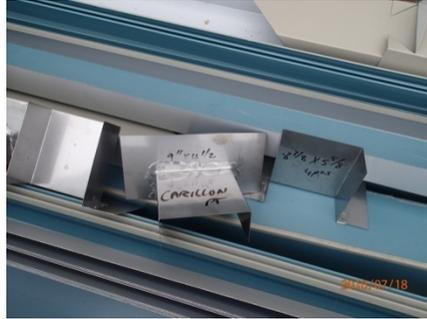
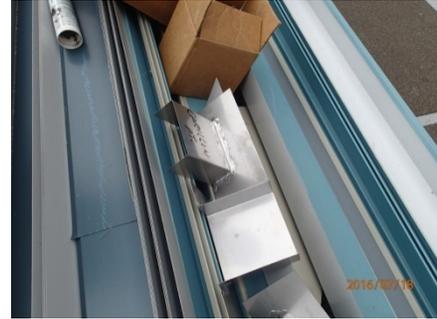
11.8 The fully soldered stainless steel saddle flashings have been fabricated and are on site for installation where eyebrow roofs tie-in to the rising wall.

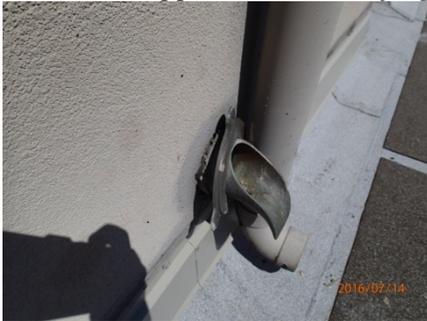
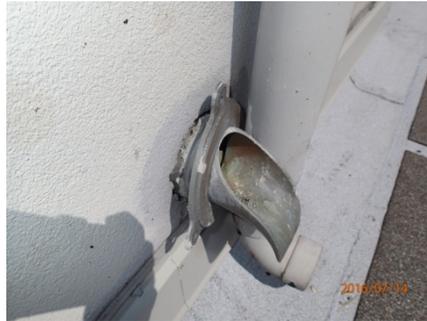
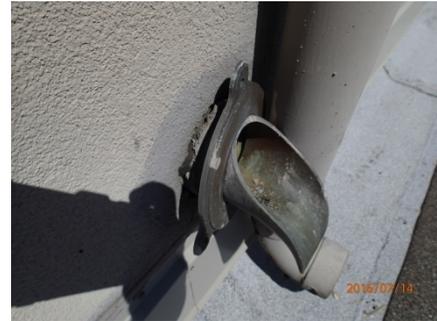
10.12 At the west side of the screen wall, the collar around the cow's tongue has become unsecured from the wall. The collar should be re-secured and new sealant applied around the collar if necessary. *This does not appear to be a roofing related item.*

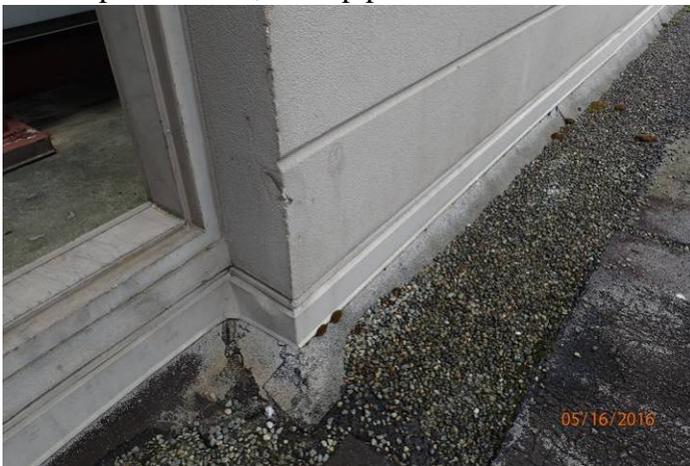
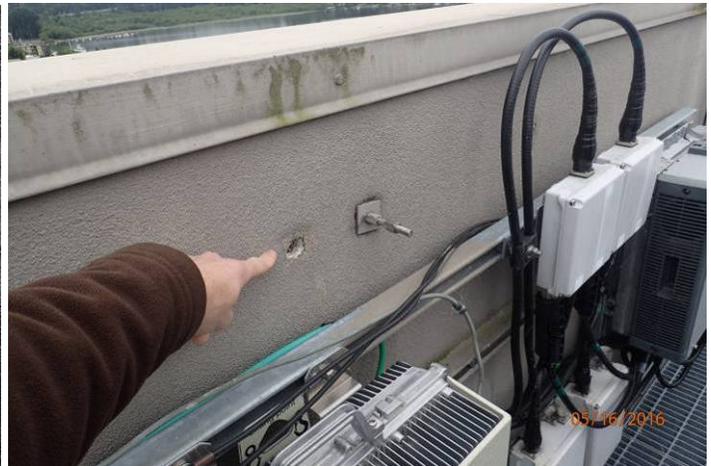
1.6 EIFS on Penthouse Walls: There is existing damage and penetrations to the EIFS on the penthouse walls. A few locations were photographed during the site visit. SR Bldg Services should document all damage prior to work. It is suggested that Carillon Properties repair damaged areas, and areas with penetrations, to help prevent water infiltration.

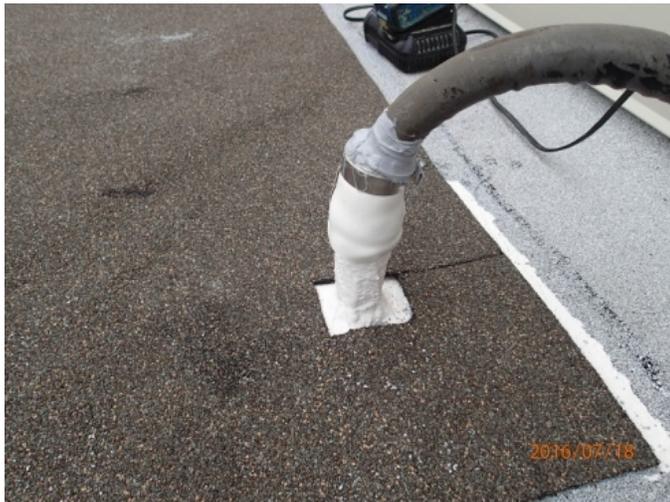
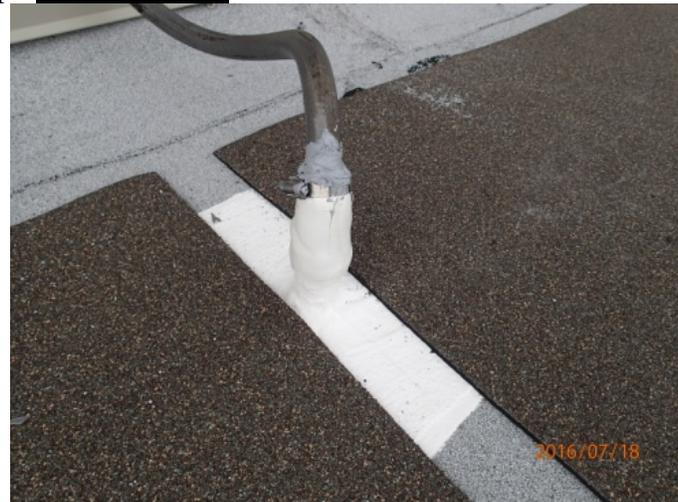
1.8 Short conduit penetrations with flexible conduit above, are present at the north and south ends of the penthouse. These penetrations should be detailed with Parapro, and an EPDM boot at the top edge secured with band clamps that extends onto the flexible conduit above the connection point.

Rep #10, 7/14/16 Update: Parapro installed around conduit. EPDM boot to be installed at top edge.

Update Rep #11, 07/18/16: Parapro has been installed around the base of the conduit penetrations with an EPDM boot secured with a stainless steel band clamp. Sealant has been applied along the top termination of the EPDM boot and band clamp. **Item Resolved.**

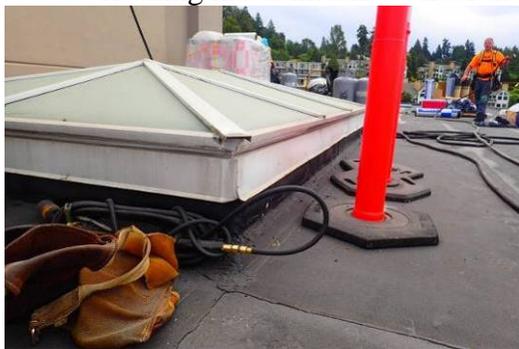
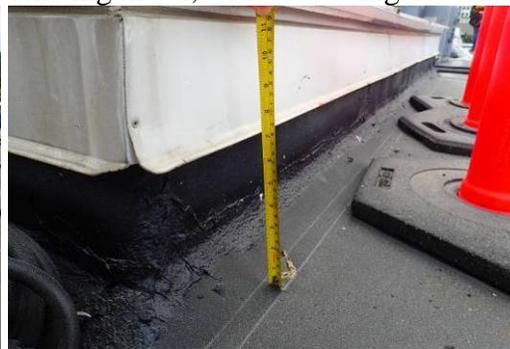
1.9 Low Skylight: The large, older, skylight at the west side of the penthouse has sheet metal counterflashing that extends under the skylight frame preventing the new roof membrane from extending minimum 8 inches vertically. As discussed, cut the existing skylight approximately halfway up the width to allow the roof membrane to extend vertically 8 inches. New sheet metal flashing to be inserted up under the existing flashing and riveted to existing flashing.

Update Rep #5, 6/20/16: The new roof membrane was tucked under the existing flashing and appears to be extended 8 inches off the finished roof surface. It appears the existing metal can be left and new skirt flashing metal installed under the existing metal, without cutting the existing metal.

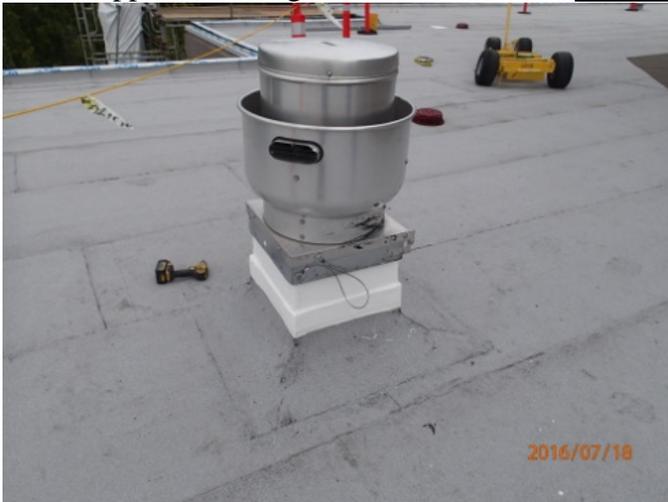
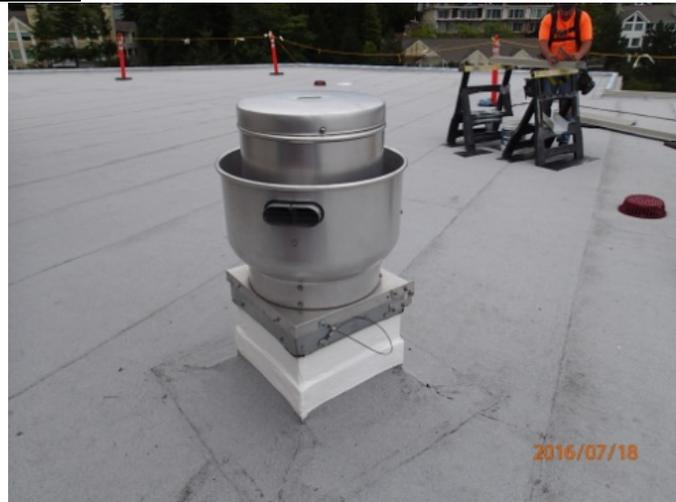
1.10 Existing Fan Curbs: Two newer fan curbs are installed on the roof, that appear to have flanges that are tight to the existing roofing. SR to review options to reduce the width of the roofing at the top of the curb, or install sheet metal to tuck under the flange of the unit.

Update Rep #5, 6/20/16: The existing curbs are metal. SR plans to install new sheet metal under the existing flange. Screws will need to be removed and reinstalled.

Update 07/12/16 Report #9: The As discussed with Dustin (ASM), the existing sheet metal flashing around the base of the roof top mechanical fan units does not have enough space to tuck the new counterflashing under. It is suggested that the unit be removed, the installed capsheet baseflashing is terminated approximately 8-inches above the deck and the remainder above is removed. Liquid applied flashing (depicted in red) can then be installed from the top of the curb and lap down onto the baseflashing and the unit can be reinstalled and properly secured to the curb. *A sketch is attached for reference.*

Update Rep #11, 07/18/16: The curbs of the roof top mechanical units have been detailed with Parapro liquid applied flashing as described above. **Item Resolved.**
