Tree Removal/Pruning Request

Property Address 7355 120TH AVE NE
 Date 7/14/09 Permit # TRE 09-00139 For City Use
 BY PLANNING DEPARTMENT AM/PM

Arborist Report

Site/Address: Holy Family Church, 120 Ave NE, Kirkland, WA 98033

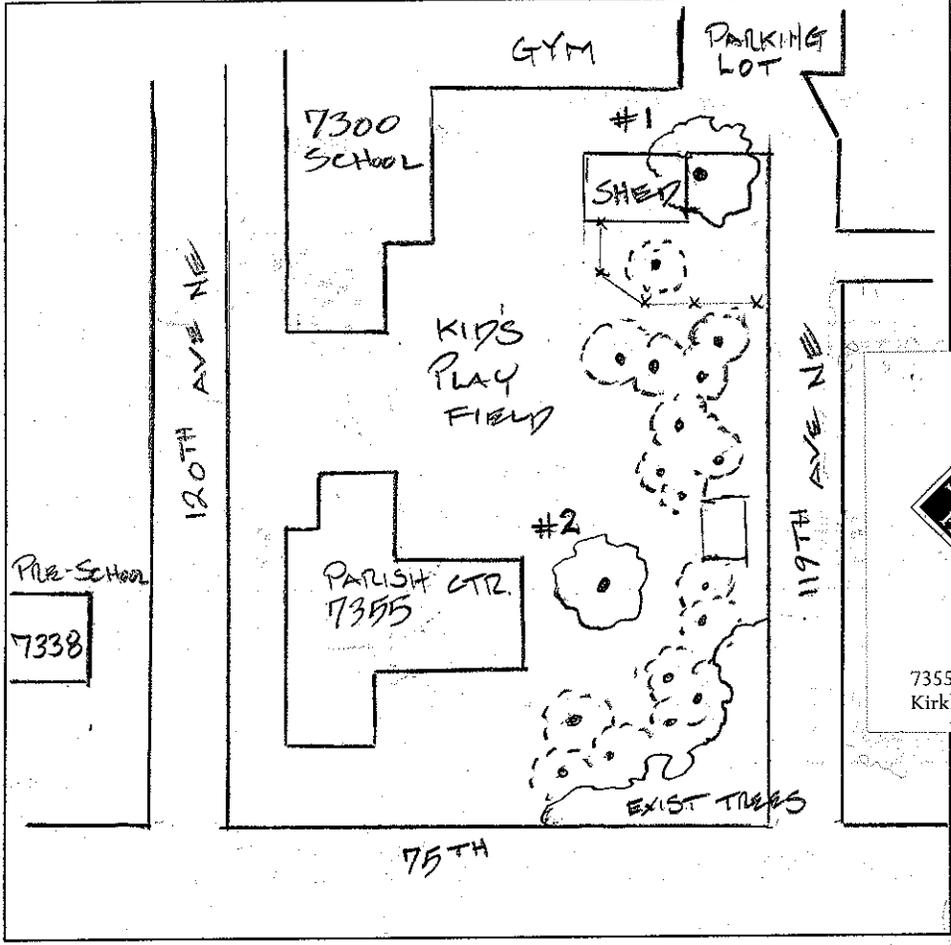
#1: Draw Site Plan Here

Tree # from site plan	Type/Species	Size (dia)*	Location	Reason for removal/pruning	Public tree?	For city use
						Public Inv #
(example) #1	Big-leaf maple	18"	East of garage behind house	Remove - rotten in the middle	no	
#1	BIG-LEAF MAPLE	40"	WEST OF SHED	REMOVE - TOO CLOSE TO SHED	NO	
#2	BIG-LEAF MAPLE	30"	WEST OF PARISH CTR.	REMOVE - TOO MANY TREES IN PLAY AREA.	NO
