Stream and Buffer Modification/Restoration and Arch Culvert Plan by Re-Align Environmental, 2015

Stream and Buffer Modification/Restoration and Arch Culvert Plan

Kirkland Cottages
Kirkland, Washington

September 18, 2015

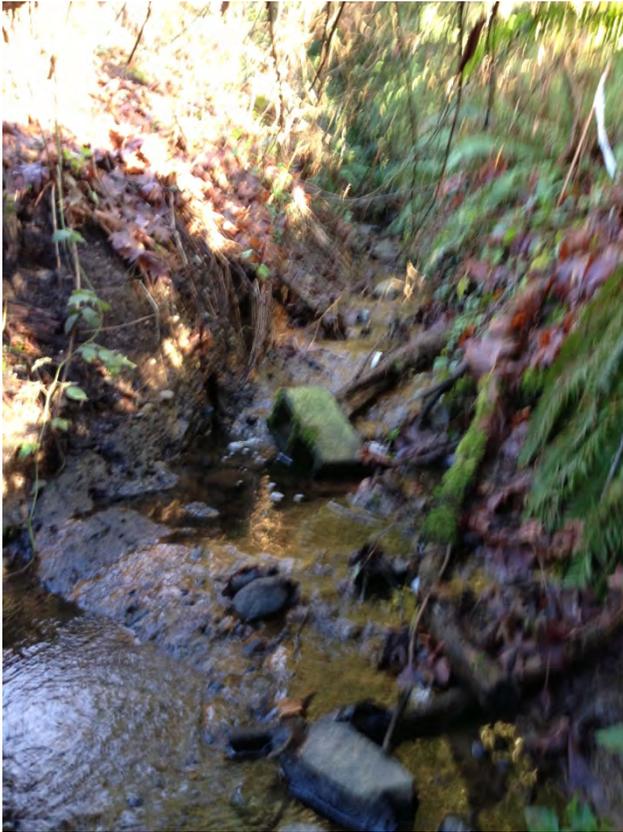
Photo 1 – Upper reaches of Champagne Creek in the project area looking east and upstream. Note the presence of bricks in the channel.

- a. Remove cinder blocks
- b. Remove car parts
- c. Remove coffee pot
- d. Remove any other man-made debris

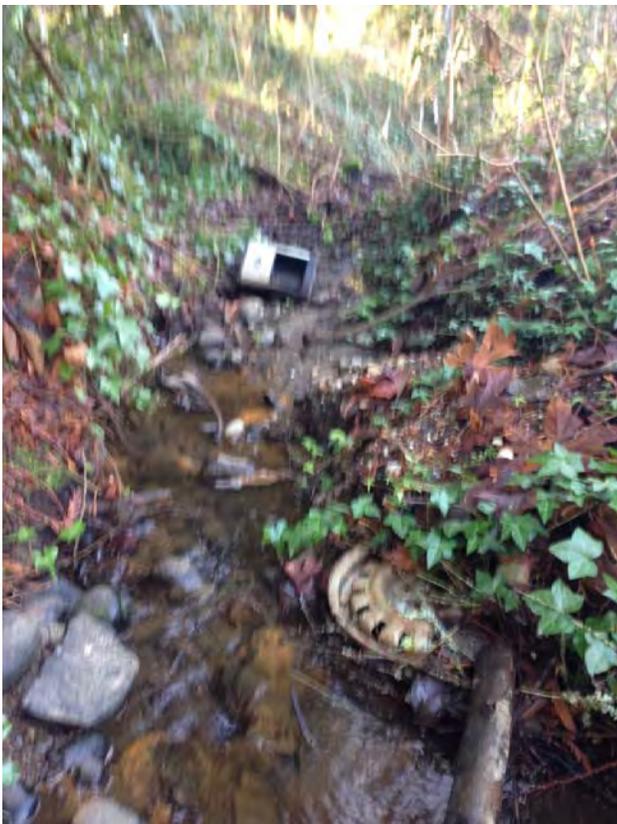
Photo 2 – Upper reaches of Champagne Creek in the project area looking west and downstream. Note the presence of an automobile rim and a coffee pot in the channel.

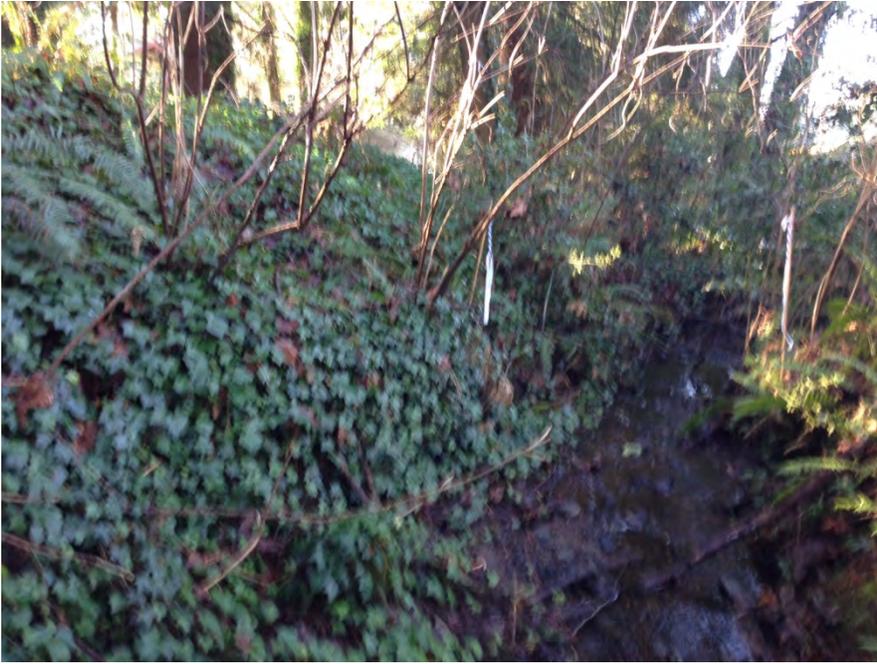
Photo 3 – Upper reaches of Champagne Creek in the project area looking west and downstream. Note the dominance of the invasive English ivy in the herbaceous layer.

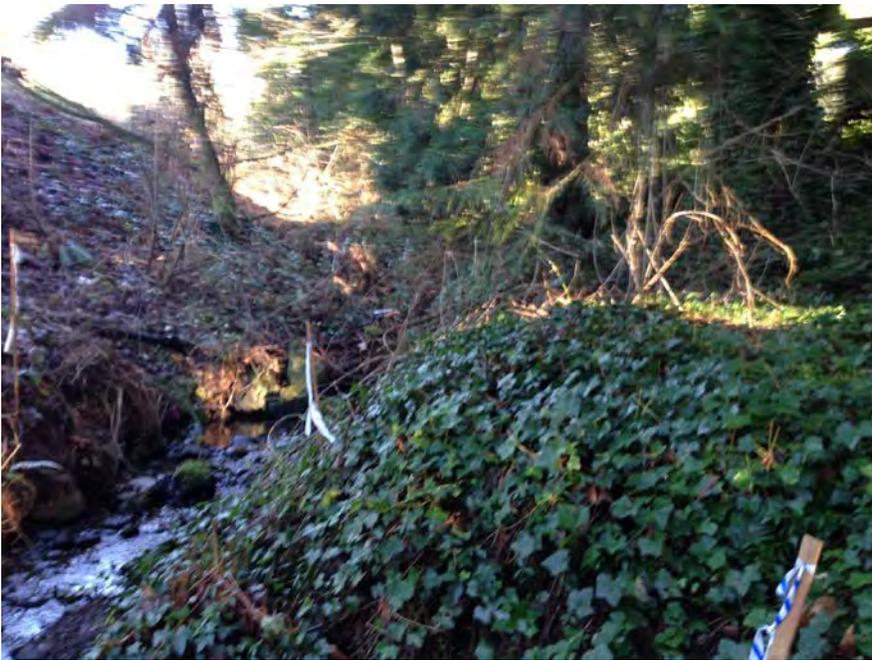
Photo 4 – Upper reaches of Champagne Creek in the project area looking east and upstream. Note the dominance of the invasive English ivy in the herbaceous layer and lack of vegetative cover or shade on the northern bank (left in this view).

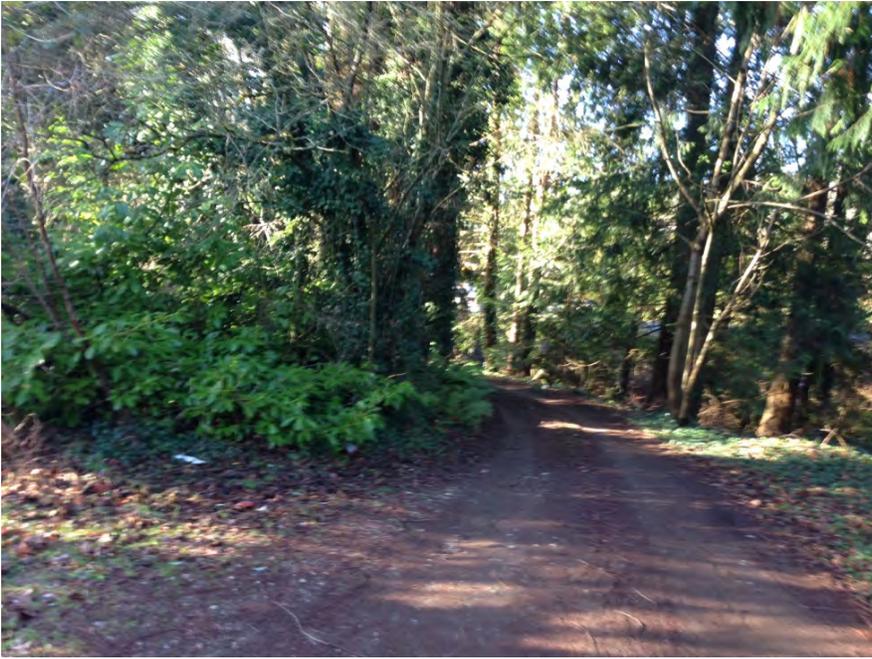
Photo 5 – Looking west along the existing driveway from the parking area at the homesite. Note the invasive English Laurel in the left of the photo. This view is inside the stream buffer and the stream is out of view to the right.

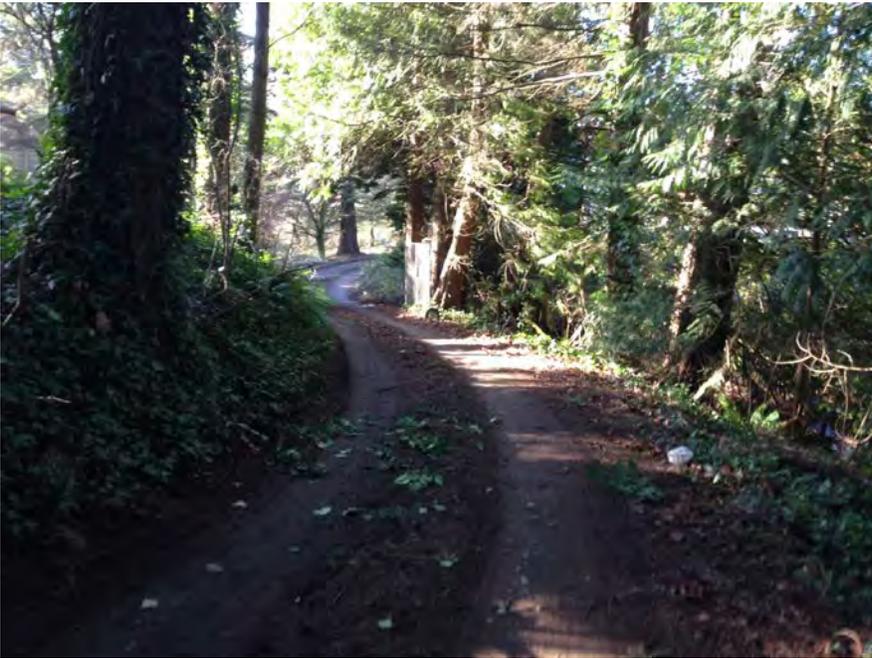
Photo 6 – Looking west along the existing driveway, approximately 75 feet west of photo 5. Note the invasive English Laurel and English ivy. Note that the driveway is cut into the slope. This view is inside the stream buffer and the stream is out of view to the right.

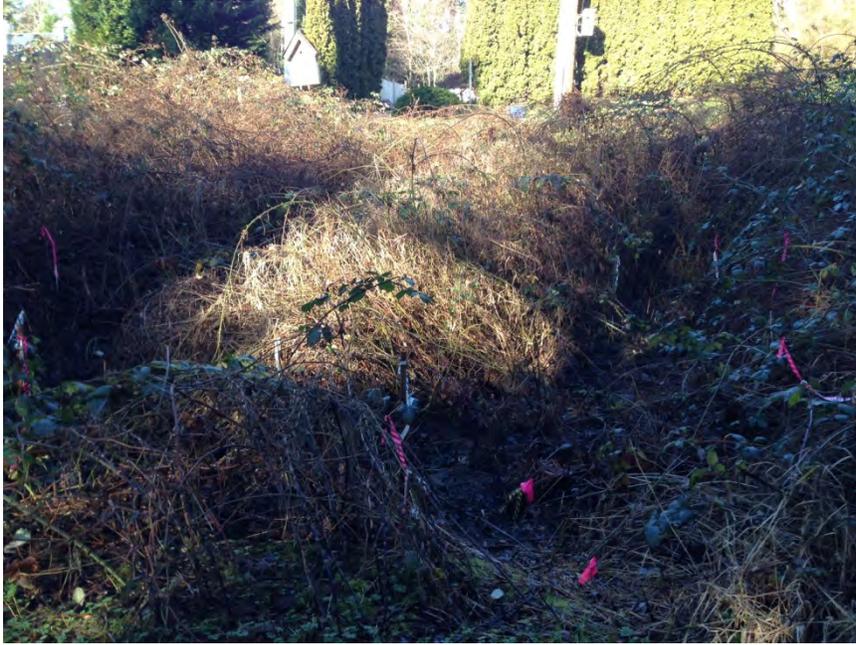
Photo 7 – Looking north from the culverted driveway crossing into the wetland area. Note the prevalence of invasive Himalayan blackberry, and the presence of invasive reed canarygrass in the lower right of the photo.

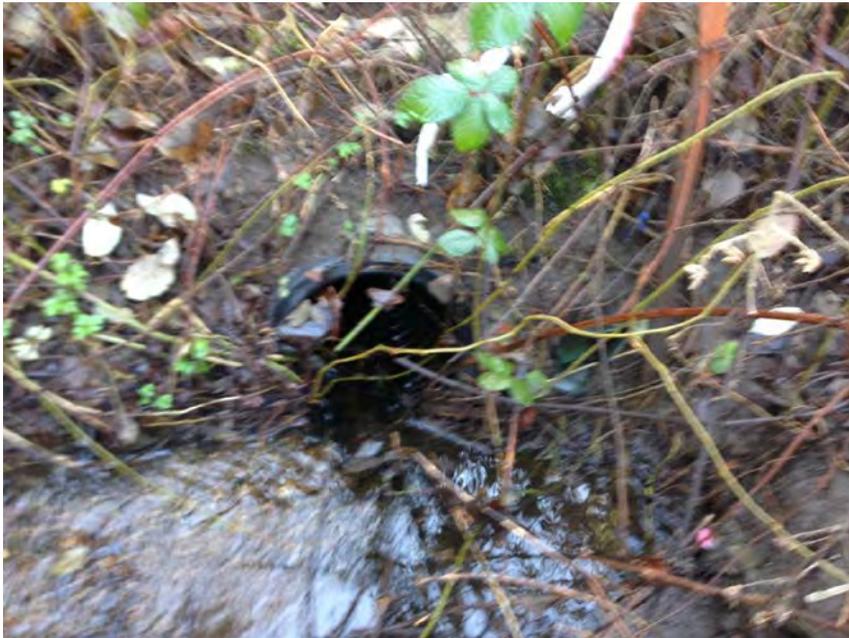
Photo 8 – Looking south at the inlet of the driveway crossing culvert.

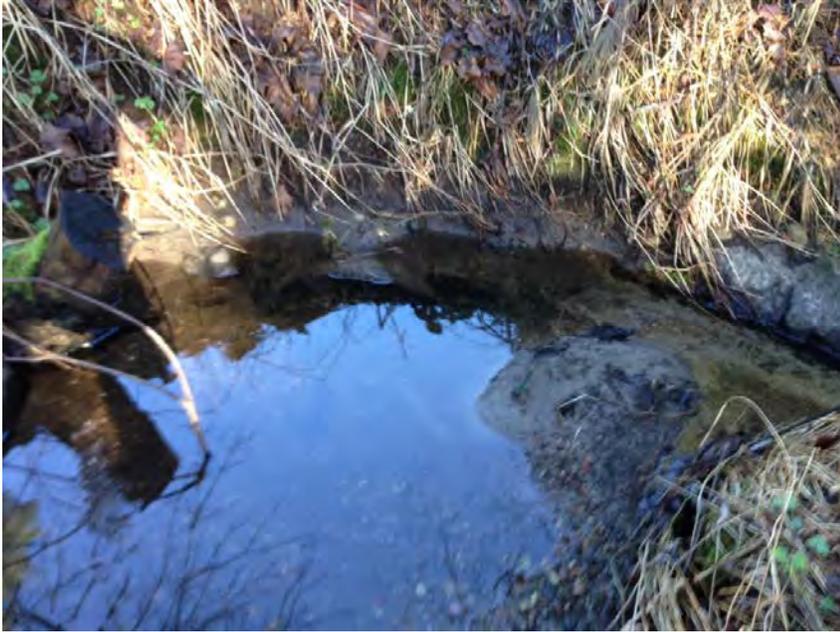
Photo 9 – Looking north at the outlet of the driveway crossing culvert.

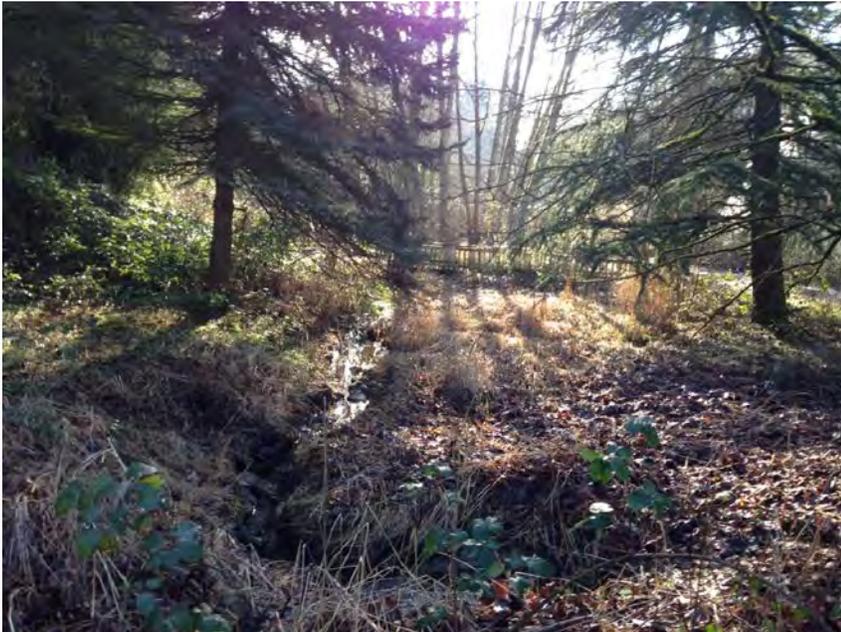
Photo 10 – Looking south at the stream below the culvert, off of the subject property.

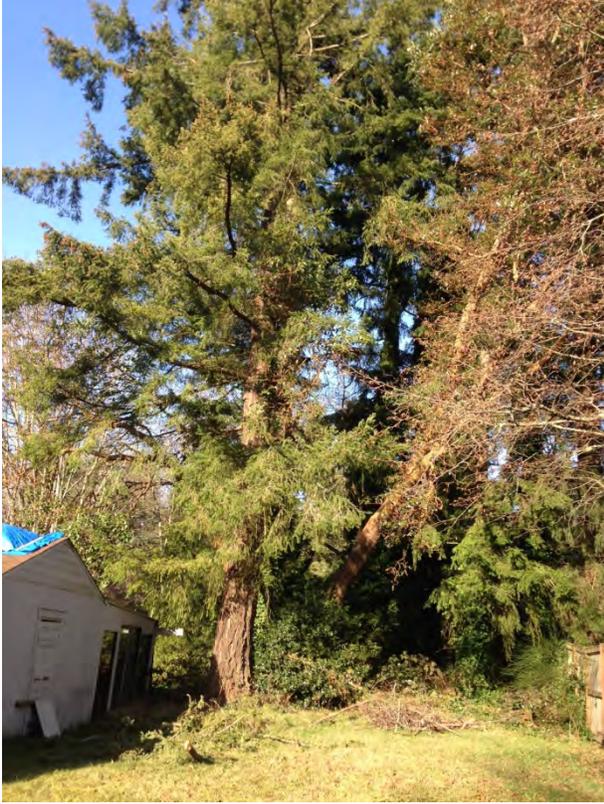
Photo 11 – Looking north at the shed and carport near the buffer edge. The large trees in this view are just outside of the buffer.

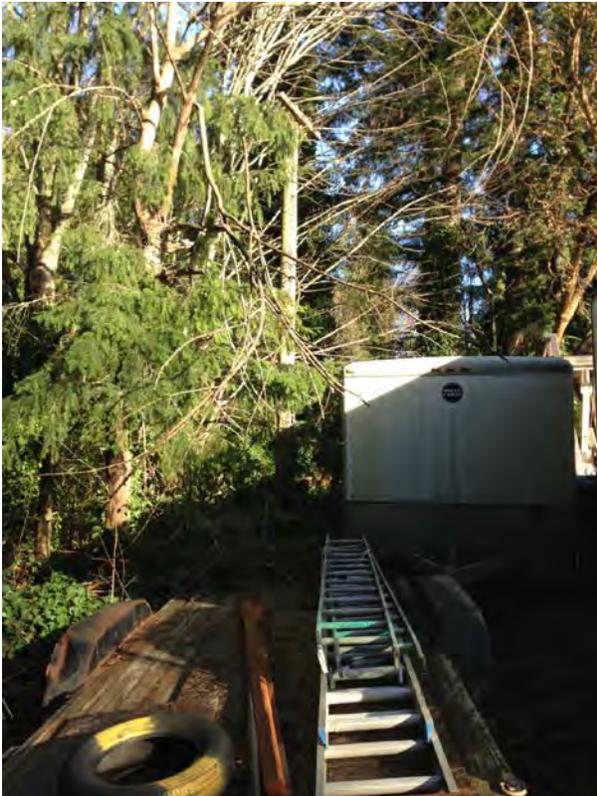
Photo 12 – Looking east at the equipment being stored adjacent to the shed and carport. The equipment is inside the stream buffer. Note the power pole in the center of the photo. This pole is inside the stream buffer.
