## CRITICAL AREAS REPORT AND MITIGATION PLAN

**BRIDLESTONE ESTATES**  
4626 116<sup>TH</sup> AVE NE  
KIRKLAND, WASHINGTON 98125

## Executive Summary

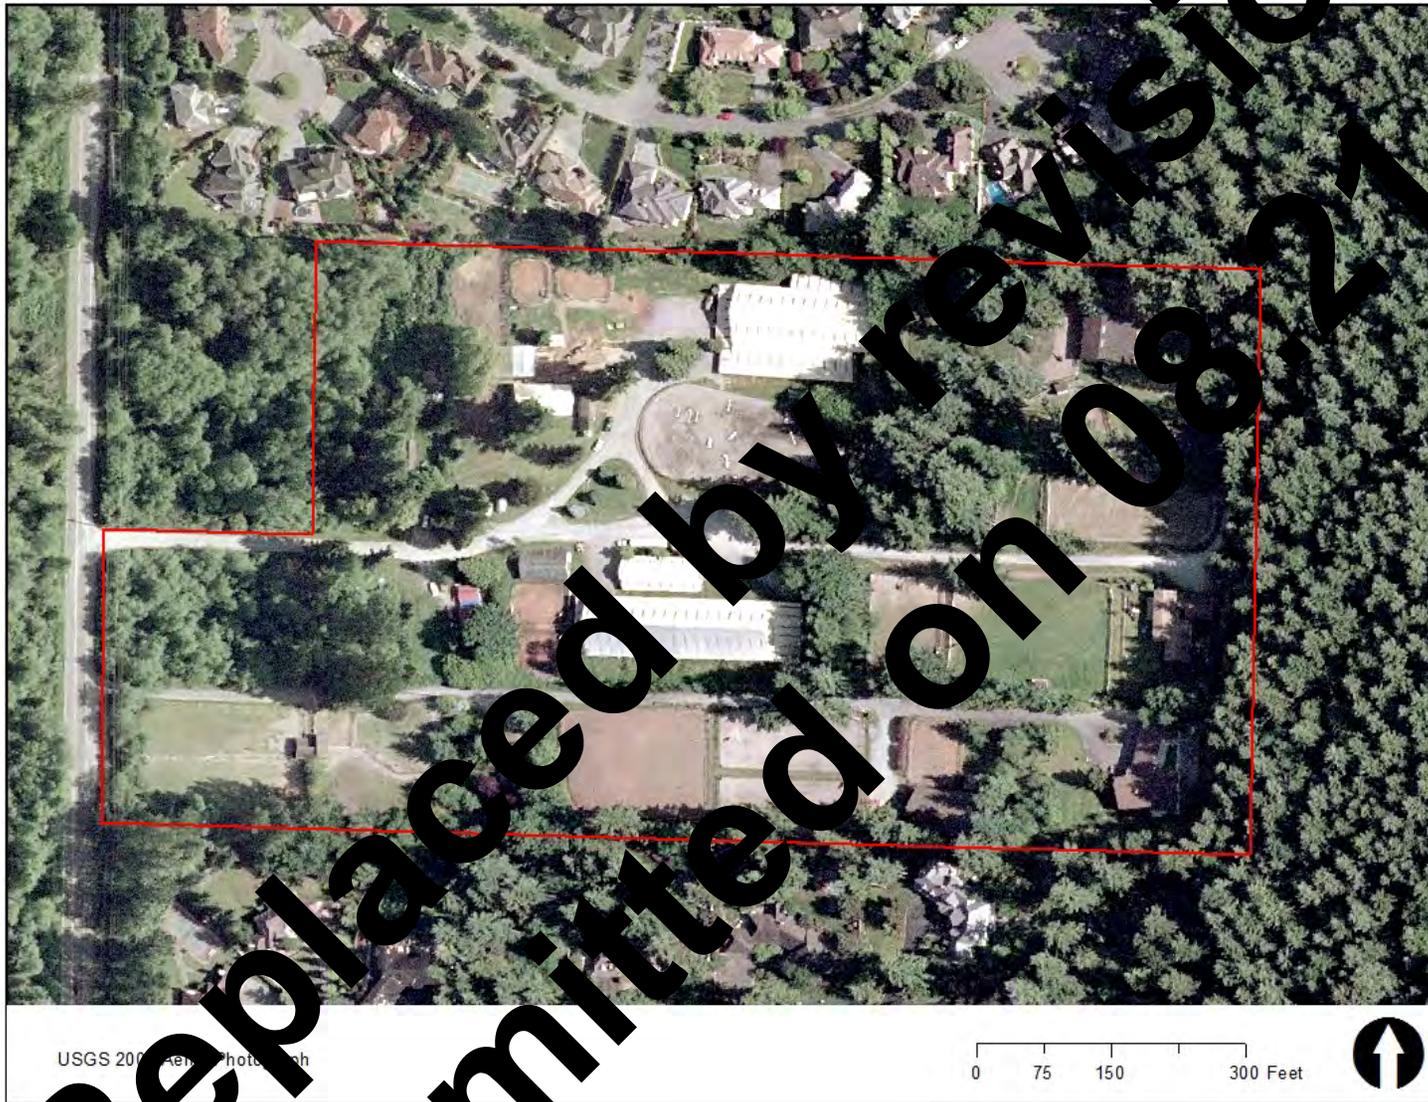
Figure 2: 2002 USGS color aerial photograph of the subject property

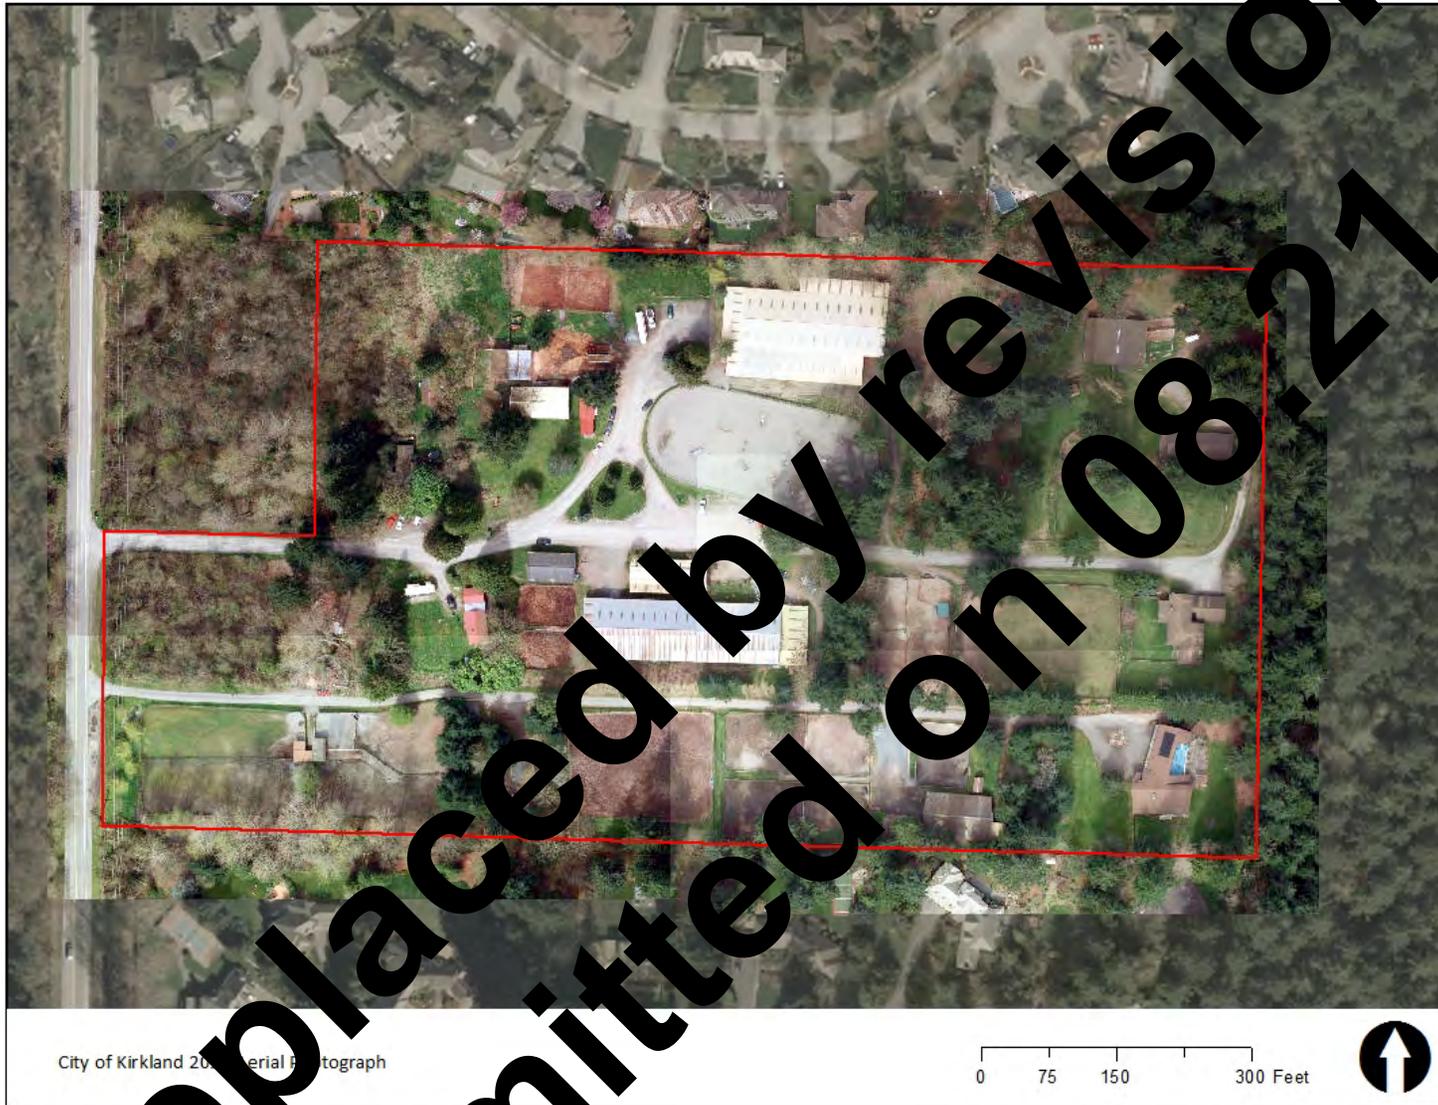
Figure 201 Aerial photograph of the subject site

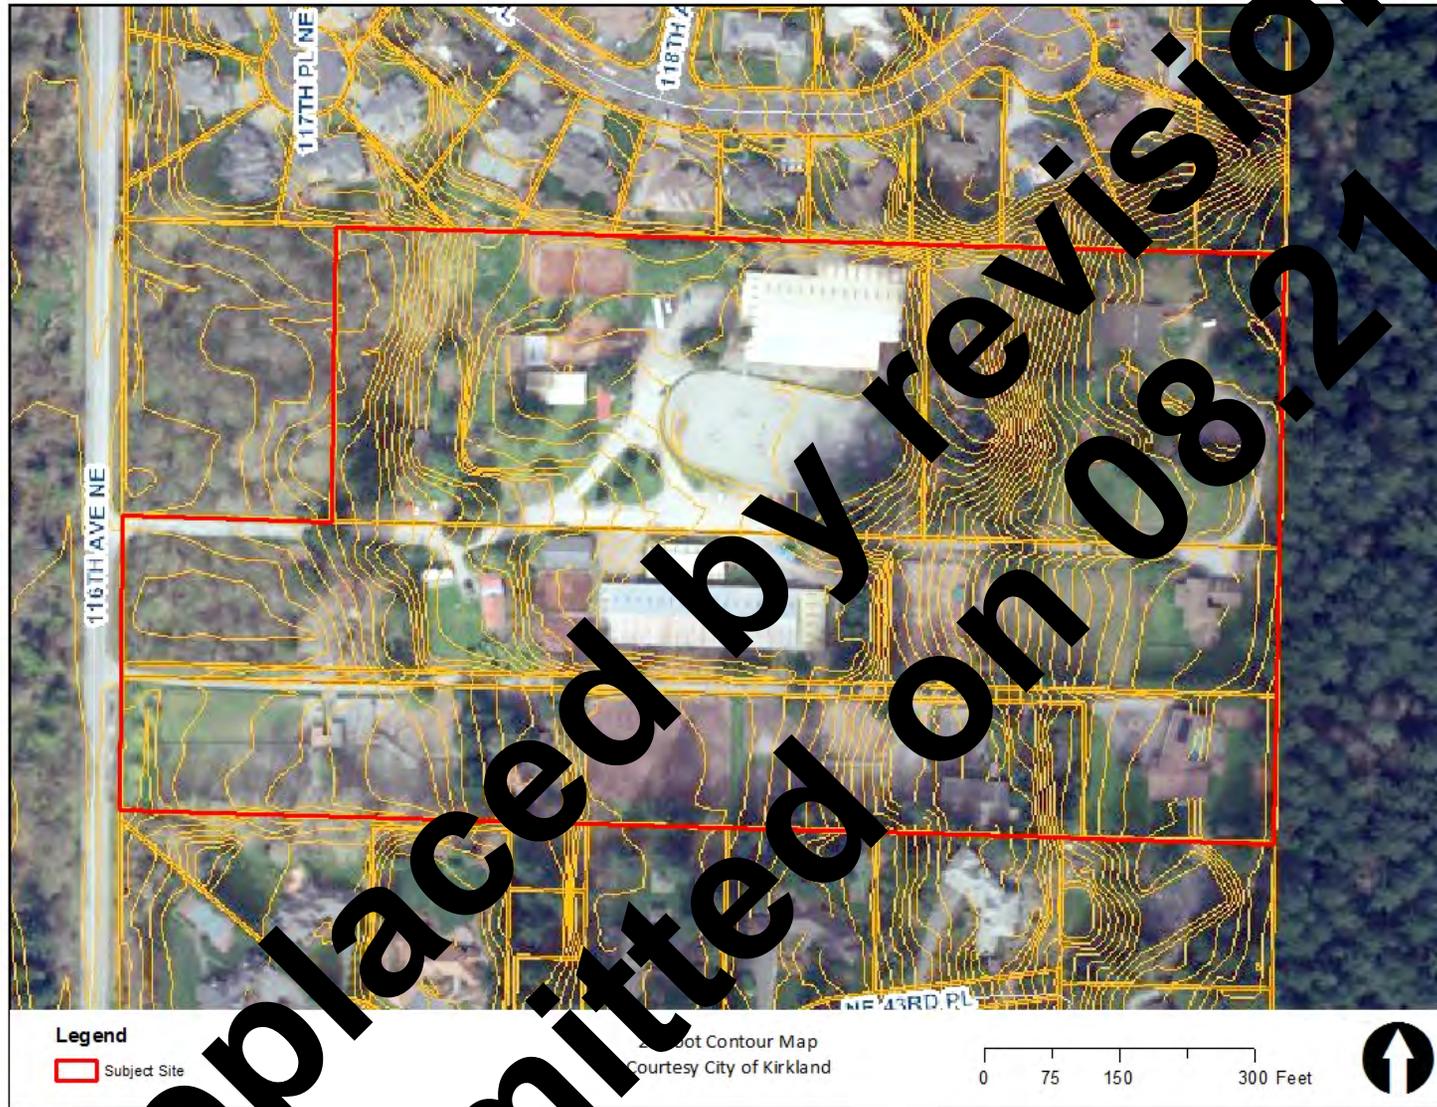
Figure 1 Topographic map of the project site

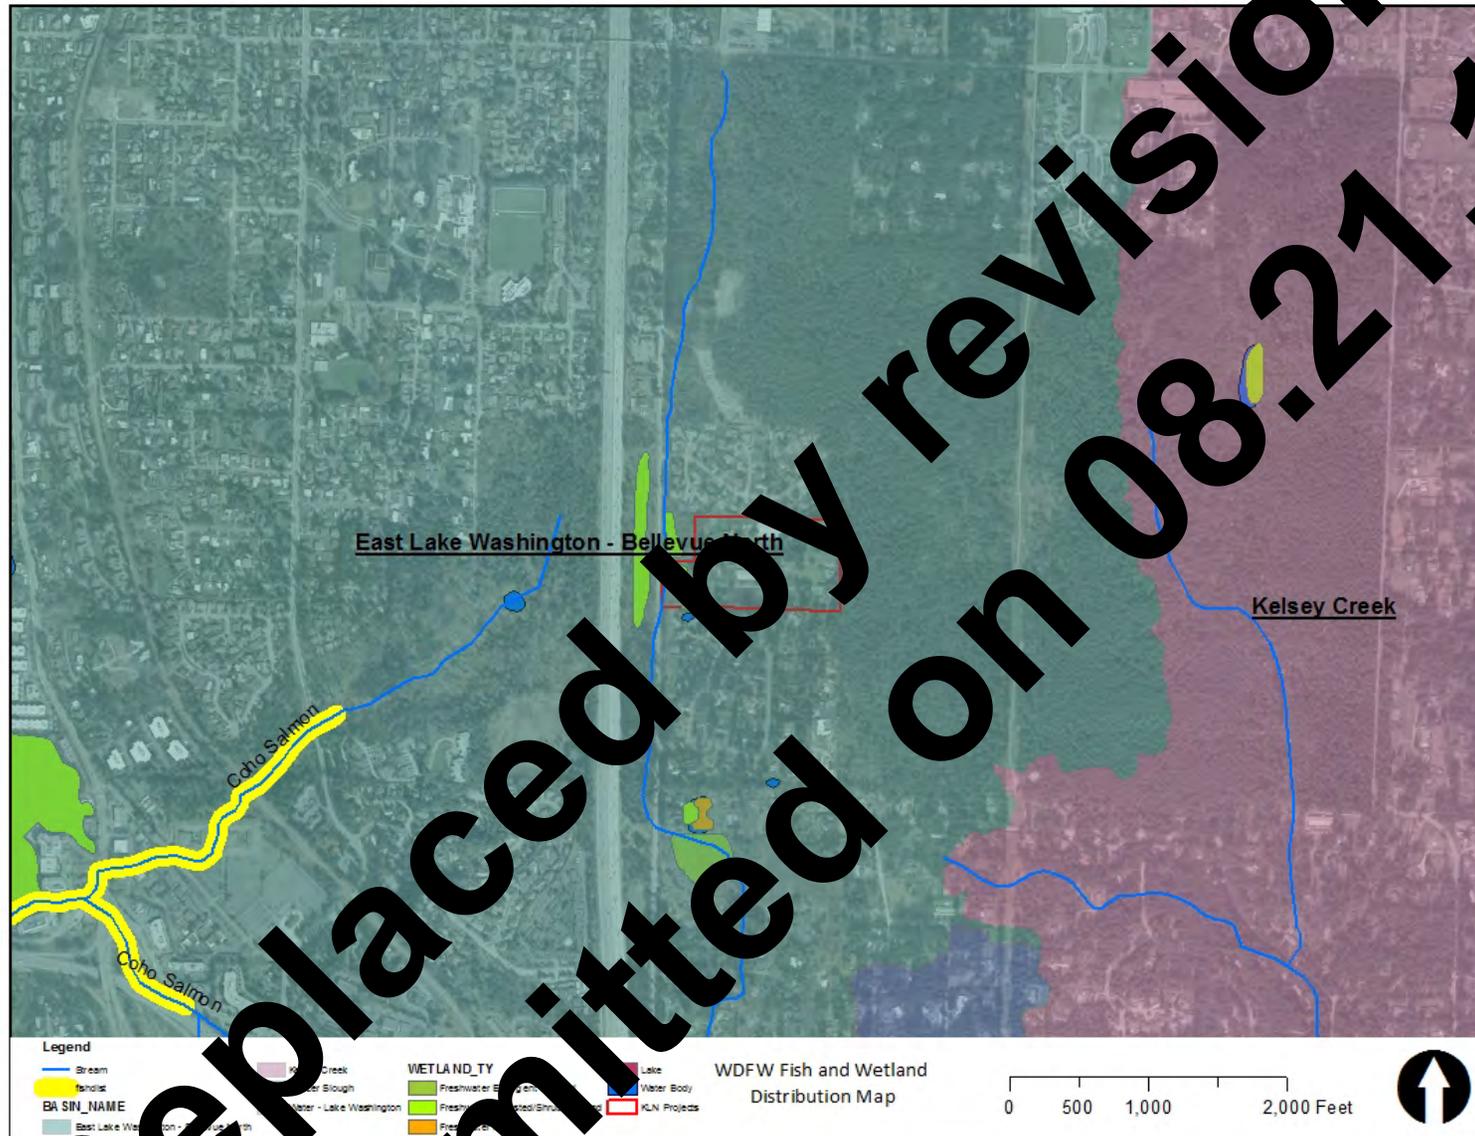
Figure 5: City of Kirkland Hydrology Map with WFDW Fish Distribution Data.

The stream corridor has been degraded by land development throughout the majority of the stream segment. The stream continues south through the City of Bellevue and eventually drains to Lake Washington. The stream flows through urbanized areas and adjacent to paved roadways, with limited areas of native vegetation. The stream segment immediately north of the subject site has been piped along 116<sup>th</sup> Ave NE.

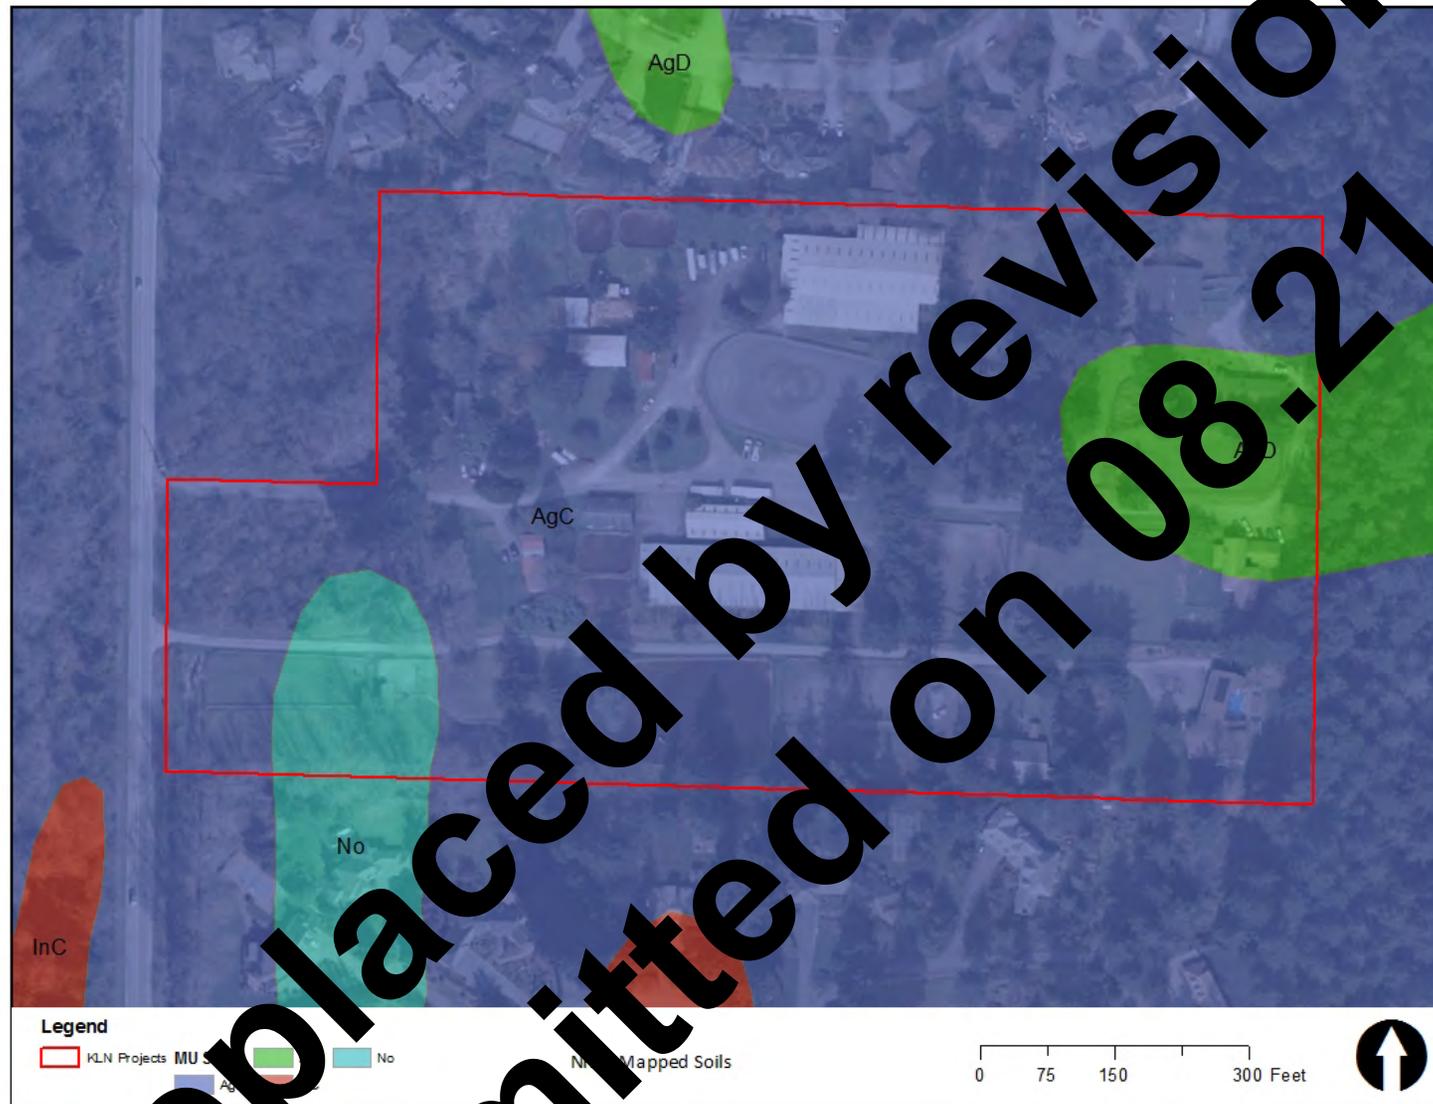
Figure 1. NR Soil Survey of the project area.

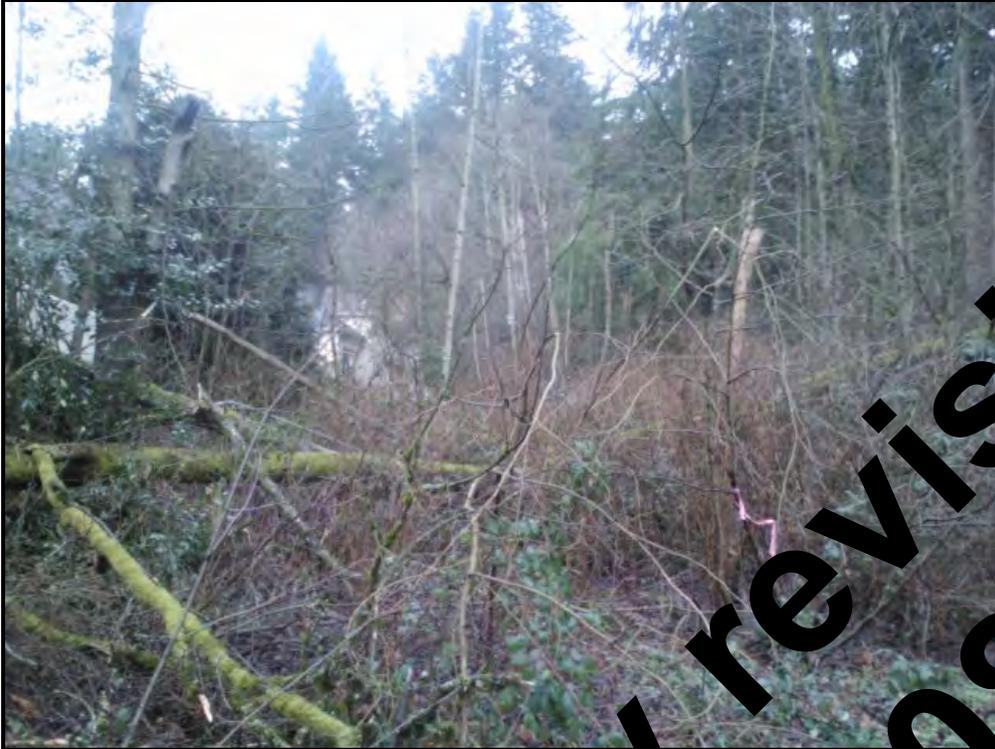
Figure 7: Existing conditions of Wetland A facing north off-site.

Saturation to the surface, shallow ponding, and surface runoff hydrologic indicators were observed within the delineated wetland boundaries during KLN's follow-up site visit in January 2014. The hydrology appears to be a result of shallow groundwater and subsurface flow with surface flow draining to the southwest and into an existing culvert. The eastern wetland boundary near the north property line is at an elevation of 410 FT and continues downhill to 400 FT near the existing culvert. There is a natural drainage feature extending off-site flowing from northeast to southwest.

Wetland A provides moderate overall functions and values based on the size, location, and condition of the wetland system. Wetland A provides very good habitat and refuge for local wildlife. The wetland corridor connects to the Bridge Trails State Park, which is forested with mature trees and shrubs. The wetland provides moderate stormwater control functions, with limited area available for storage and detention. Wetland A provides moderate to high water quality improvement functions based on the opportunity to receive runoff (from residential and agricultural sources) and ability to filter and infiltrate water with the existing vegetation and soil characteristics.

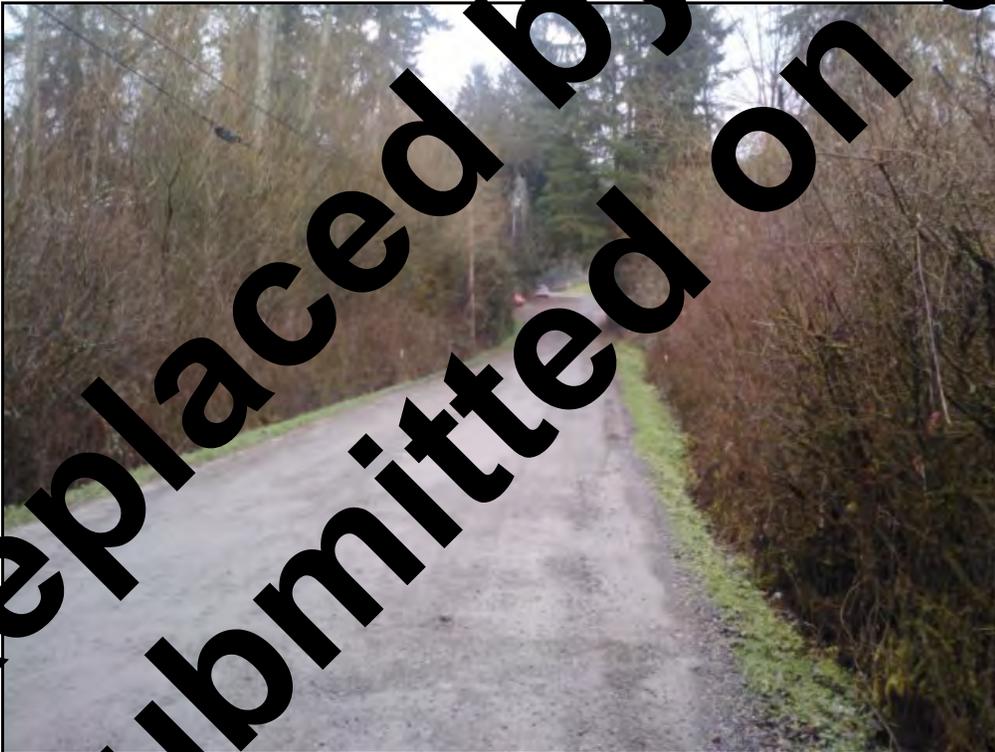
Figure 8: Existing vegetation gravel road bisecting Wetland B – wetland re-establishment area.

The wetland re-establishment area located where the existing northern access driveway will provide a net increase of existing wetland area on-site. The mitigation measures in this area will provide an excellent opportunity to connect a fragmented habitat and remove regular disturbance. The existing gravel pad directly wetland area impairs habitat functions within this area. The road is also a conveyance of impaired surface water runoff that includes turbid water (observed during site investigations) and water that is likely high in nutrients (assumed) due to local sources.

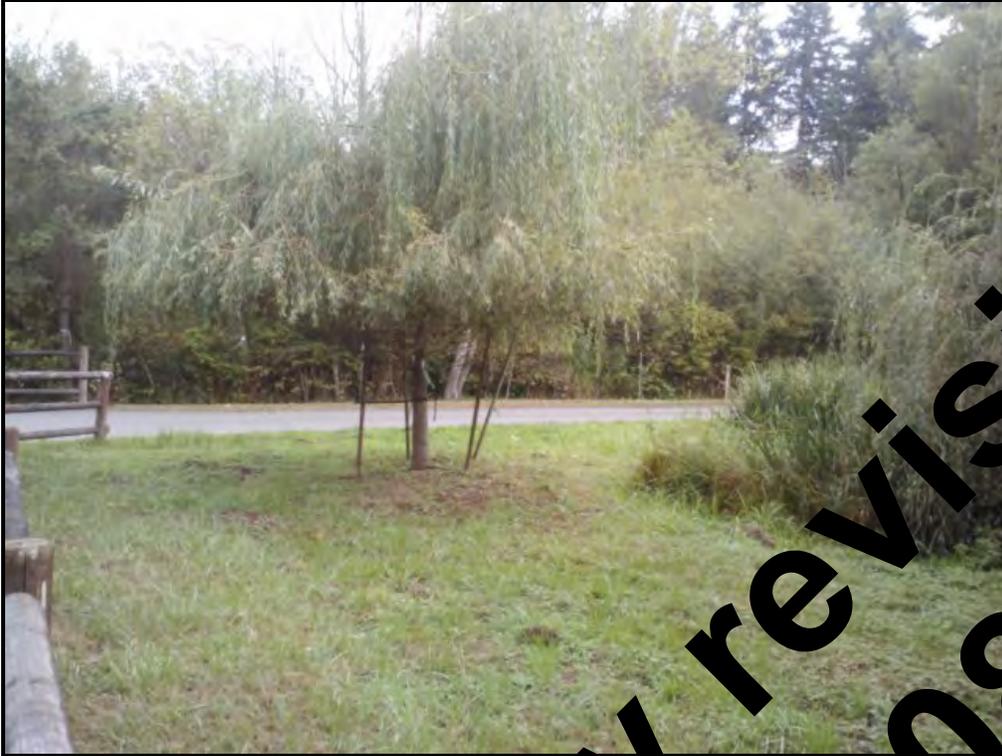
Figure 9: Existing vegetation community Wetland C facing north towards proposed road impact area.

Wetland C provides low to moderate overall functions and values based on the size, location, and condition of the wetland system. Some of the existing factors that negatively influence the functions and values include the lack of a functional buffer along the western boundary, fragmentation from existing access driveways through the wetland, and encroachment from equestrian activities to the east. The majority of buffer area on-site has been severely impacted from past clearing and grading and current livestock use.

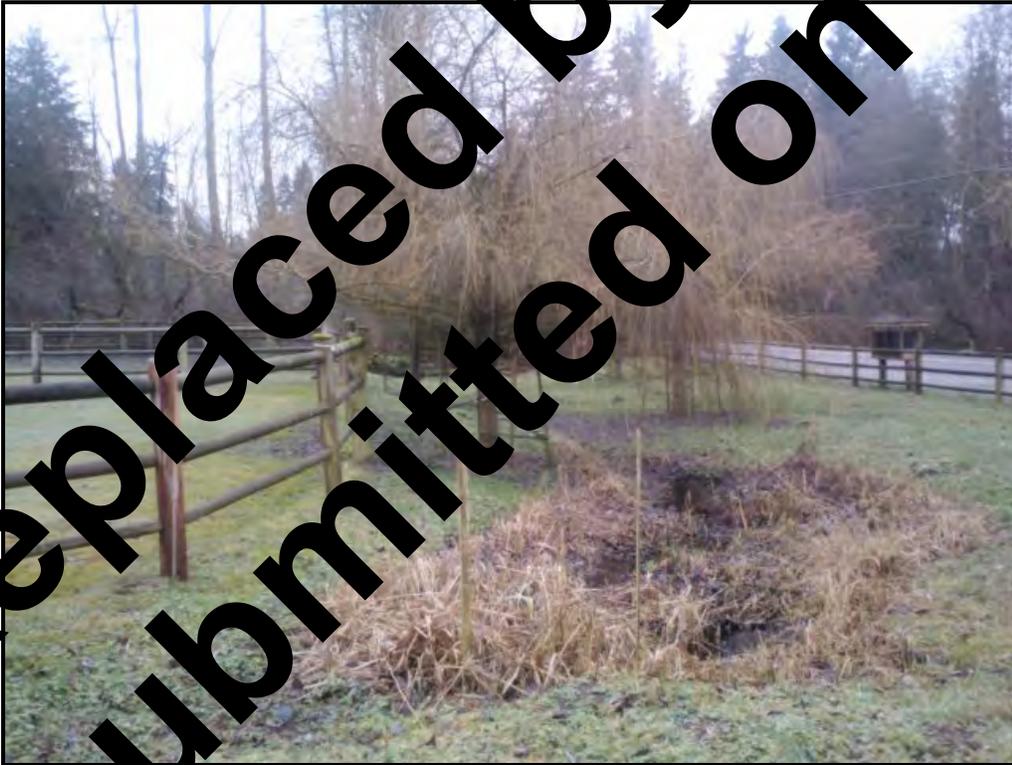
Figure 10: Existing vegetation community Wetland C facing south near proposed road impact area.

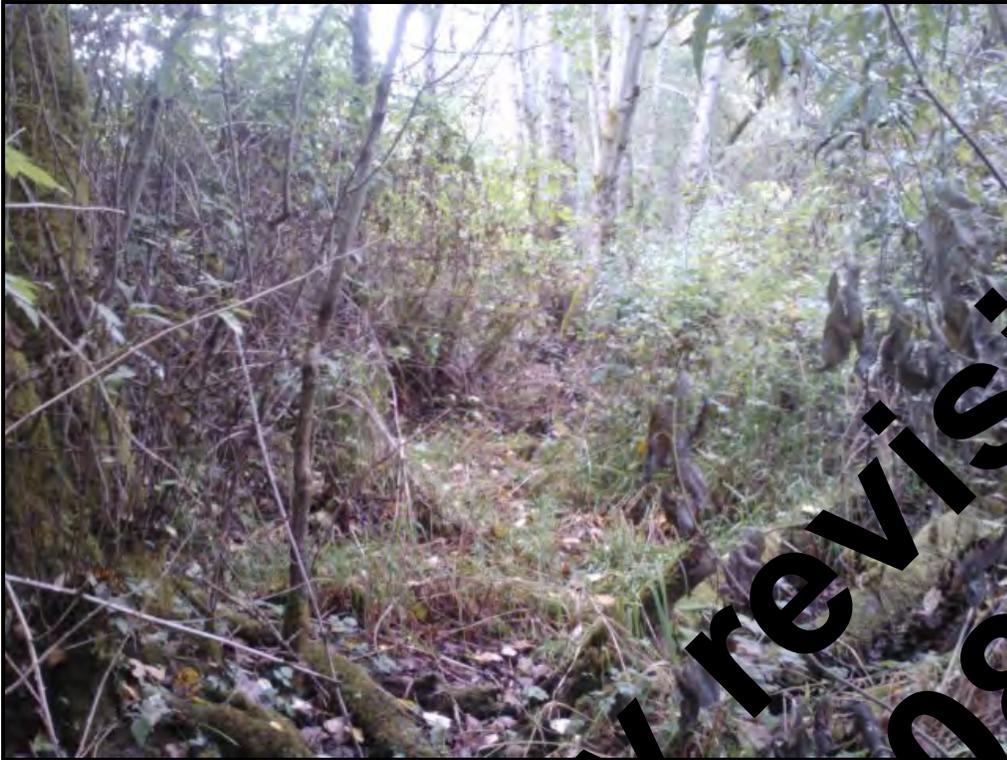
Figure 11: Off-site Wetland C connection.

Yarrow Creek and associated Wetlands B and C continue off-site to the north and south. Wetland A extends off-site to the north and northeast. The off-site areas have been identified on the critical area map in Appendix A. These areas appear to be largely defined by the existing topography. Additional wetland areas have been observed on the west side of 116<sup>th</sup> Ave NE adjacent to the subject site. No other wetland or streams have been mapped within 300-feet of the subject site.

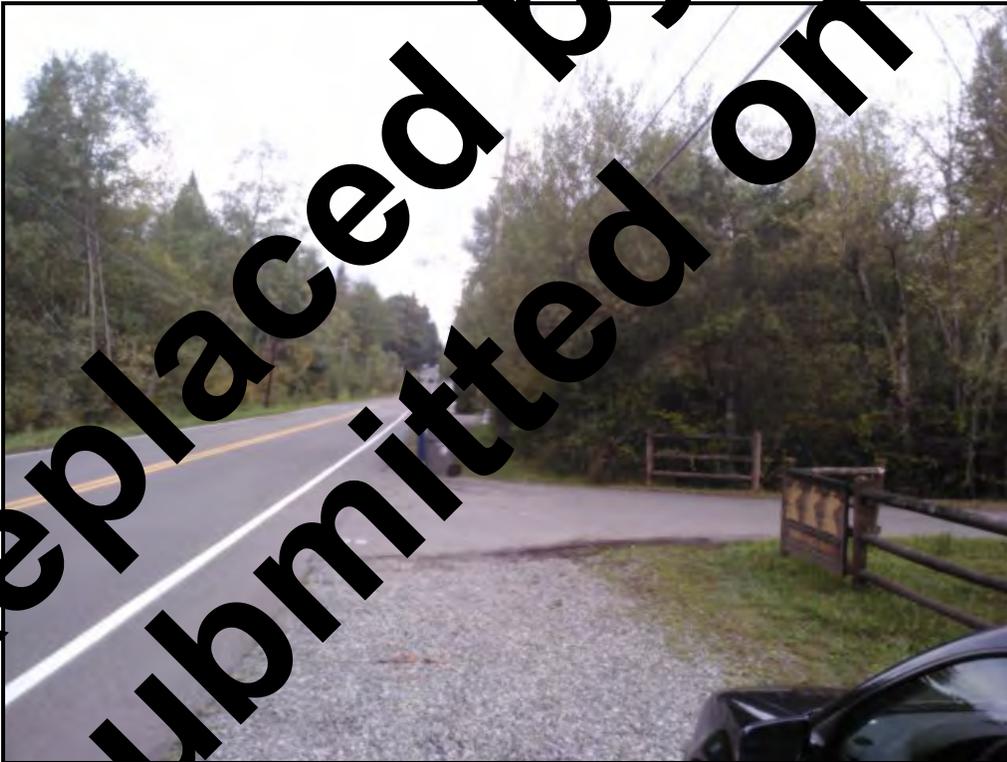
Figure 12: Existing road frontage conditions facing north along 116<sup>th</sup> Street

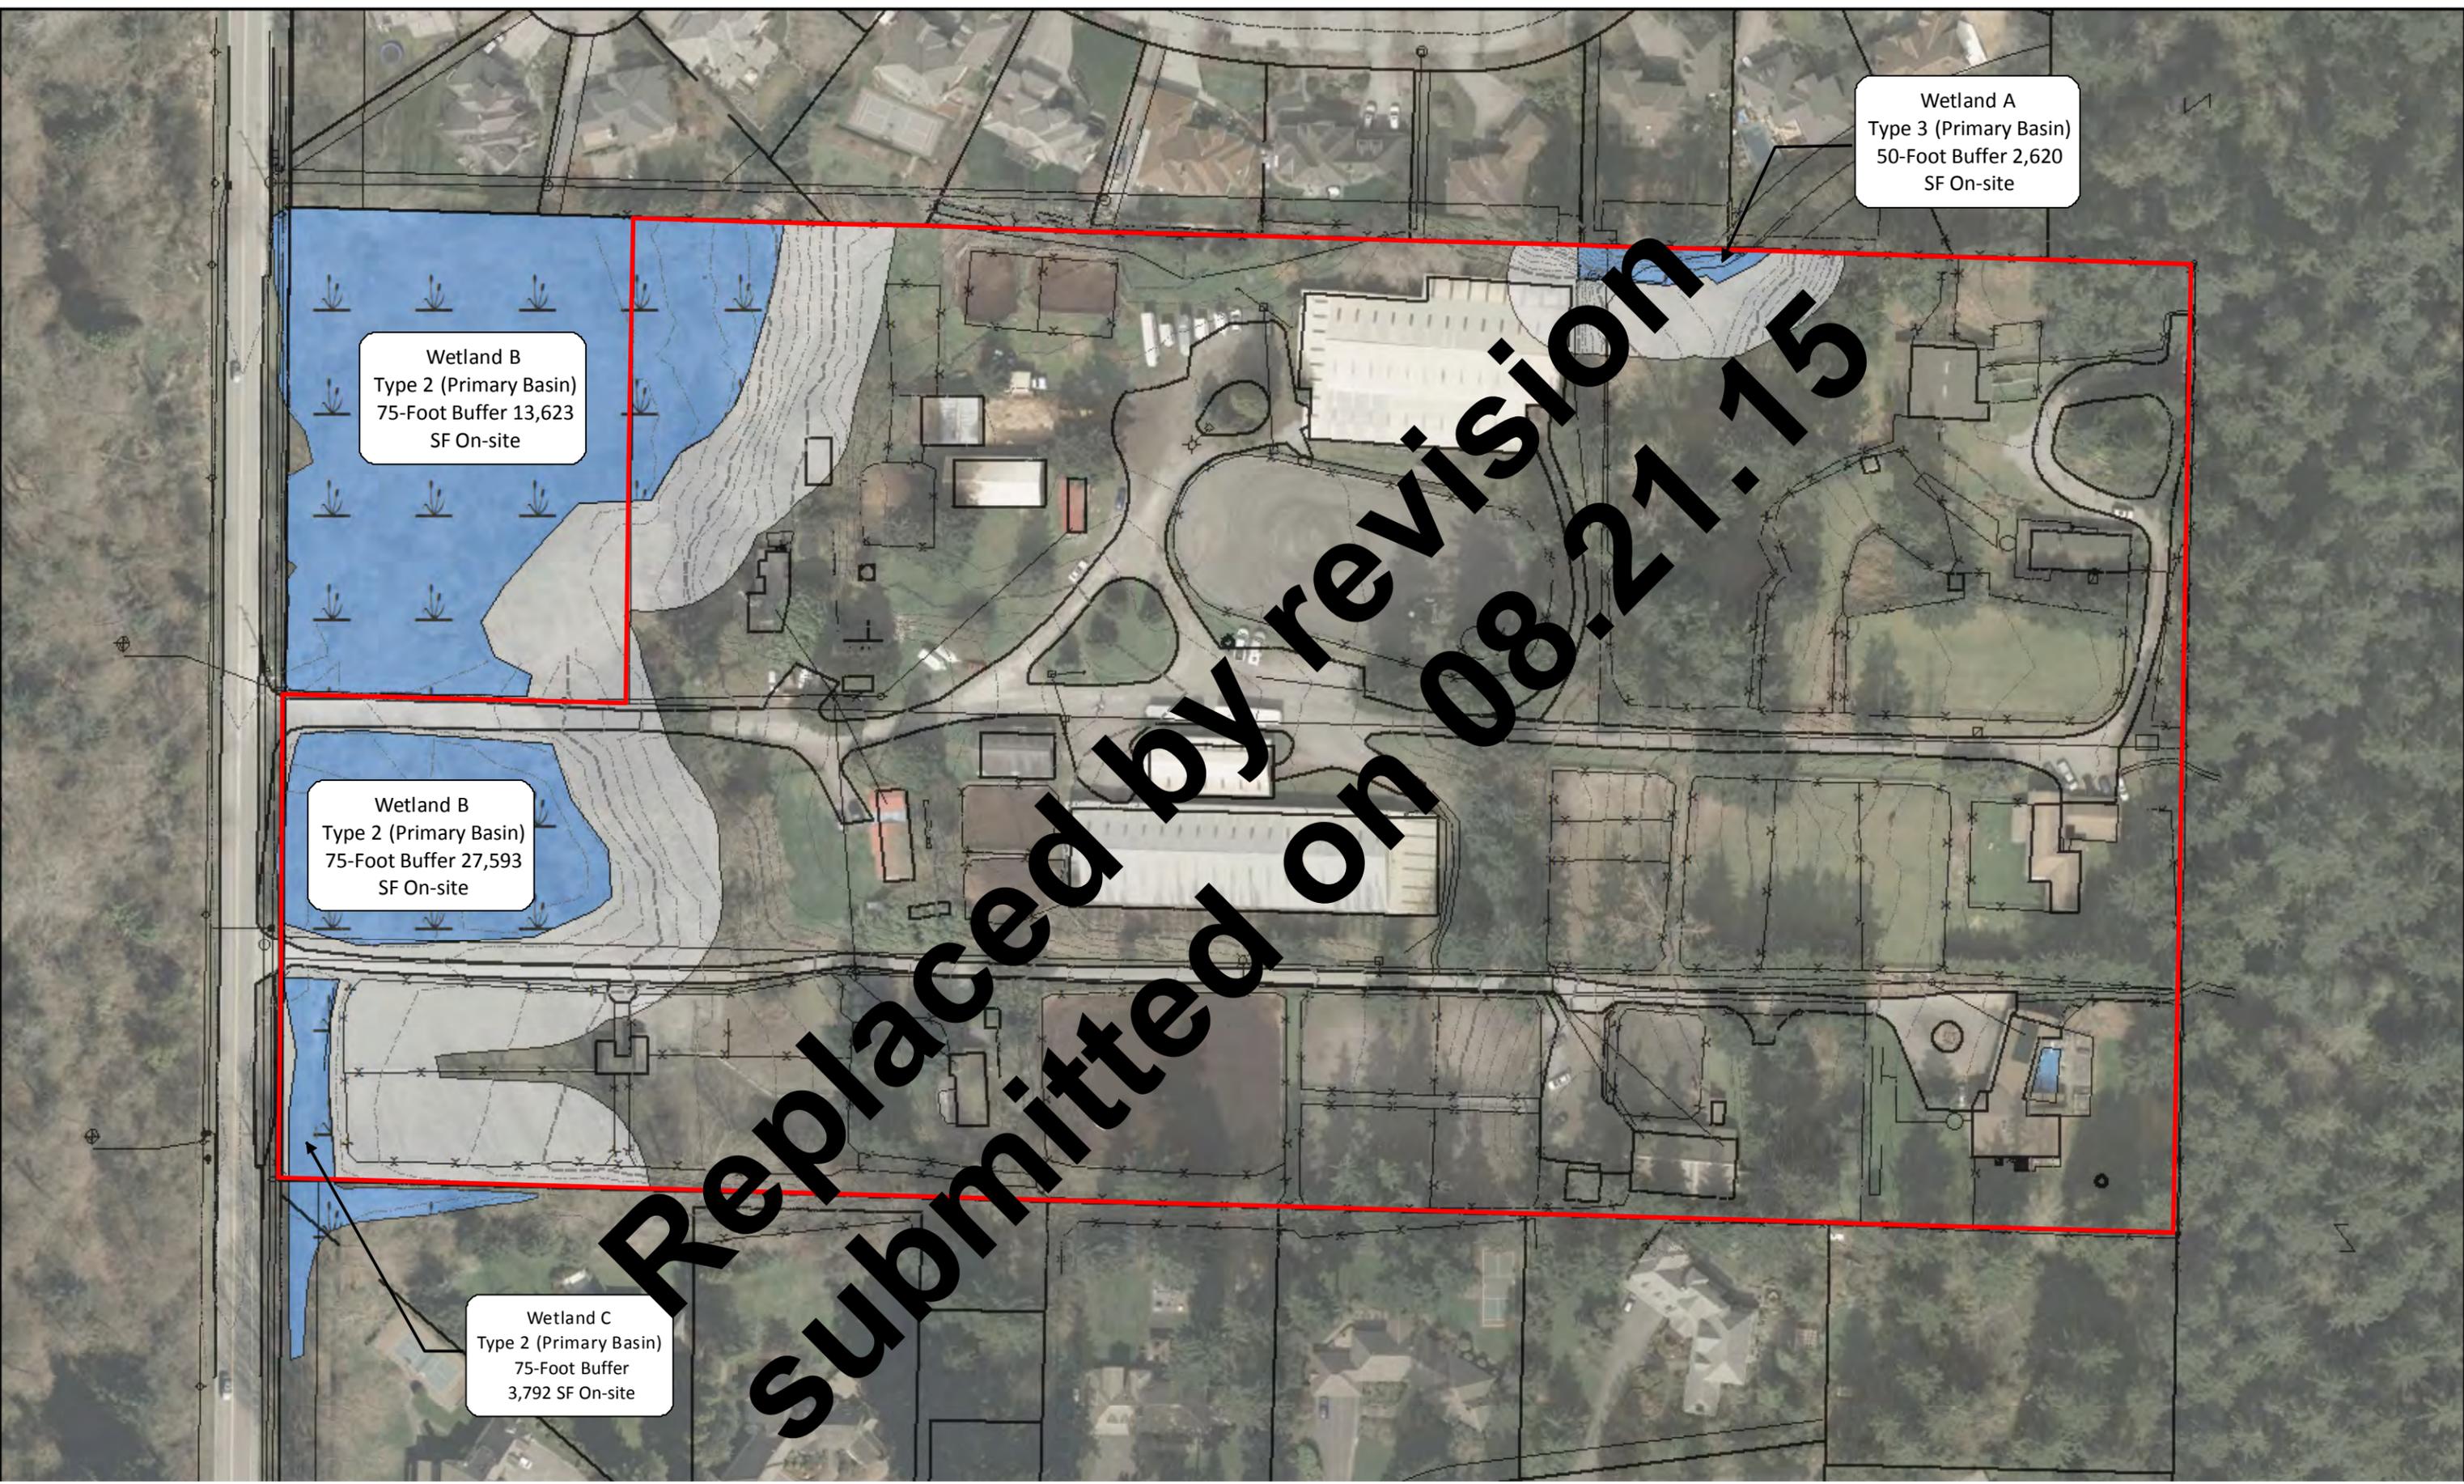
Wetland A  
Type 3 (Primary Basin)  
50-Foot Buffer 2,620  
SF On-site

Wetland B  
Type 2 (Primary Basin)  
75-Foot Buffer 13,623  
SF On-site

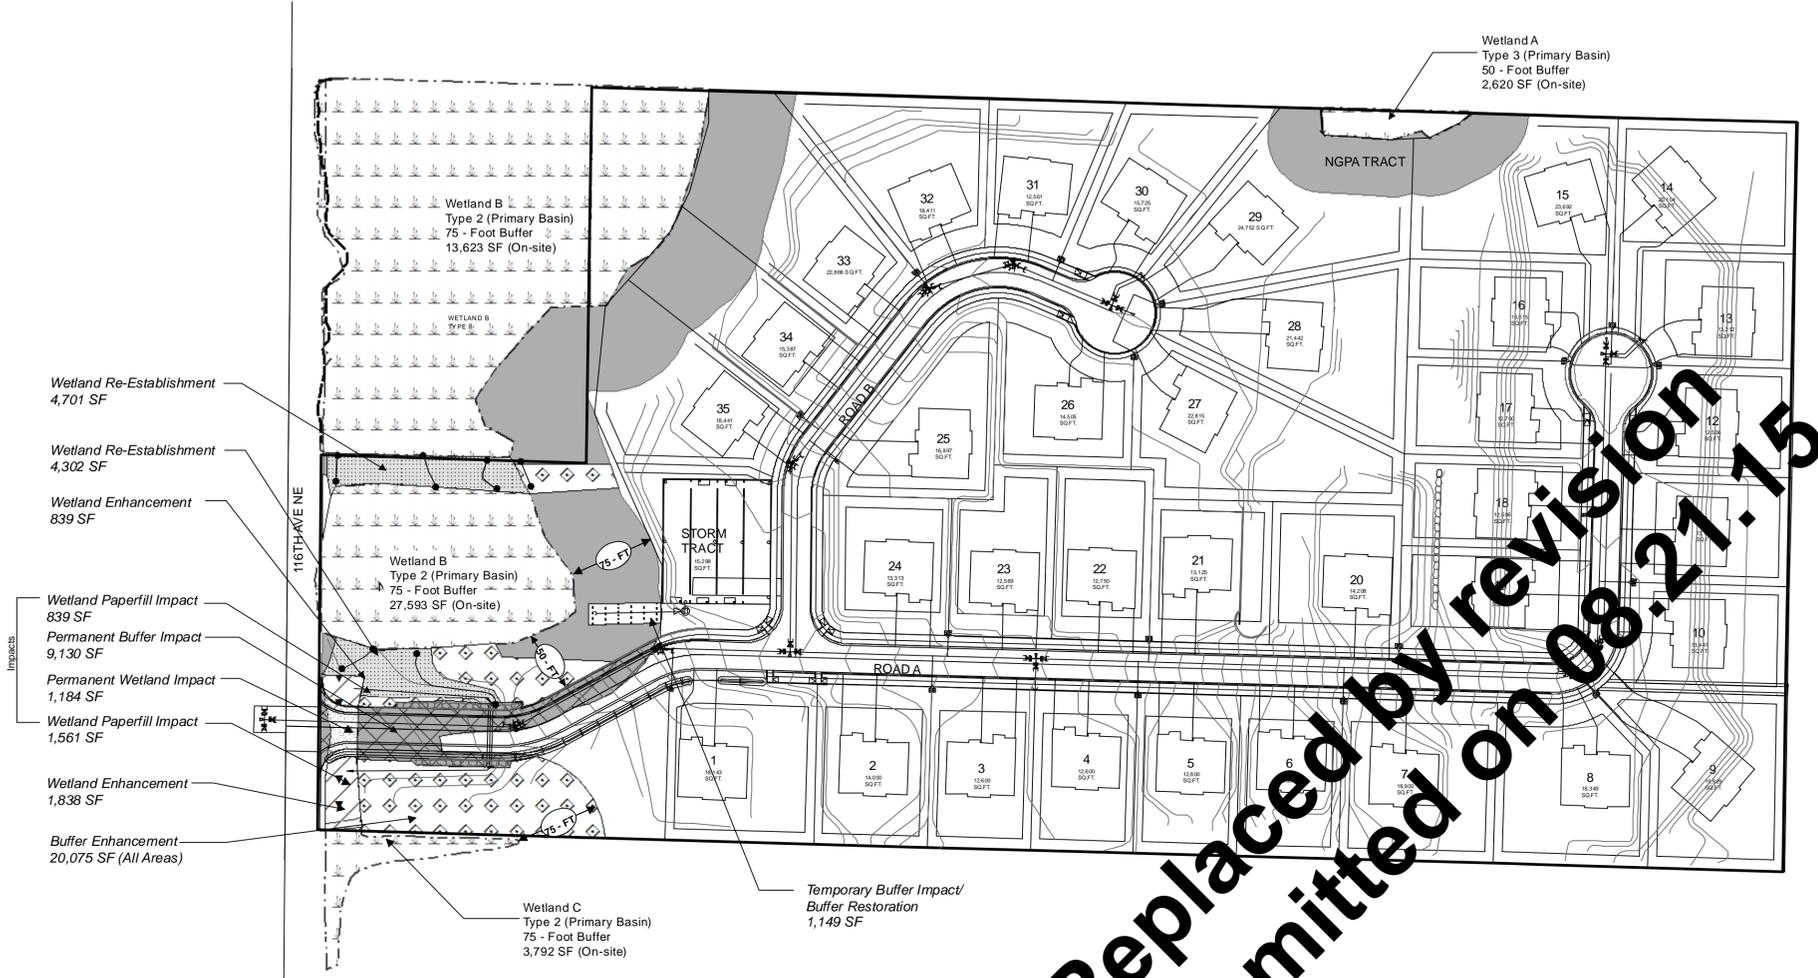
- Wetland Re-Establishment 4,701 SF
- Wetland Re-Establishment 4,302 SF
- Wetland Enhancement 839 SF
- Wetland Paperfill Impact 839 SF
- Permanent Buffer Impact 9,130 SF
- Permanent Wetland Impact 1,184 SF
- Wetland Paperfill Impact 1,561 SF
- Wetland Enhancement 1,838 SF
- Buffer Enhancement 20,075 SF (All Areas)

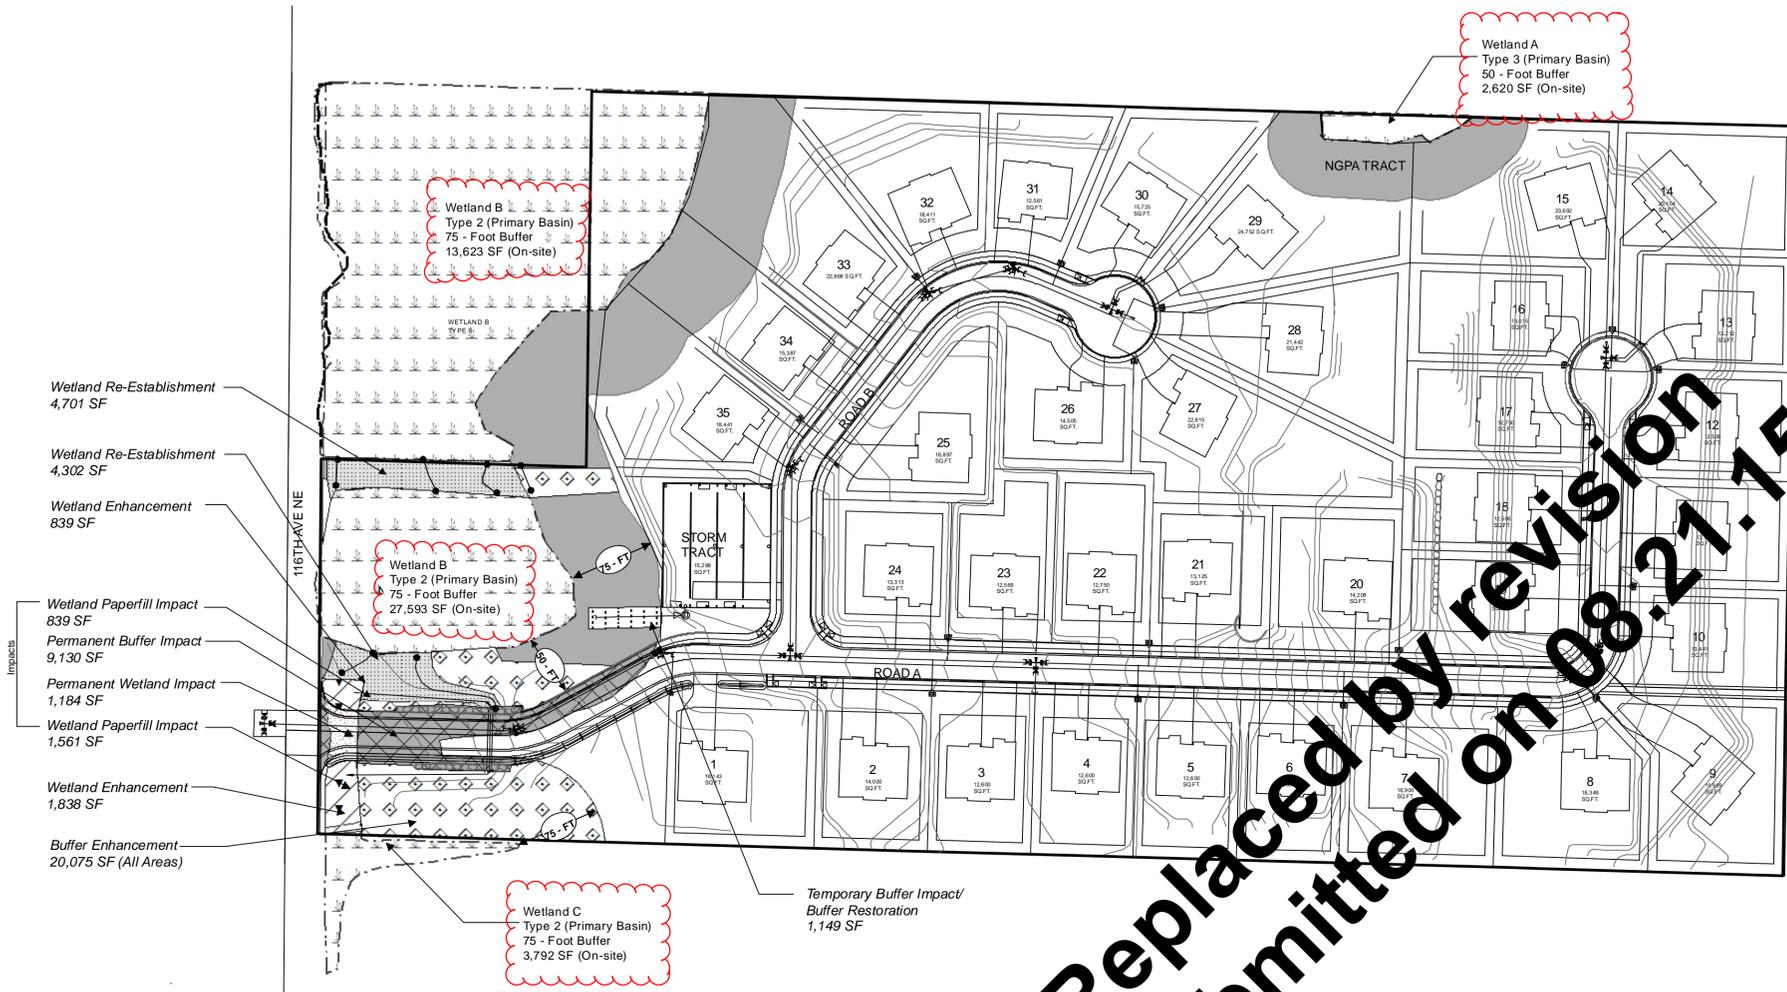
- Wetland Re-Establishment 4,701 SF
- Wetland Re-Establishment 4,302 SF
- Wetland Enhancement 839 SF
- Wetland Paperfill Impact 839 SF
- Permanent Buffer Impact 9,130 SF
- Permanent Wetland Impact 1,184 SF
- Wetland Paperfill Impact 1,561 SF
- Wetland Enhancement 1,838 SF
- Buffer Enhancement 20,075 SF (All Areas)

Wetland B  
Type 2 (Primary Basin)  
75 - Foot Buffer  
13,623 SF (On-site)
