## CITY OF KIRKLAND NOTICE OF DECISION

**Permit application:** HBG Market Short Plat, File No. [SUB15-01895](#)

**Project description:** Subdivide one parcel of 0.41 acres into two separate parcels in the RS 7.2 Zone (see Attachment 2).

# HBG MARKET SHORT PLAT SUB15-01895

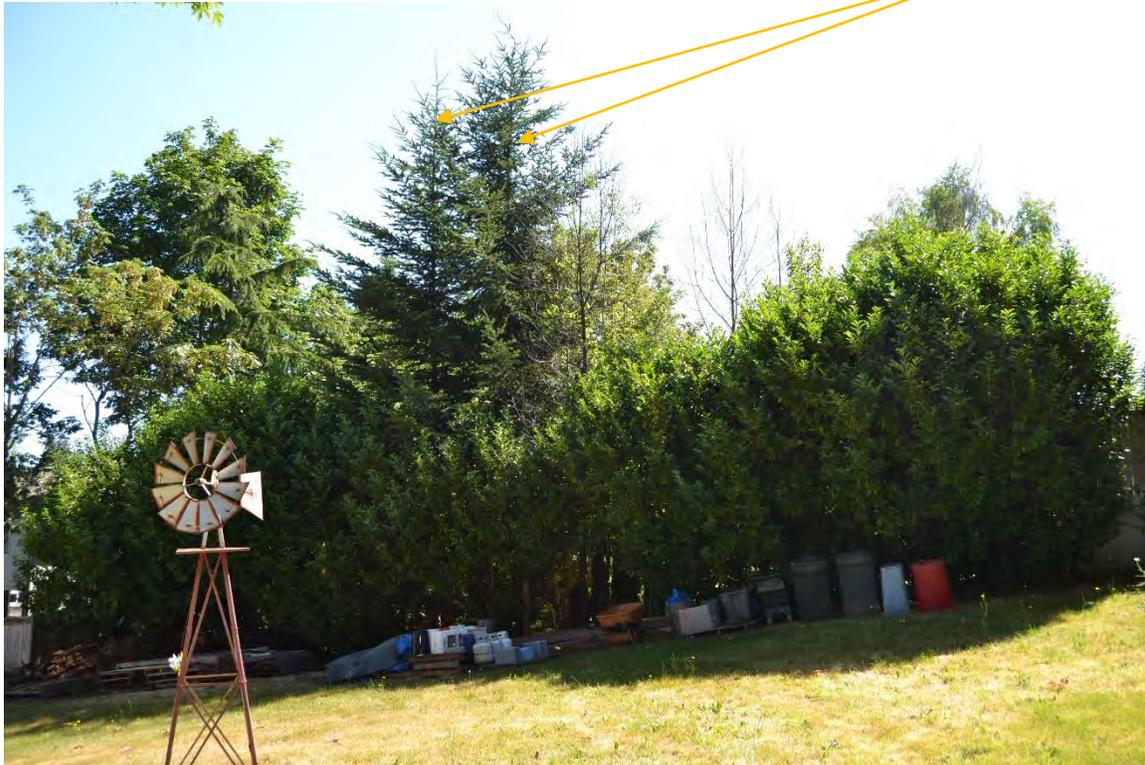
- Trees # 946 and 947 are just east of the east property line.
  - Their canopies overhang the subject property by two to three feet.
  - They can be adequately protected by the minimum “limits of disturbance” fencing on the yard setback.

Photo # 2: Looking north east at the back yard. Trees # 946 & 947 on the adjacent property are located here. These two trees can be adequately protected with a fence 5 feet west of the east property line.

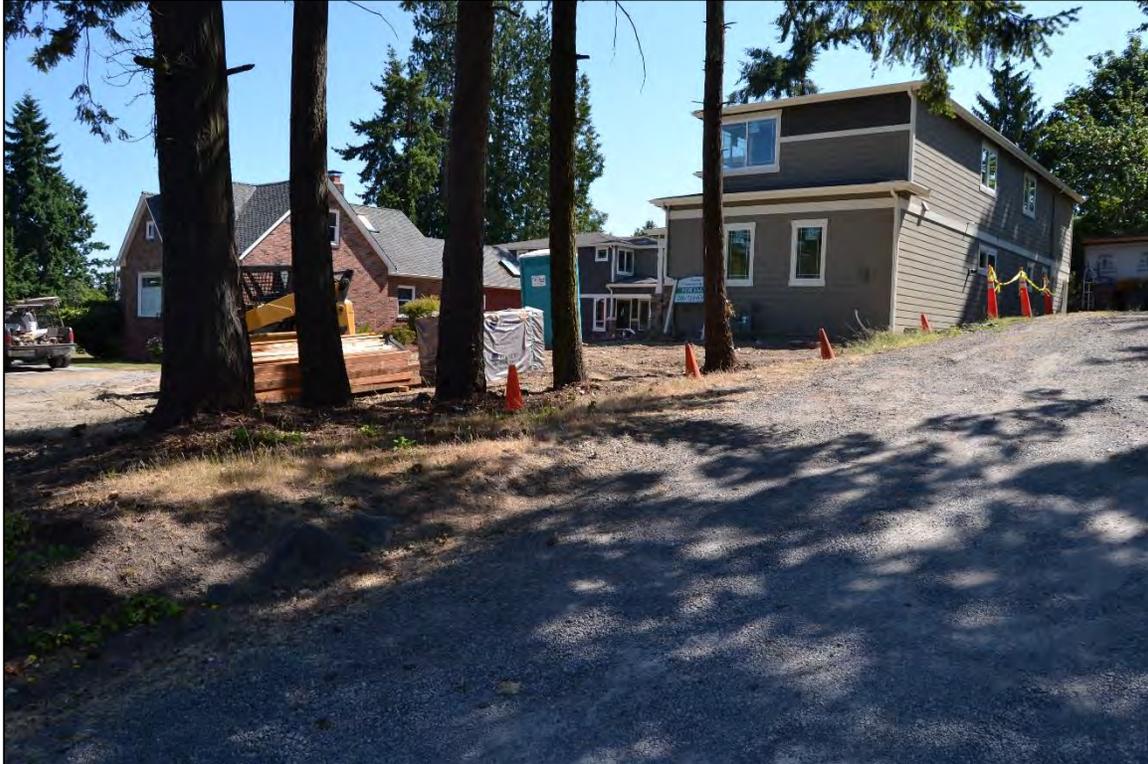
- Trees 950 through 954 are a row of 5 Douglas Fir trees north of the north property line near the northwest property corner.
  - Their bases are very close to the property line.
  - Their canopies overhang the subject property for a significant portion of their driplines.
  - The critical root zones have been impacted by the re-development of the adjacent property at 1936 Market Street.
  - The trees have adapted well to the gravel drive over their critical roots on the south side—that is the driveway for the subject property.
  - They can be adequately protected with a tree protection fence at the edge of the existing gravel driveway.

Photo # 3: Looking from the sidewalk northeast at the row of Douglas Fir trees on the adjacent property to the north. The trees appear to have adapted well to the existing driveway on the subject property. The redevelopment of the adjacent property, specifically the construction of a new house north of the row of trees may have negative consequences for the row of trees.

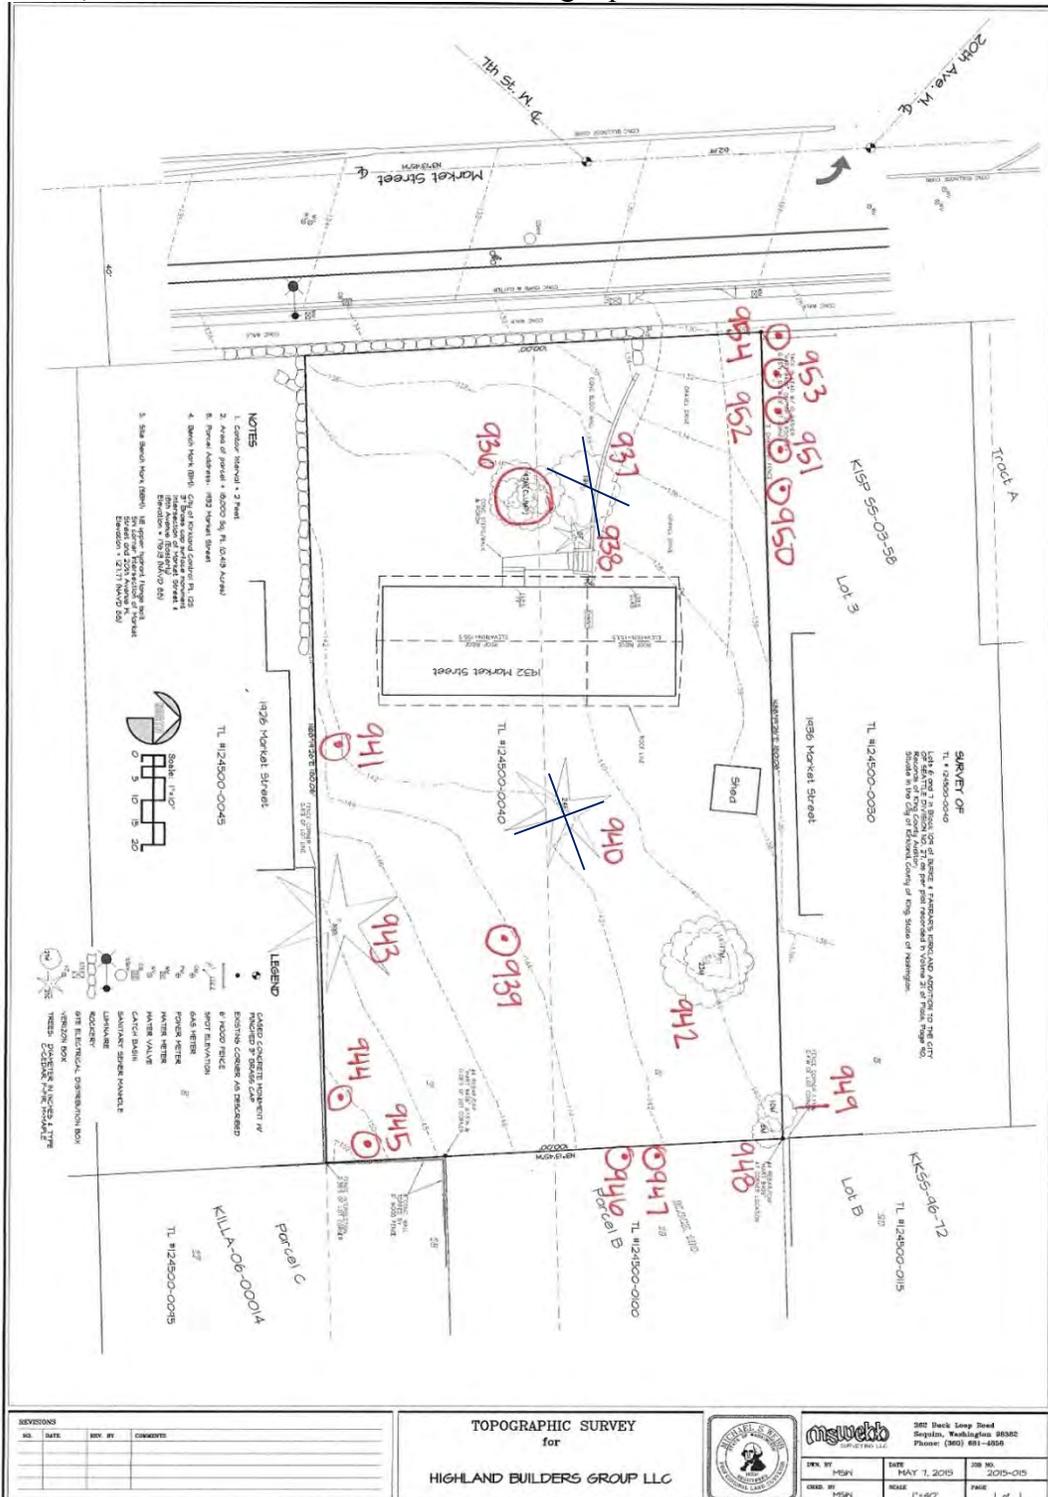
**ATTACHMENT 1 - SITE SURVEY W/TREE #'S**

✗ Means trees 937 and 940 are no longer present.
