Re: Bristol Lane Sensitive Area Study and Buffer Enhancement Plan Review

The Watershed Company Reference Number: 140622.68

SENSITIVE AREA STUDY AND BUFFER MITIGATION MAP

BRISTOL LANE

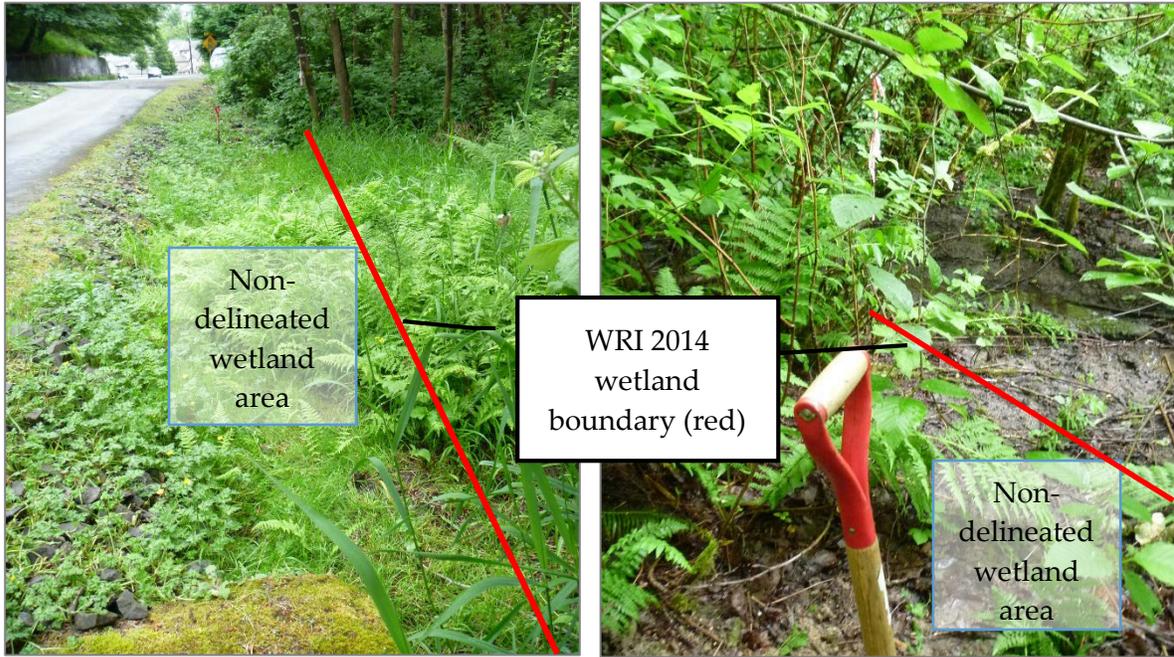
Wetland A is located next to the driveway off of Simmonds Road. Classification as a Type 2 wetland is correct, despite minor scoring differences. Two sections of Wetland A's boundaries were not consistent with field observations. The encumbering

boundaries between flags 1 and 2 should extend further west, and the wetland boundary to the northeast should extend to the base of the quarry spill sides of the driveway (Photo 1).

Photo 1. Slightly larger wetland area of encumbering boundaries of Wetland A.

- Re-delineate the encumbering boundaries of Wetland A indicated on the map.
- Re-delineate and re-classify Wetland B.
- Delineate boundaries and classify Stream B associated wetland(s).
- Re-flag OHWM of Stream A.
- Delineation map should indicate the wetland boundaries were mapped by a licensed surveyor.

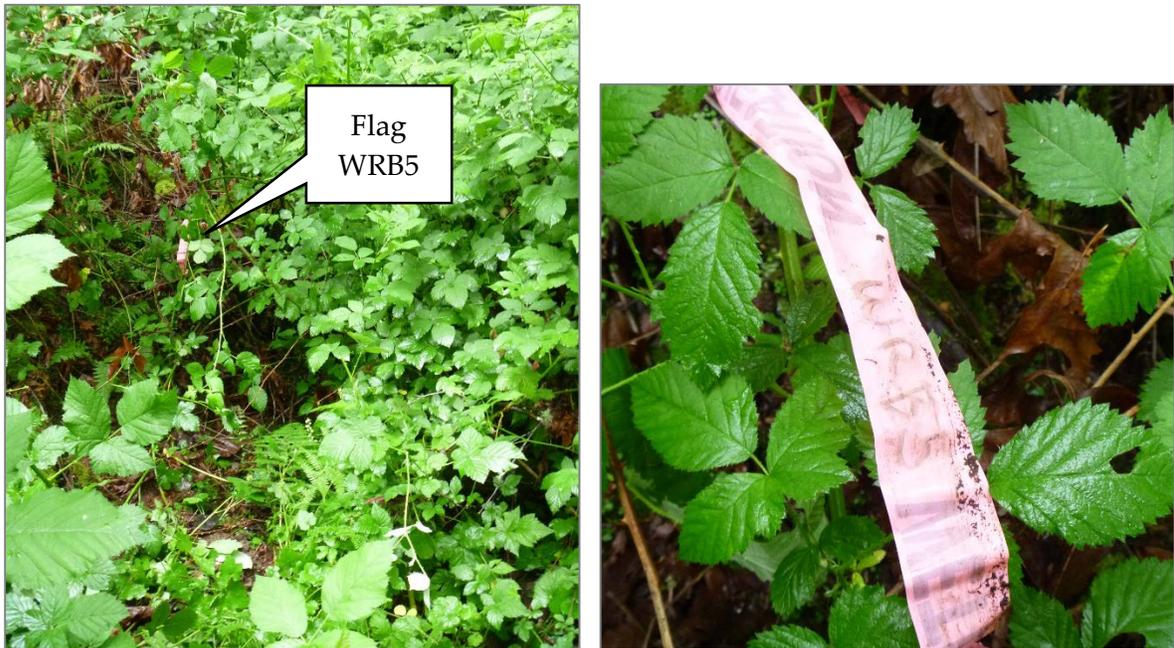
Classification of Wetland B as a Type 2 wetland is correct, despite minor scoring differences. Wetland B extends across the eastern property line, along both banks of Stream A. The left bank (looking downstream) wetland boundary flagging appears to be correct; however, at the eastern property line, wetland conditions are also present on the right (south) bank of Stream A. The WRI map does not show wetlands on this side of the stream. A WRI wetland boundary flag (Photo 2) was found in this area, indicating that it was delineated but not mapped. On the right bank, the wetland starts near the toe of the steep slope and connects to Stream A. The lack of mapped wetland features is concerning as it is also in the vicinity of the proposed stormwater outfall.

As mentioned above, the proposed stormwater outfall appears to be located within Wetland B.

Photo 2. Unmapped Wetland B flag (WRB5) south of stream A. This part of Wetland B is in the vicinity of the proposed stormwater outfall.

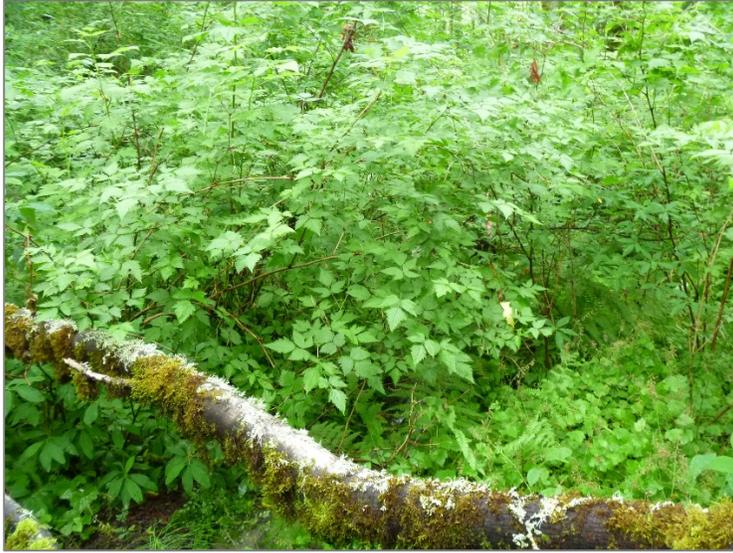
Riverine/slope wetland(s) were found along both banks of stream B but were not described or delineated by WRI (Photo 3).

Photo 3. Slope/riverine wetland(s) next to Stream B.

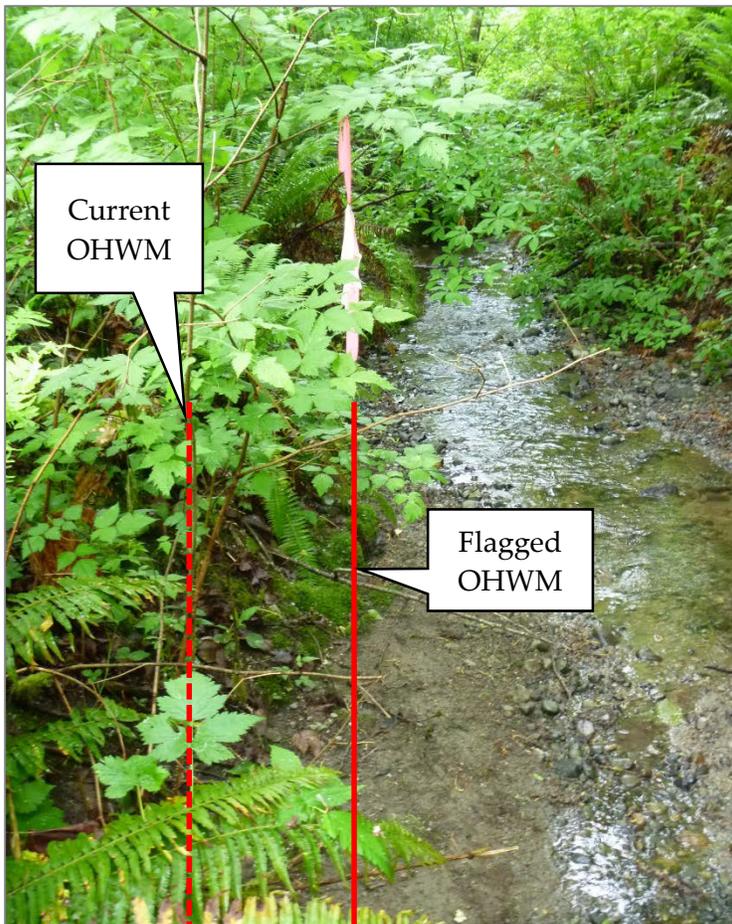
Classification of Stream A as Class A is consistent with publicly available sources. Stream A OHWM flagging appears to be too narrow (Photo 4). OHWM indicators, including erosion patterns and hydraulically sorted sediment, were found outside the flagged stream banks.

Photo 4. Stream A OHWM is wider than flagging indicates.

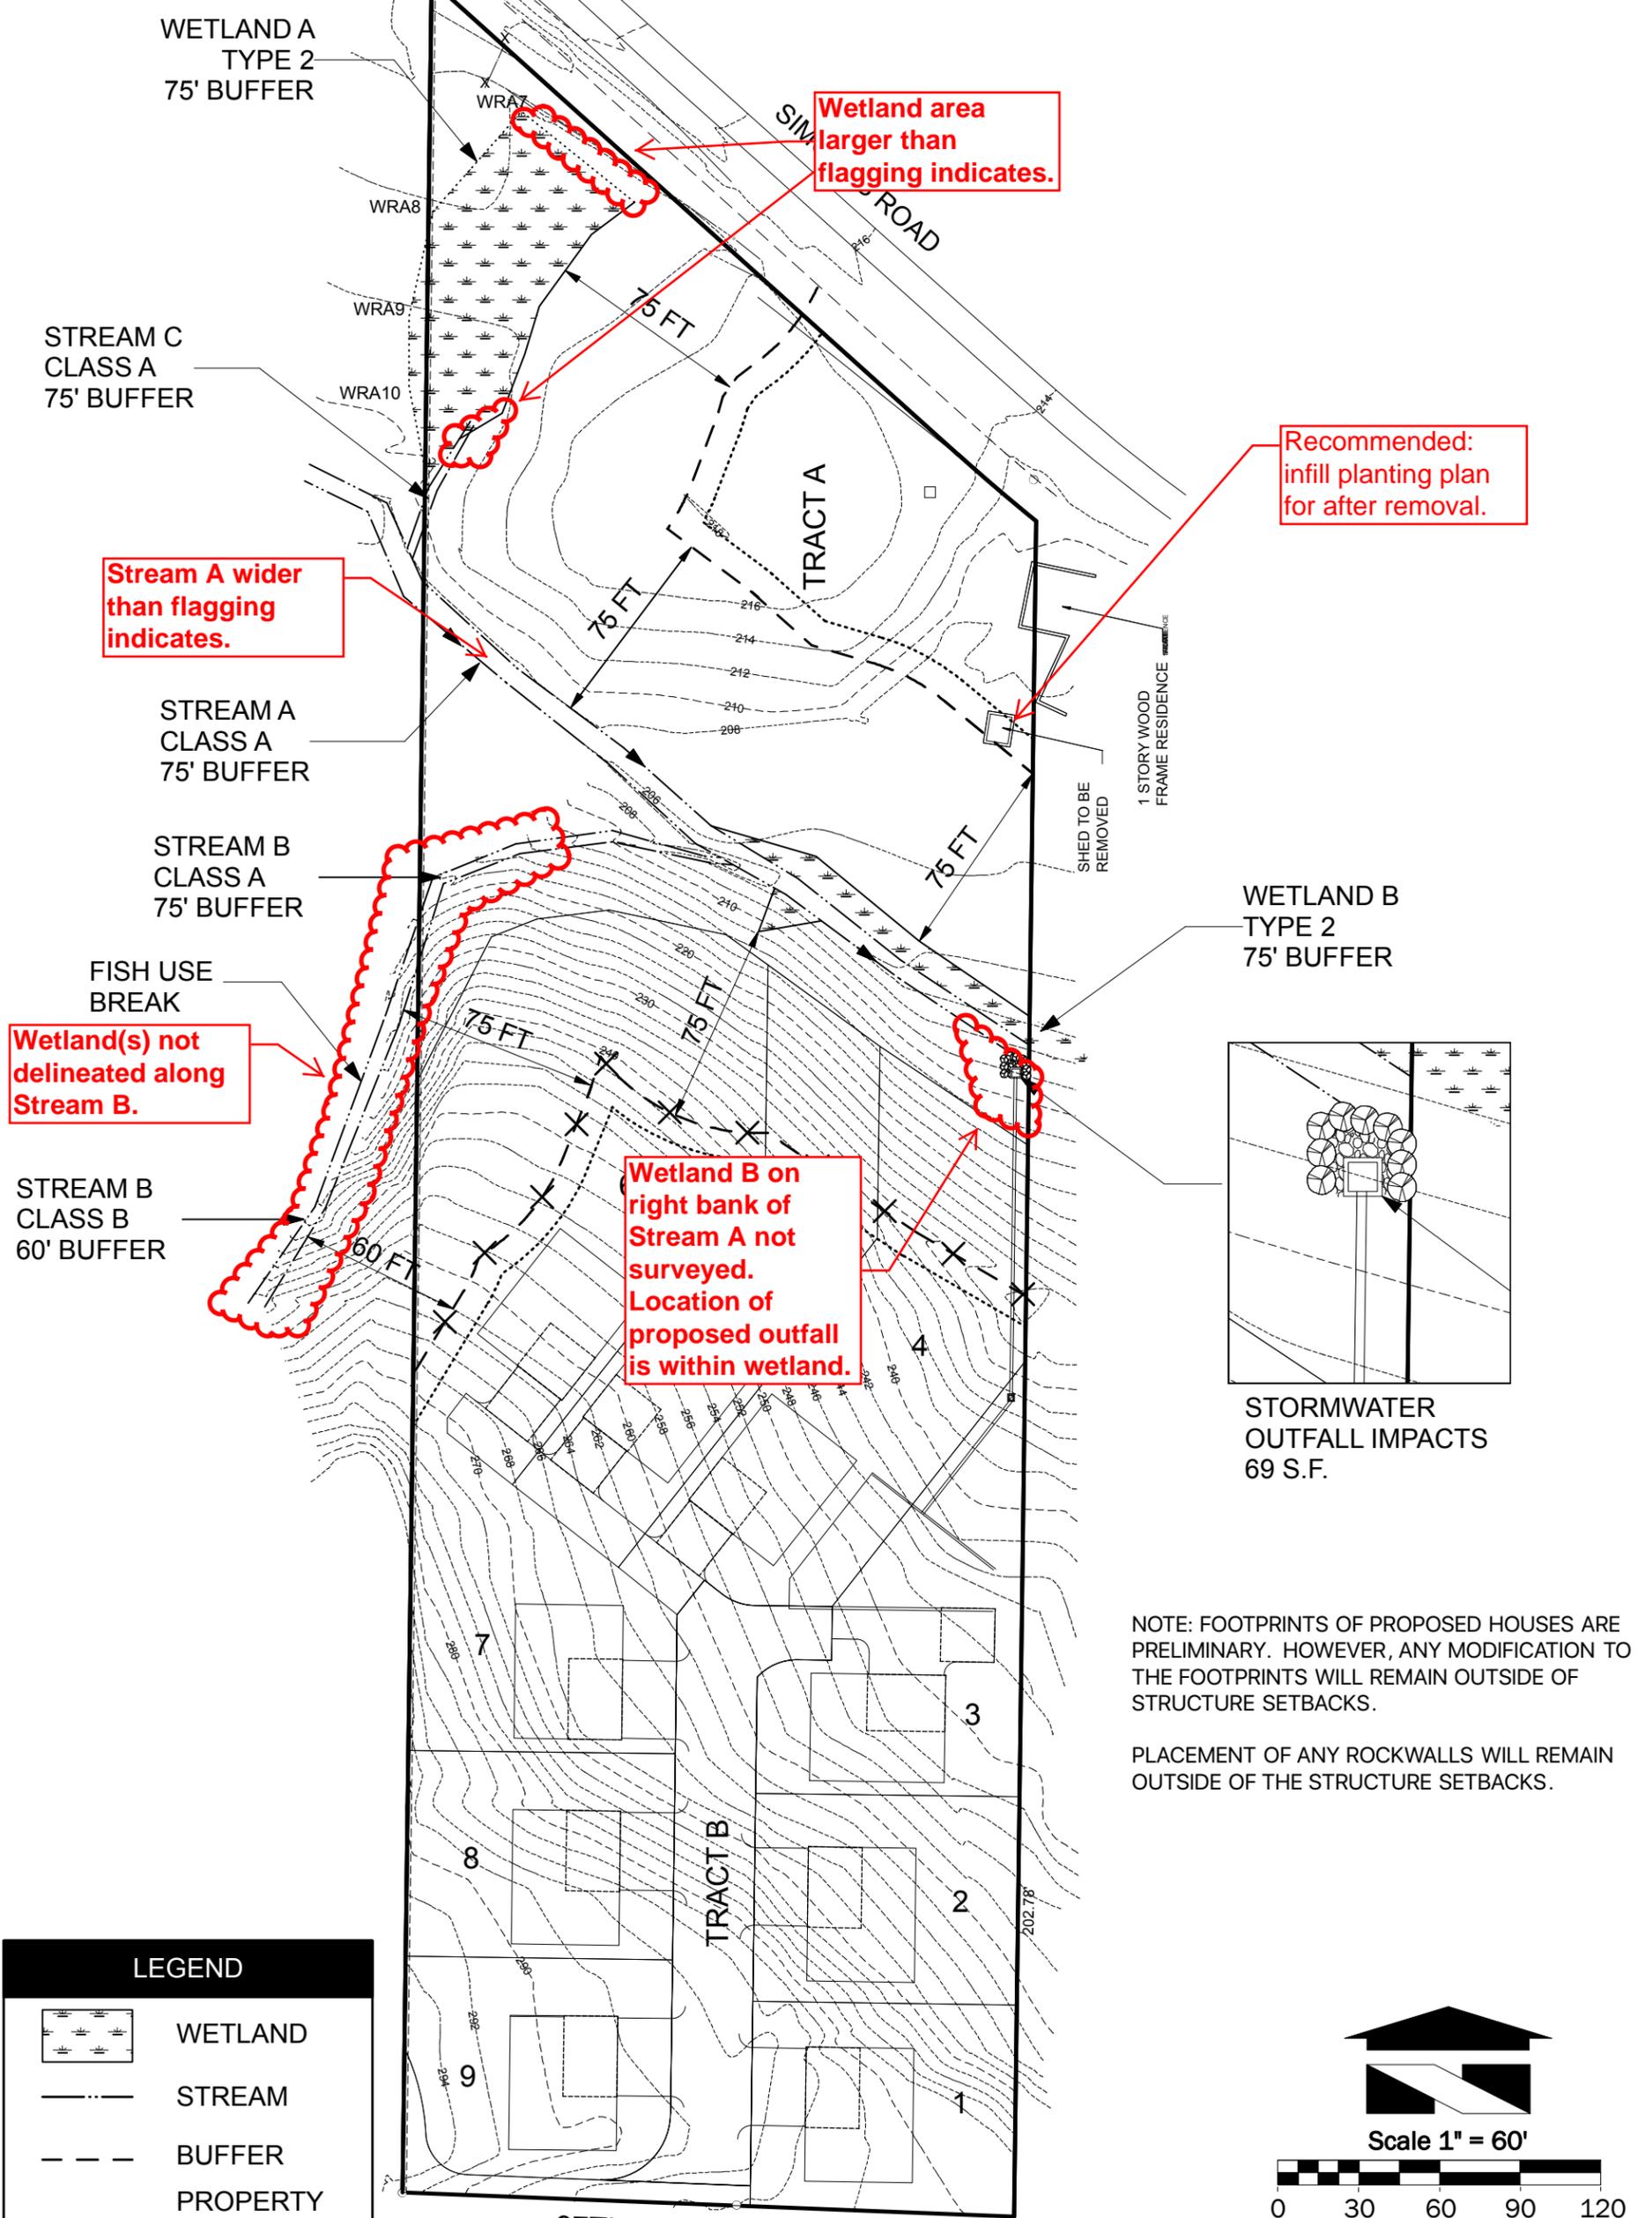
SENSITIVE AREA DETERMINATION MAP
BRISTOL LANE

Stream A wider than flagging indicates.

Wetland area larger than flagging indicates.

Recommended: infill planting plan for after removal.

Wetland(s) not delineated along Stream B.

Wetland B on right bank of Stream A not surveyed. Location of proposed outfall is within wetland.

- To promote native plant diversity, avoid erosion and prevent spread of invasive plant species, namely Himalayan blackberry, an infill planting plan should be created.
