GDI Project:	CenterCal-23-01
RE:	Totem Lake Mall

Addendum 4
Additional Explorations – Lower Mall
Totem Lake Mall
Kirkland, Washington
GeoDesign Project: CenterCal-23-01

GeoDesign requested to visit the site to observe subgrade conditions at the locations where the old mall buildings had been demolished at the locations of proposed Buildings A, B, and C; we visited the site on July 5, 2016.

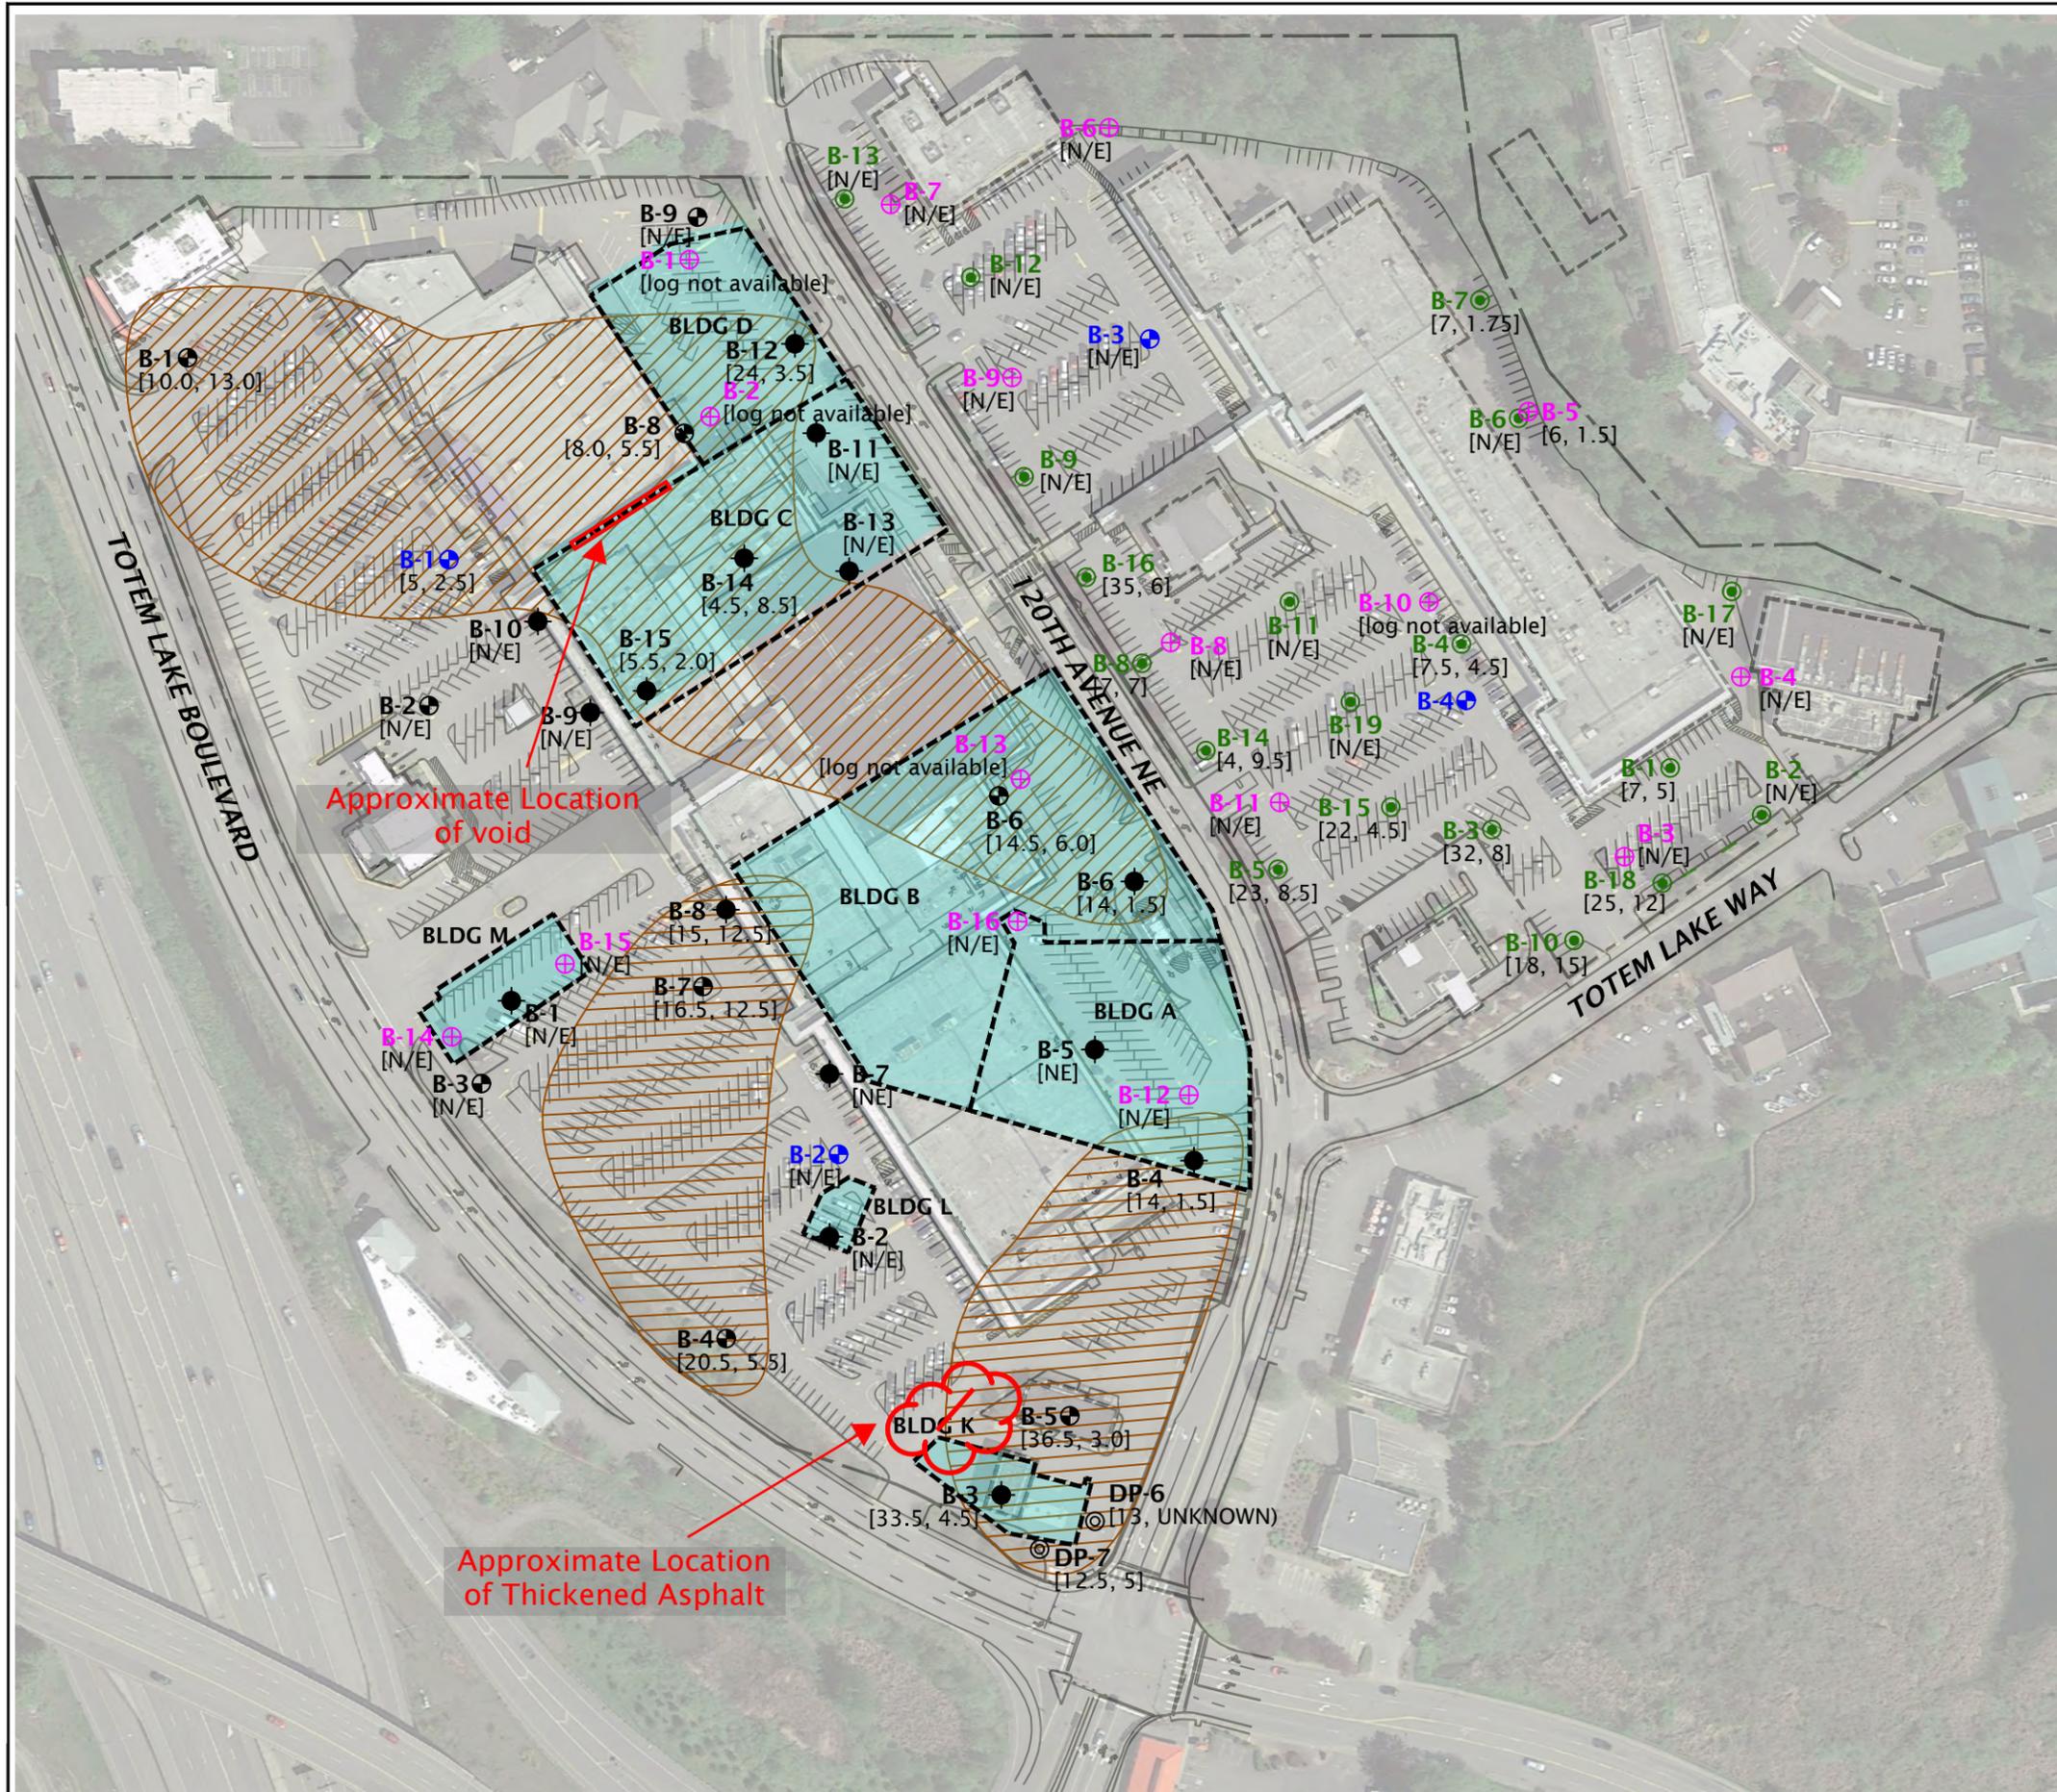
SITE PLAN	FIGURE 1
TOTEM LAKE MALL KIRKLAND, WA	
CENTERCAL-23-01	JULY 2016
 15575 SW Sequoia Parkway - Suite 100 Portland OR 97224 Off 503.968.8787 Fax 503.968.3068

It had been brought to our attention that an asphalt concrete section of between 1 and 3 feet thick was encountered on the southeast portion of the Lower Mall site near the intersection of Totem Lake Boulevard and 120th Avenue NE. Figure 1 shows the approximate location of where the thick asphalt section was observed. Figure 2 shows the thickened asphalt section.

Upon our arrival silty subgrade had been exposed over most of the area. We observed voids between the structural floor slab of the Ross store where it will adjoin the proposed Building C to the southeast. The void appeared to vary in width up to approximately 10 inches. The approximate location of the void is shown on Figure 1; Figures 3 and 4 show the void.

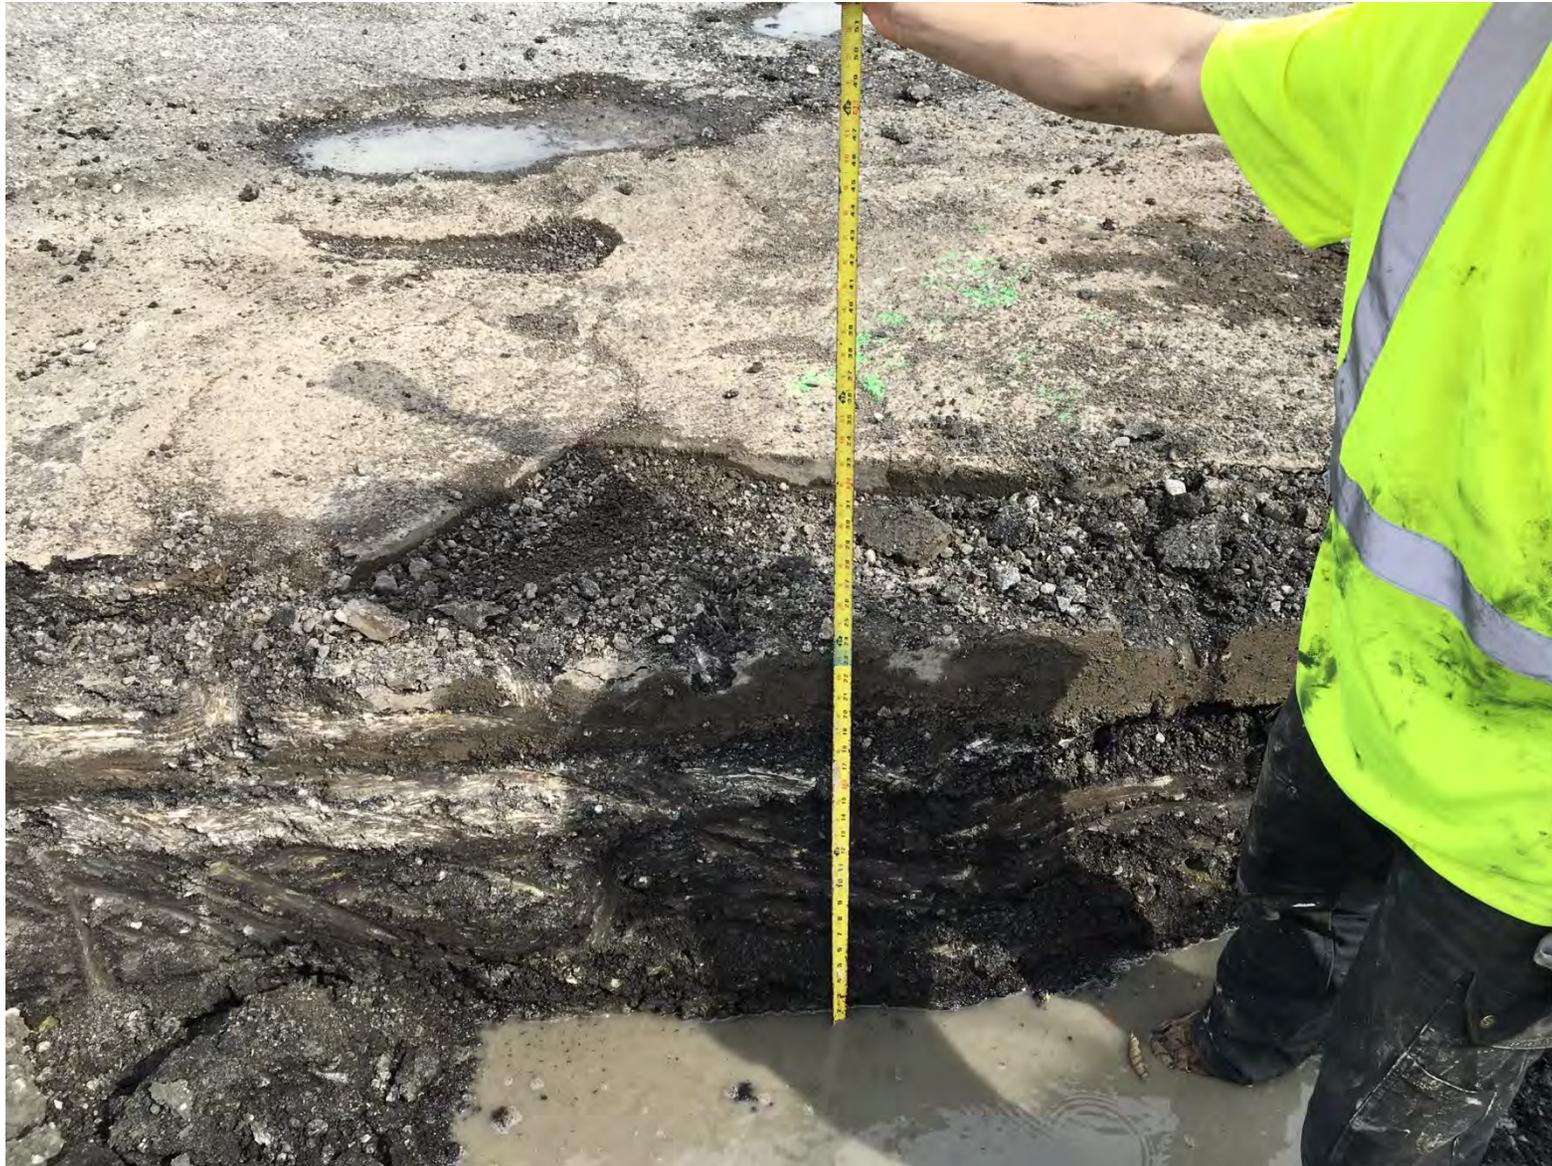
FIGURE 2

THICKENED ASPHALT CONCRETE

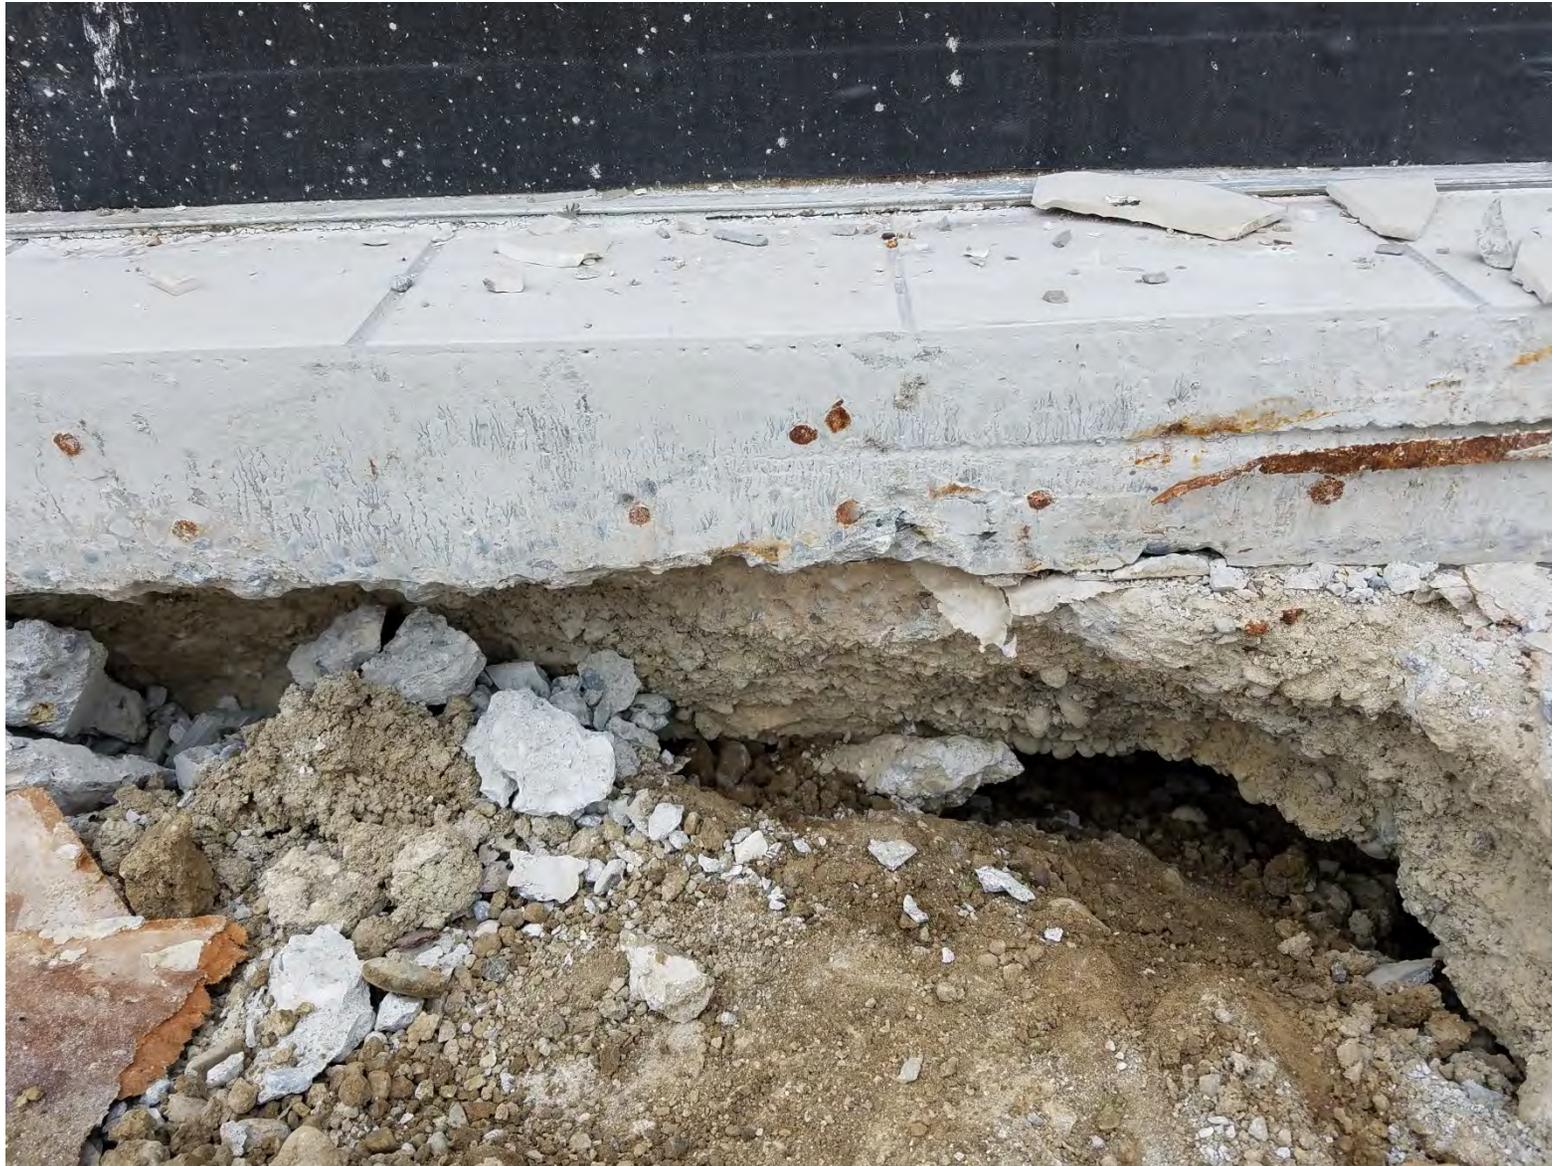
FIGURE 4

VOID BENEATH SLAB

Peat was encountered during various phases of subsurface exploration at the site. The peat appears to be randomly located at various depths across the site. Since the Ross building is supported on piling, the peat appears to be causing settlement at the ground surface without any stress increase from foundation loads. The most likely cause of this is degradation and decay of the organic peat soil. Further decay of the peat soil could cause settlement of structures that are supported on the subgrade.

We understand that column footing for Buildings B and C will be supported on ground that is improved with Geopiers or rigid inclusions. These foundations are protected from settlement caused by decay of the peat soil. In addition to supporting the column footings on improved ground, we recommend that the ground improvement also be extended beneath exterior wall footings. Slabs on grade are also susceptible to the type of settlement described above. To avoid repair of slabs on grade in the future, they should also be supported on improved ground.
