# RE-ROOFING SPECIFICATIONS

Carillon Point  
Building 6100  
Kirkland, WA 98033

## Re-Roofing Specifications

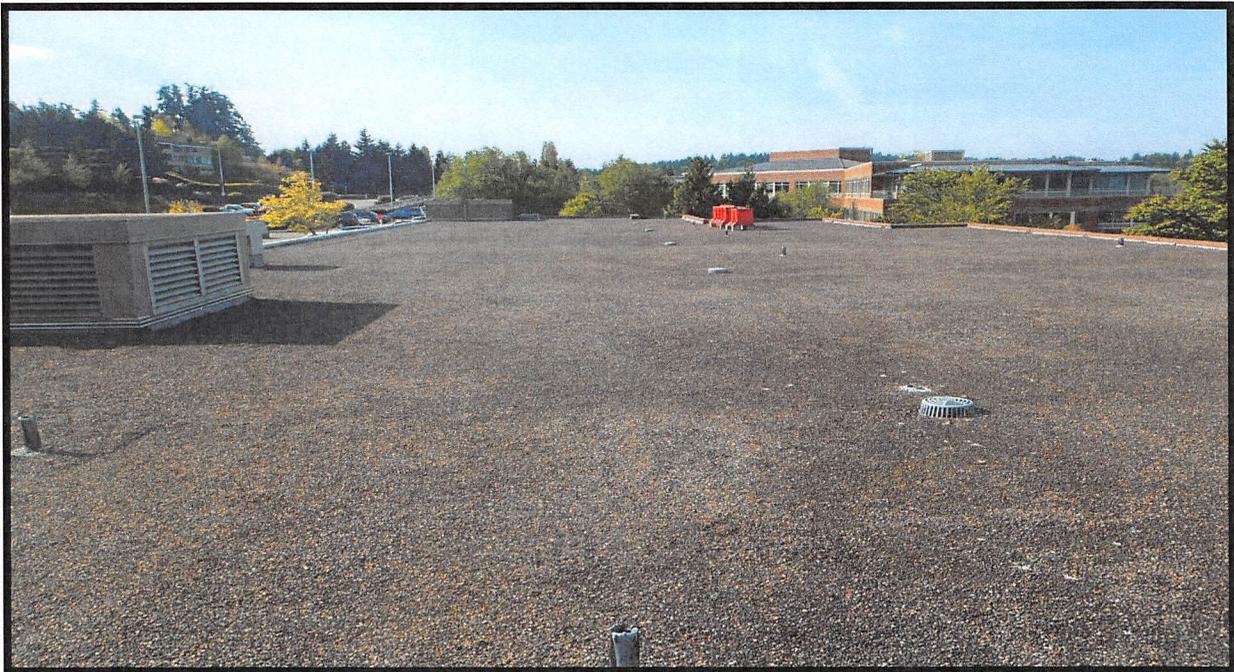
- Prior to the performance of any roofing work, we will require that a sample of the existing roofing be tested for asbestos. This is due to the current assembly on the roof, as well as the age of the building. This cost is not included in our proposal. Testing costs can range from \$150.00 to \$600.00, and we can arrange this for you if you wish.

- Remove existing roofing assembly, base flashings and roof related flashings down to an acceptable substrate.
- Sweep clean the existing roof substrate and prepare for roofing. If deteriorated material or substrate is discovered, we will replace with the same on a time and material basis as an additional cost to our agreed upon contract amount. Any extra work will be closely documented for your review. No extra work will take place without a minimum of verbal authorization to proceed and followed by written confirmation. Any extra work to be performed at \$98.00 per man-hour plus materials at cost plus 20%, engineering costs (if needed) would be an additional cost.

- After the debris has been thoroughly removed, 1-layer of inverted fiberglass cap sheet will be mechanically attached over the LWIC concrete decking. The new modified membrane will then be torch applied over the cap sheet..

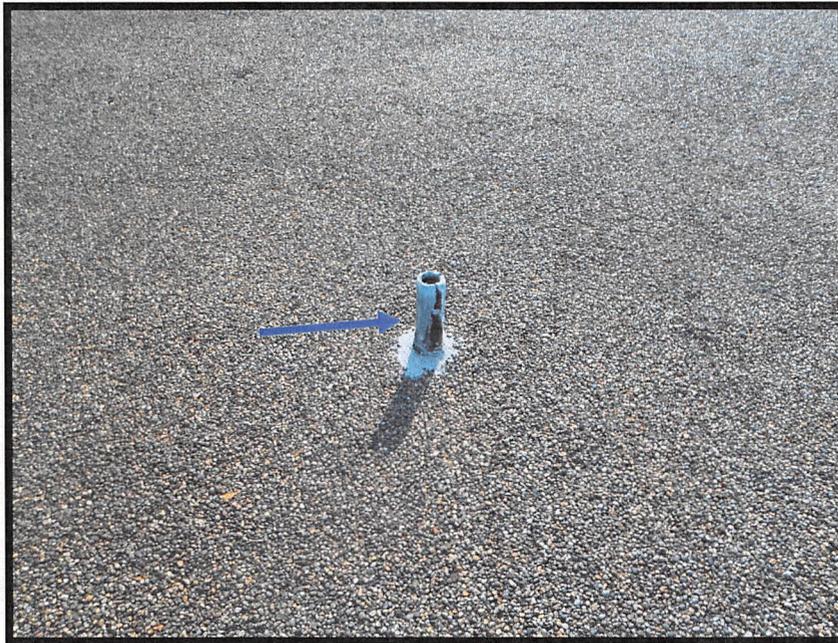
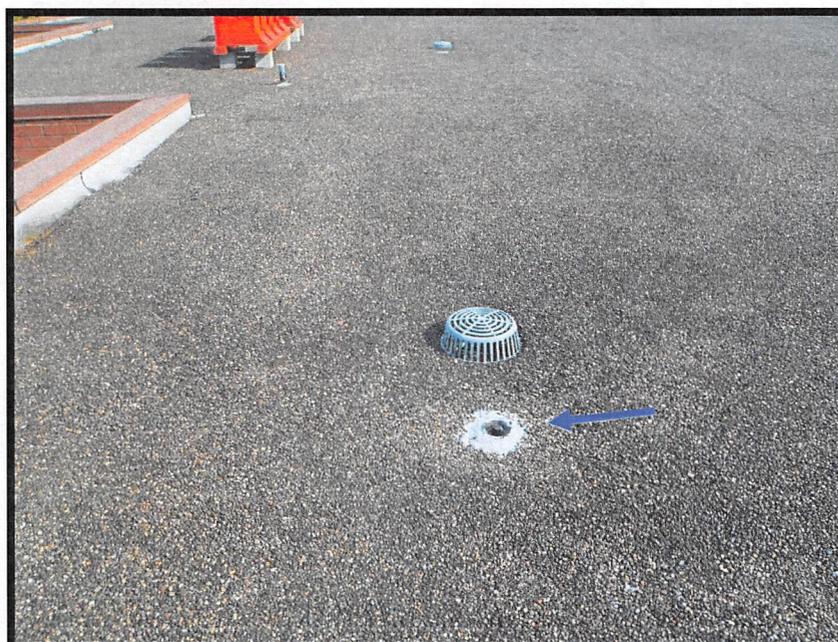
- Remove the existing pipe flashings and legally dispose of off site. All of the existing pipe penetrations and overflow drain pipes will be sealed with a 3-course application of reinforced Urethane sealant (Parapro).

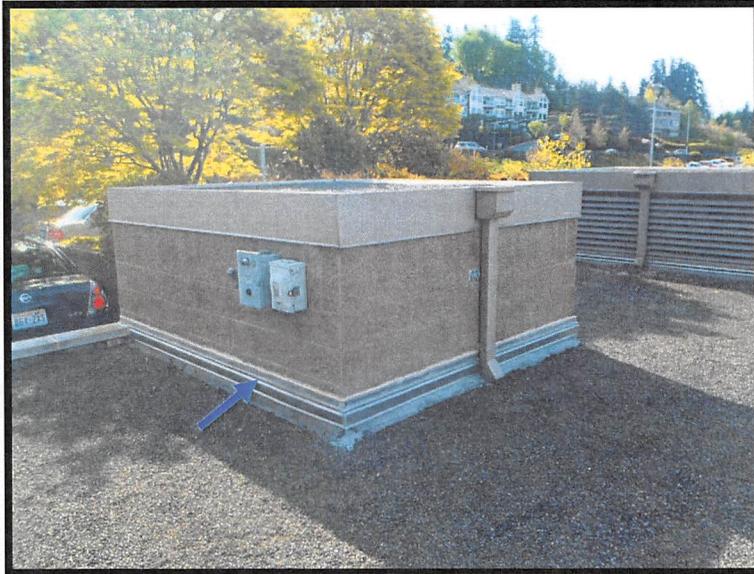
- Install new 24 GA Kynar surface mounted counter-flashings at the penthouse walls.

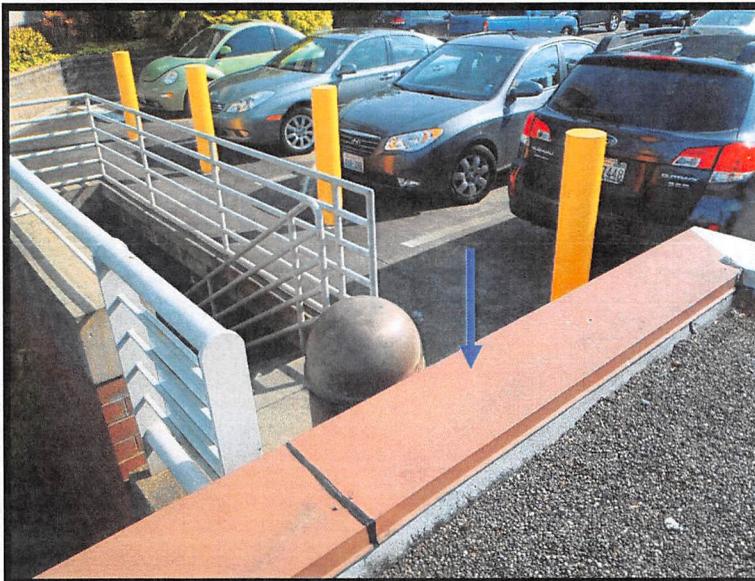
- Remove the existing coping metal on each main roof level. New coping metal will be installed upon completion of the roof work.

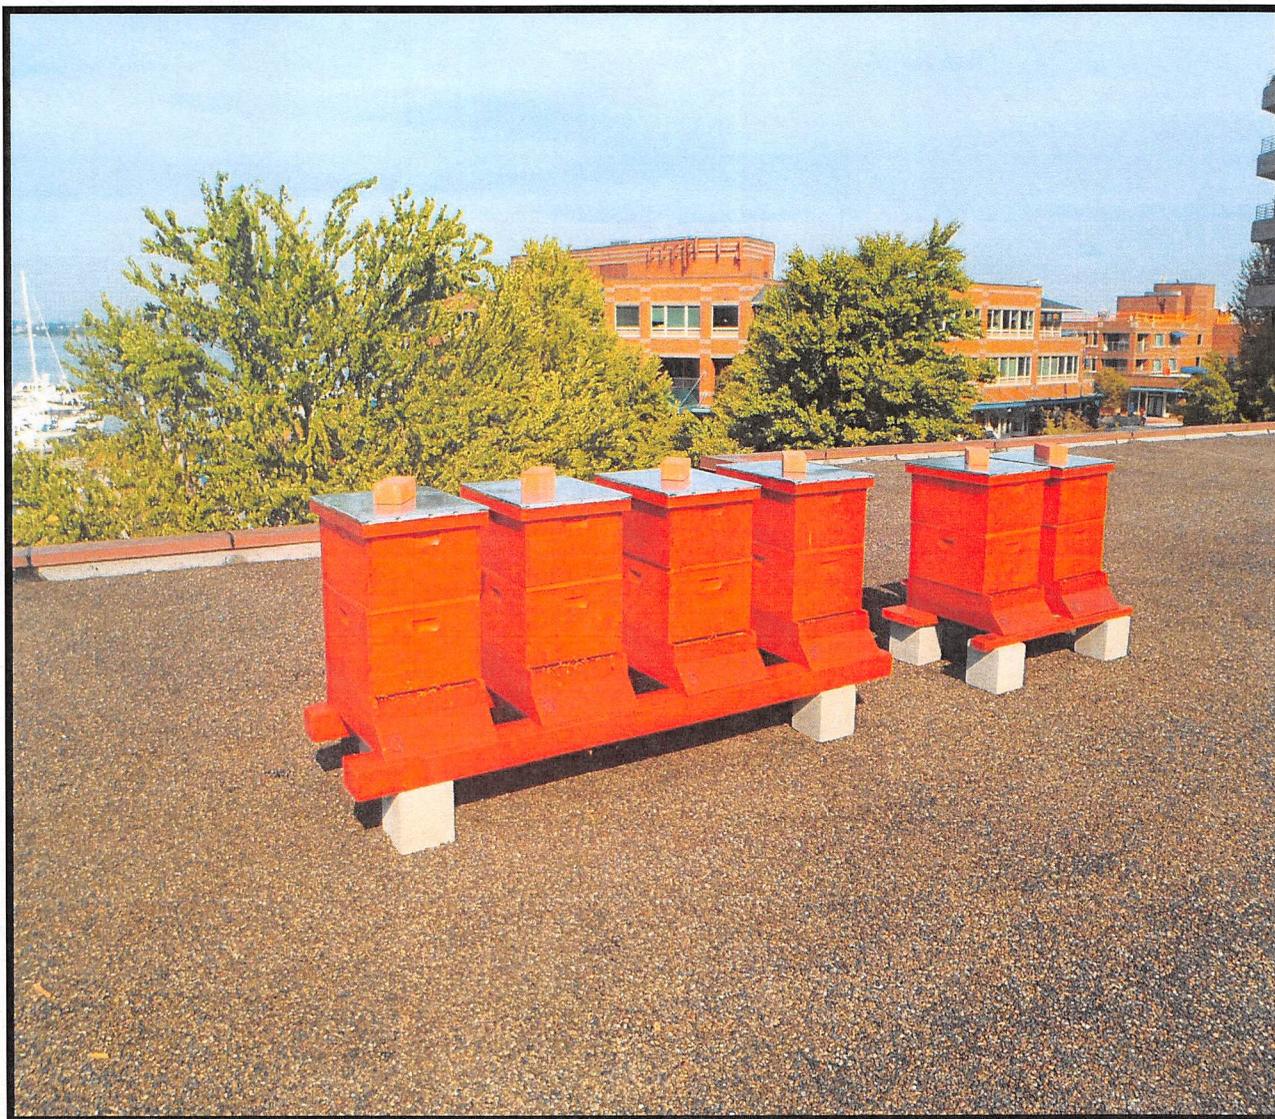
- Several Honey Bee hives have been placed on the roof surface. In consideration for the safety of both our employees and the Honey Bees, these hives will need to be removed by others prior to the our mobilization.
