TECHNICAL INFORMATION REPORT for the EOS-EAST SHORT PLAT

Prepared By:
Keith A. Litchfield, P.E.

Stormwater Technical Information Report For Small Sites

Project Name: EOS East Short Plat

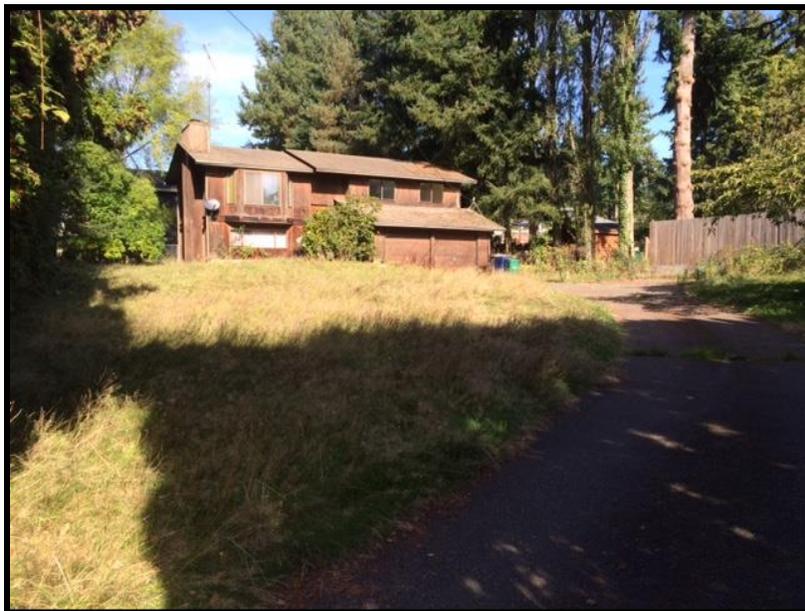
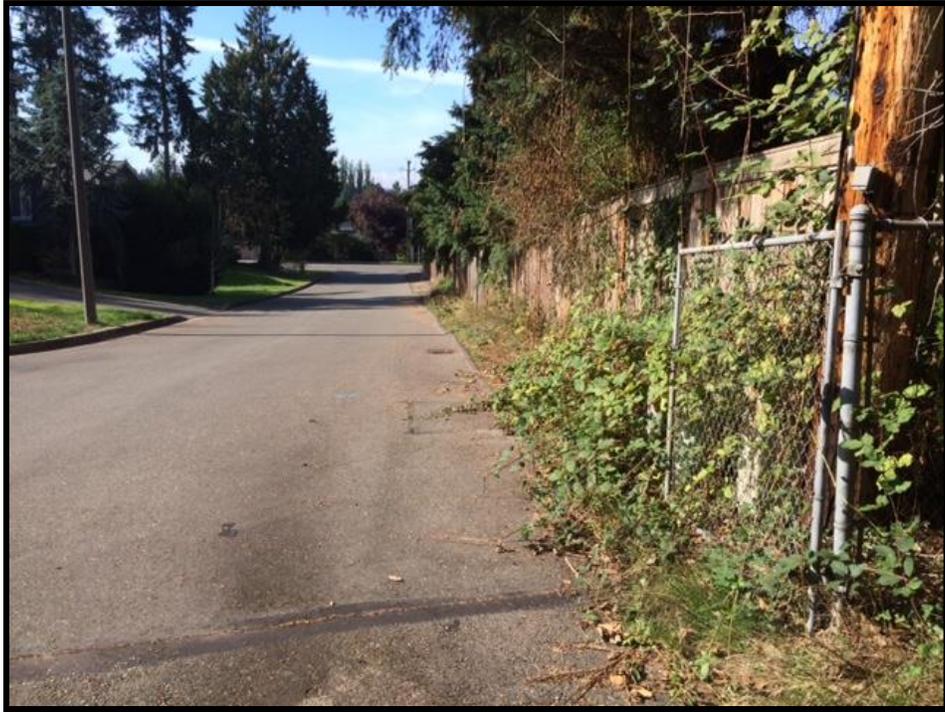
Runoff from the project site (pictured below) generally sheet flows to the south into the existing storm system on the south side of NE 72nd Street.

A field review of the downstream conditions was performed on October 10, 2014. The weather was sunny and the temperature was approximately 70 degrees. A visual reconnaissance was performed utilizing information obtained from the City of Kirkland Public Works records. Please refer to storm drainage mapping exhibits that follow for a depiction of the downstream drainage conditions.
